Bulletin No.: PIP5657C

### PIP5657C Diagnostic Aid: Engine Misfire DTC P0300

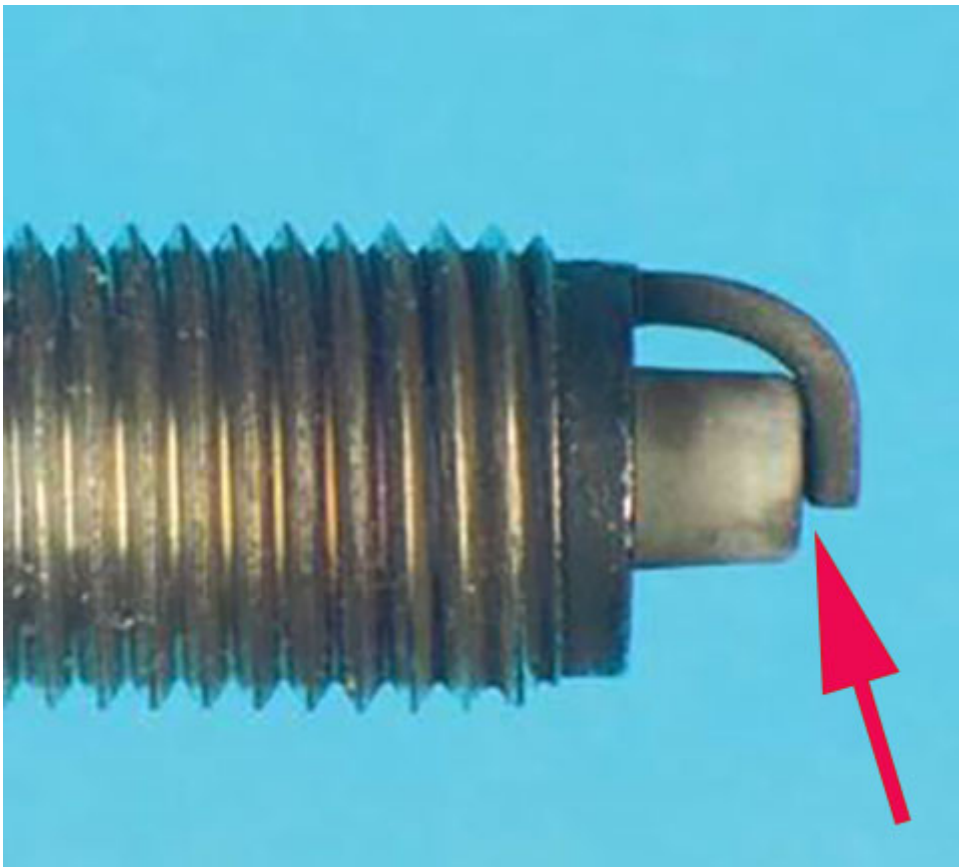
<b>Involved Region or Country:</b>	<b>North America</b>
<b>Condition:</b>	<b>Engine miss possible DTC P0300.</b>
<b>Cause:</b>	<b>Broken spark plug center insulator.</b>

Photo below shows the broken center insulator that has slid down and completely covered the center electrode.

If the above condition has been identified replace 4 spark plugs, clear any trouble codes and evaluate.
