### PIP5812A Diagnostic Tip: Potential For Oil/Moisture Condensate Freezing Up in Turbocharger Wastegate Regulator Solenoid Valve (TCV)

Brand:	Model:	Model Years:	VIN:		Engine:	Transmissions:
			from	to		
Chevrolet	Cruze	2016 - 2019	All	All	1.4 LE2	All

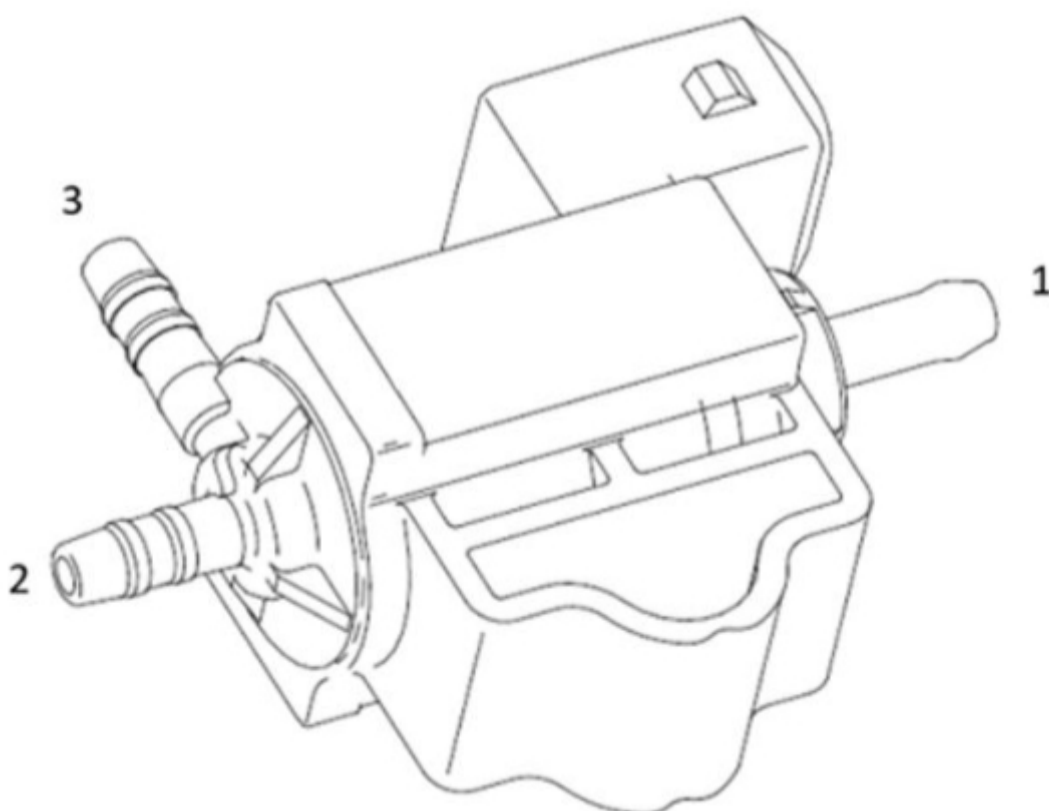
<b>Involved Region or Country:</b>	<b>North America ,Argentina, Brazil, Colombia, Ecuador, Paraguay, Uruguay, Israel, Palestine, Middle East, Israel, Chile, Peru, China, Thailand, Australia, New Zealand, Egypt, Africa</b>
<b>Condition:</b>	<b>Possible DTC P0234 P0299 that can occur during cold weather driving.</b>
<b>Cause:</b>	<b>Oil/moisture condensate freezing up in Turbocharger Wastegate Regulator Solenoid Valve (TCV).</b>

**Note: Check port #2 to assure the spring gets lifted off the seat. This will be determined by the compressed air not dead-heading when applied to port #2. When applying air**

to this port a small amount of air should be observed at port #3 and even less air will be noticed at port #1. If this does not happen, the TCV plunger may have hardened deposits from hot operating conditions which will impede TCV plunger movement and the Turbocharger Wastegate Regulator Solenoid Valve should be replaced.

1. **Remove Turbocharger Wastegate Regulator Solenoid Valve**
2. **Drain Turbocharger Wastegate Regulator Solenoid Valve (TCV) by turning valve upside down.**
3. **Using clean shop air regulated to 15-20 PSI (103kPa), blow through all three ports (1, 2 &3) for 5 seconds each. Repeat twice.**

**4. Reinstall Turbocharger Wastegate Solenoid Valve (TCV) using the latest service information and clear all DTC's using GDS and evaluate.**
