Bulletin No.: PIP5657D

PIP5657D Diagnostic Aid: Engine Misfire DTC P0300

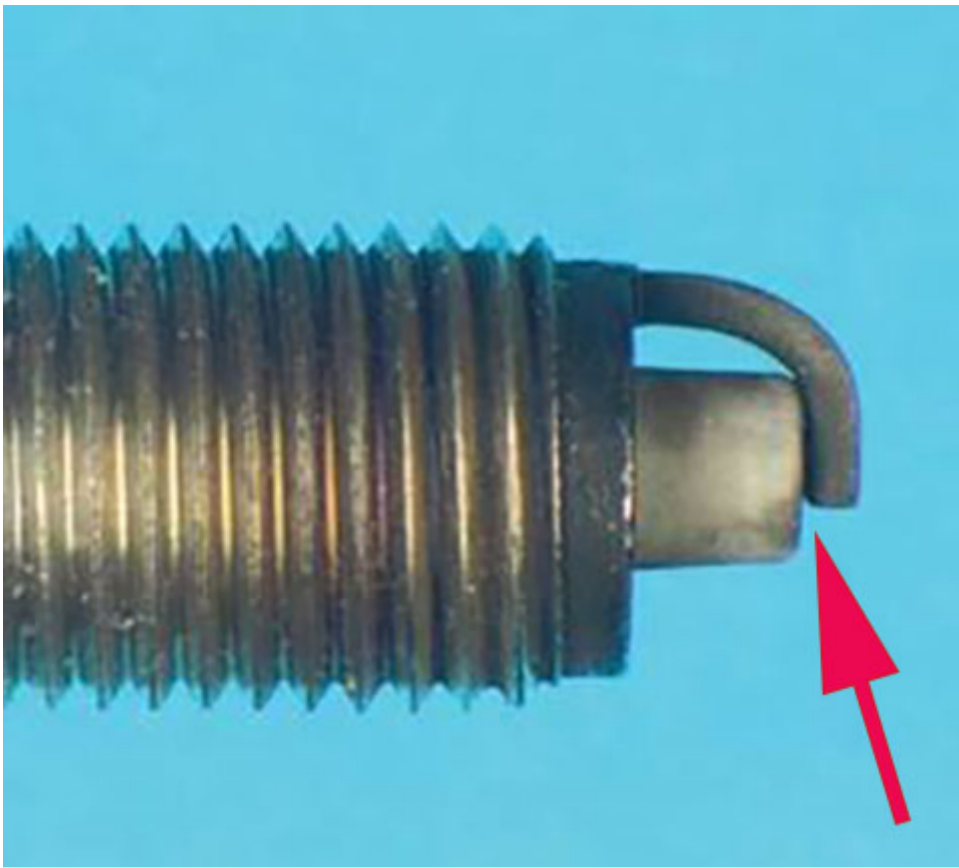
Involved Region or Country:	North America, Australia and New Zealand
Condition:	Engine miss possible DTC P0300.
Cause:	Broken spark plug center insulator.

Photo below shows the broken center insulator that has slid down and completely covered the center electrode.

If the above condition has been identified replace 4 spark plugs, clear any trouble codes and evaluate.
