Preliminary Information

PIP5651F Possible Charge Air Cooler Outlet Hose Disconnected From Throttle Body And One or More of The Following DTCs P0172, P0299, P0101, P0506, P1101

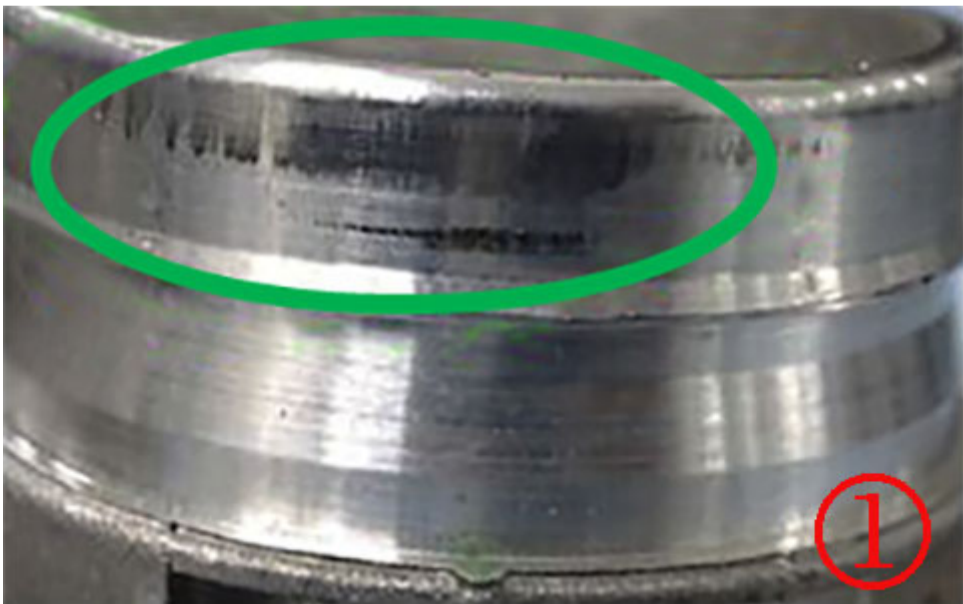
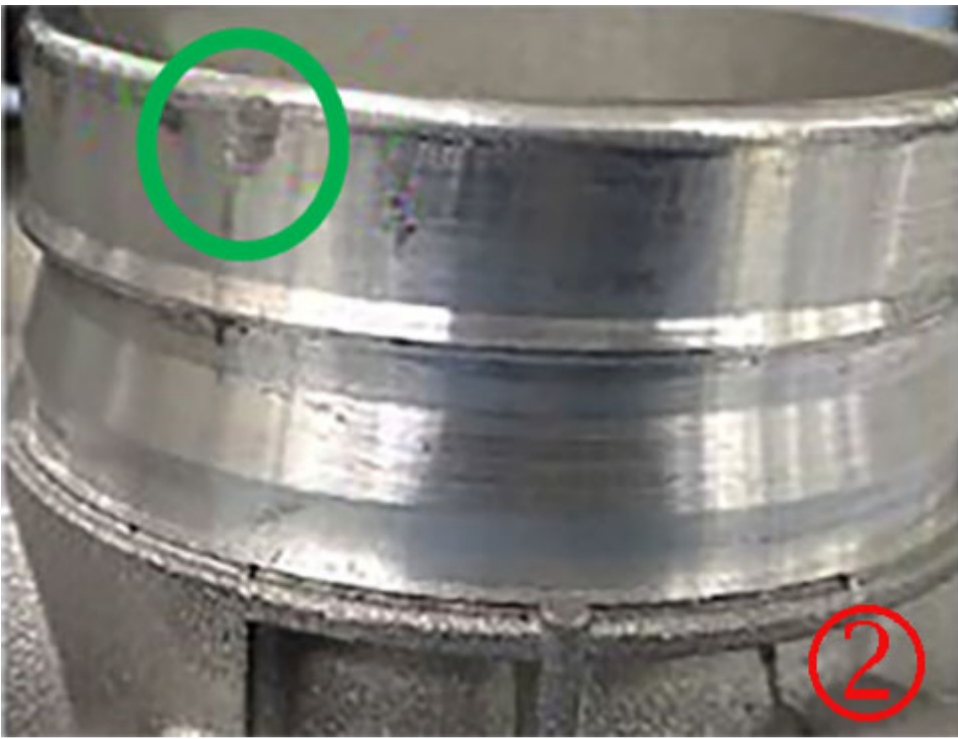
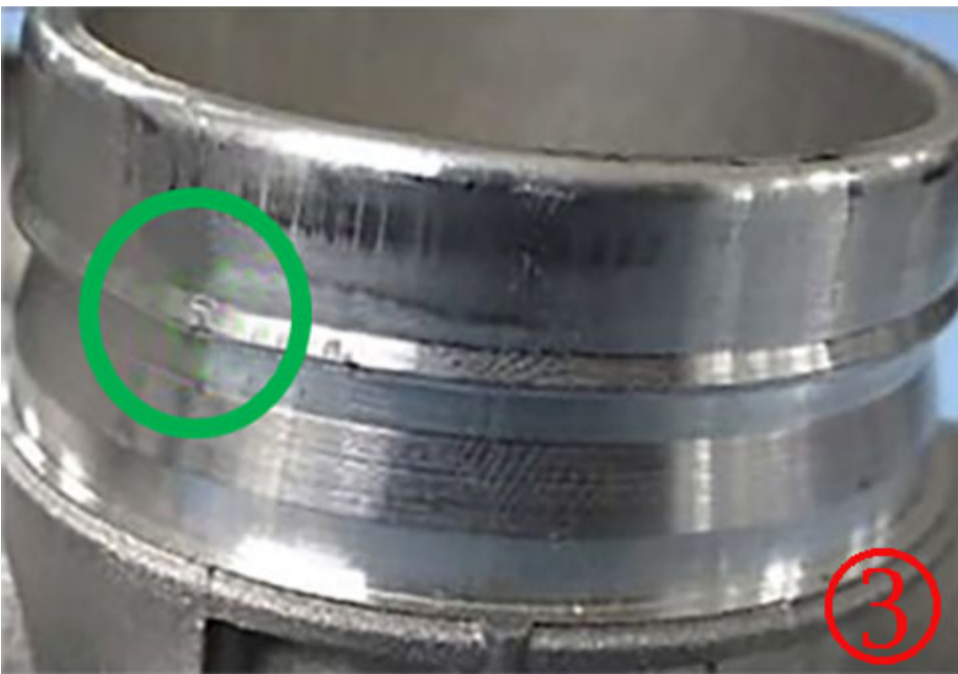
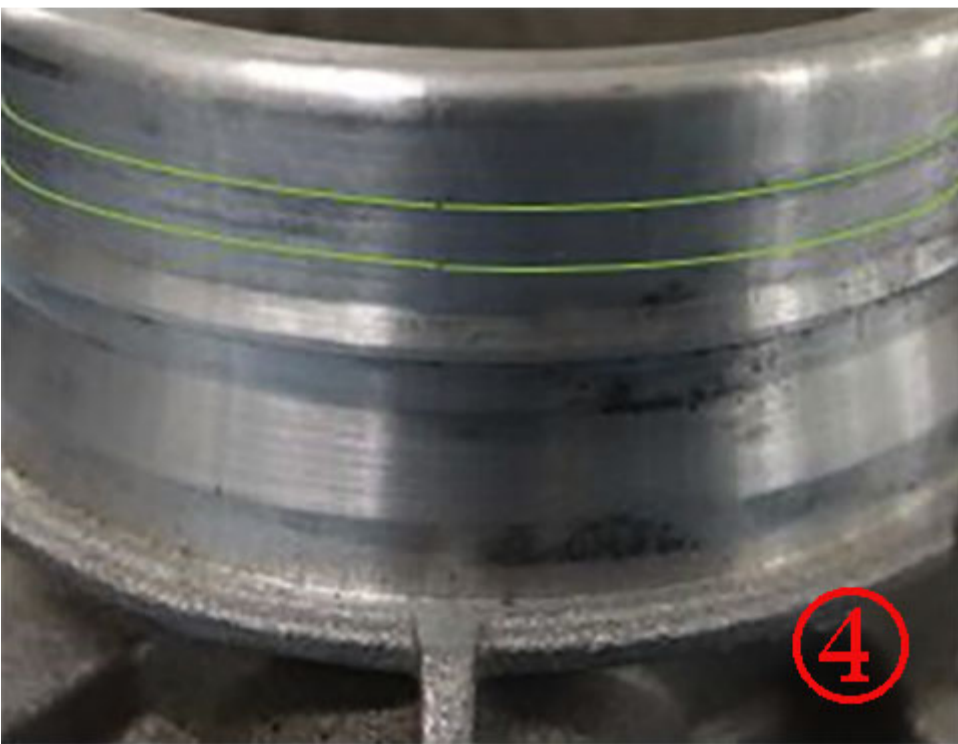
Photos 1-4 below show normal witness marks on the throttle body and normally will not require replacement.

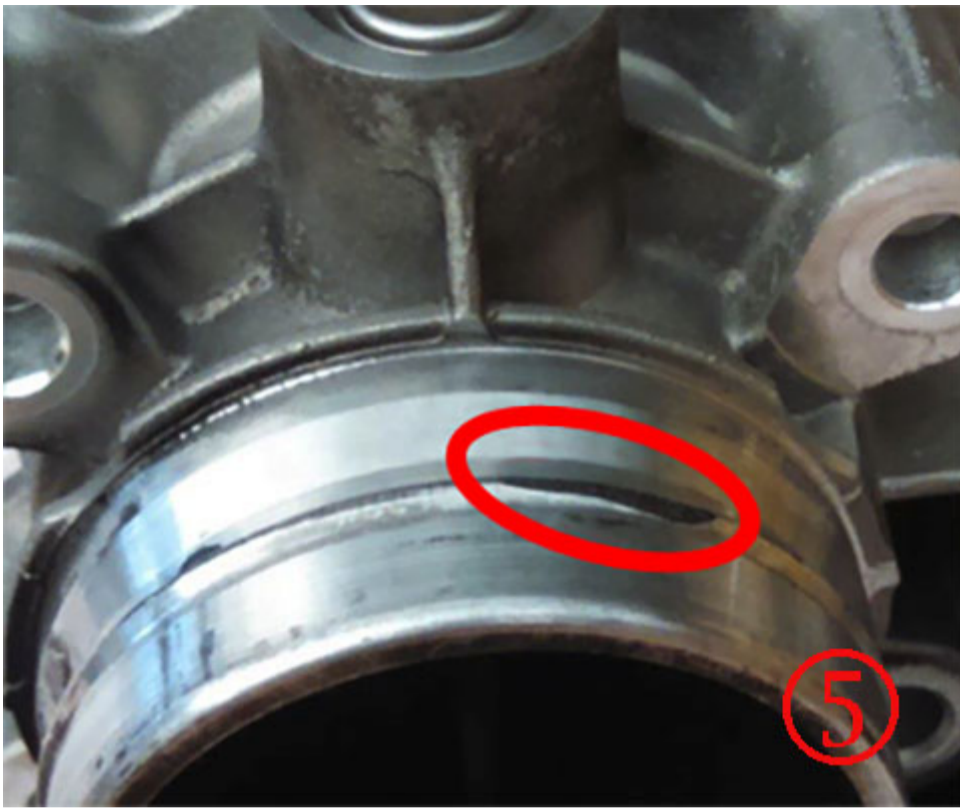
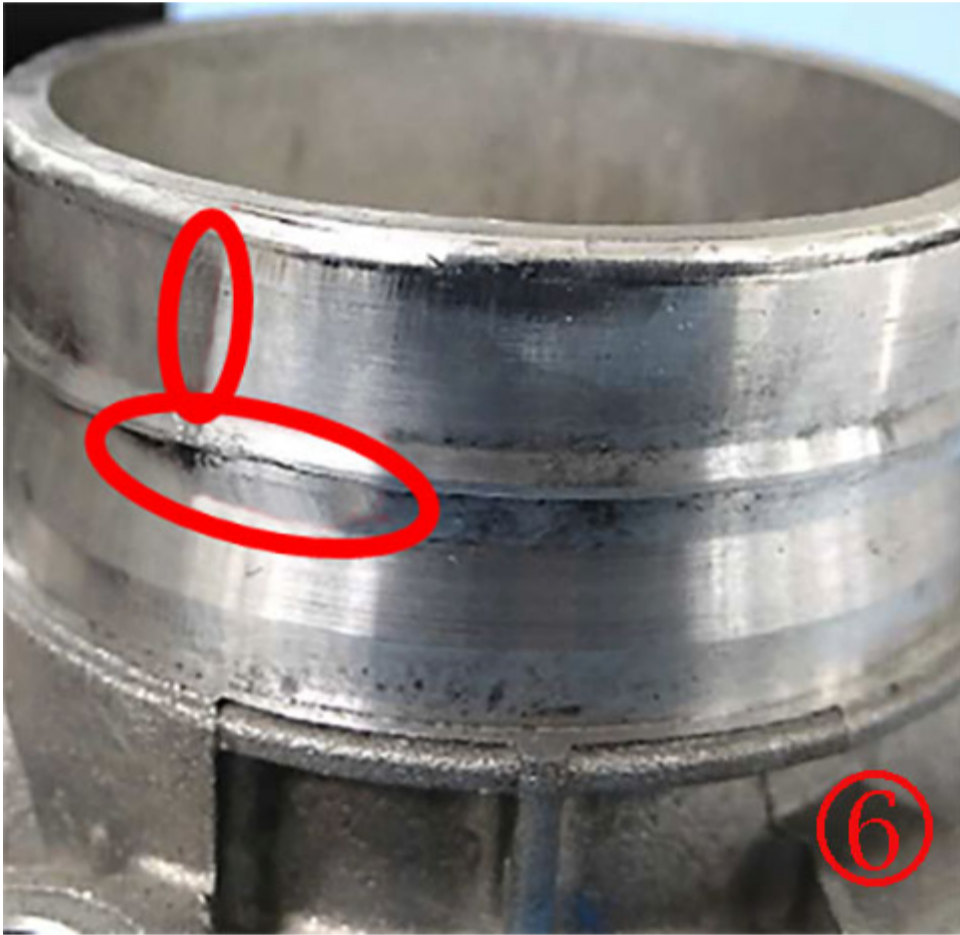
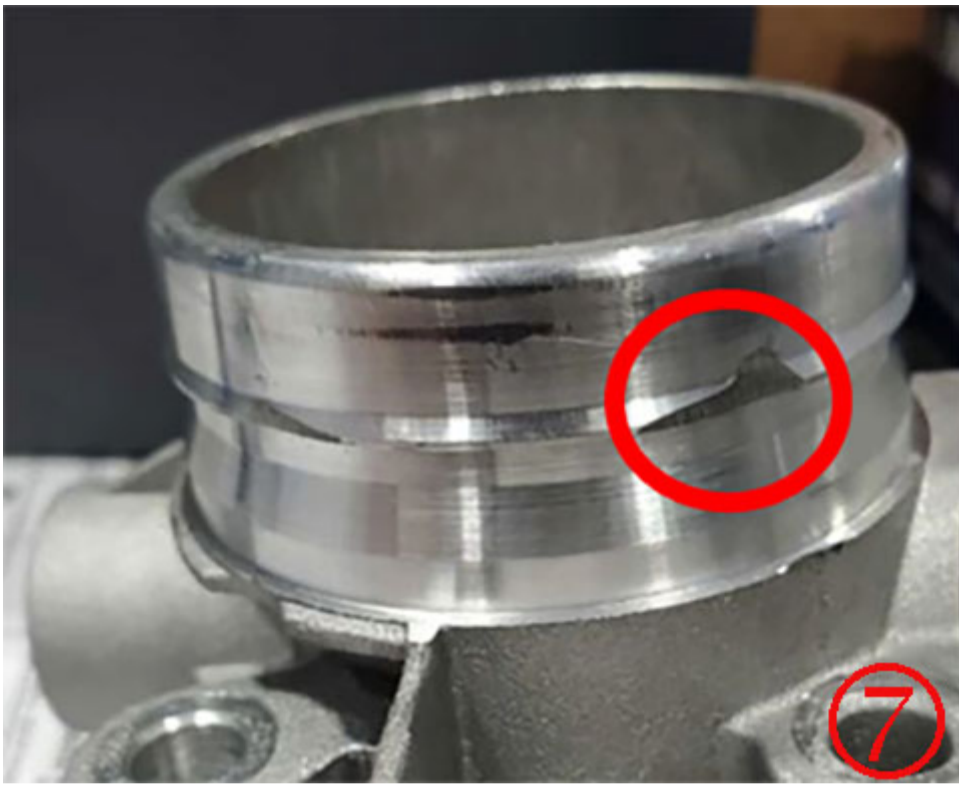
Photos 5-7 below show abnormal witness marks or damage to throttle body and replacement would be required.

If the tube is disconnected from the throttle body, inspect the charge air cooler tube and throttle body for damage. In rare cases either are damaged then replace the damaged part (reference photos below showing). The throttle body and mass airflow (MAF) sensor associated with the listed codes should only be replaced if they are damaged or found to be the cause of the code.
