<b>HYUNDAI</b> <b>Technical Service Bulletin</b>	GROUP <b>AUTOMATIC TRANSMISSION</b>	NUMBER <b>21-AT-014H</b>
	DATE <b>August, 2021</b>	MODEL(S) <b>TUCSON (TL) 1.6T, SONATA (LFa) 1.6T</b>
<b>SUBJECT: DUAL CLUTCH TRANSMISSION JUDDER DETECTION AND TCU SOFTWARE UPDATE</b>

**This TSB supersedes 20-AT-021H by putting Tucson and Sonata models on their own TSB and provides a revised GDS-M software update for low speed judder.**

**Description:** Certain vehicles (listed below) equipped with 7-speed Double Clutch Transmissions (DCT) may exhibit abnormal vibration at low speeds. This bulletin outlines the procedures for diagnosing clutch judder, updating the Transmission Control Unit (TCU) with revised logic, and/or replacing the Double Clutch.

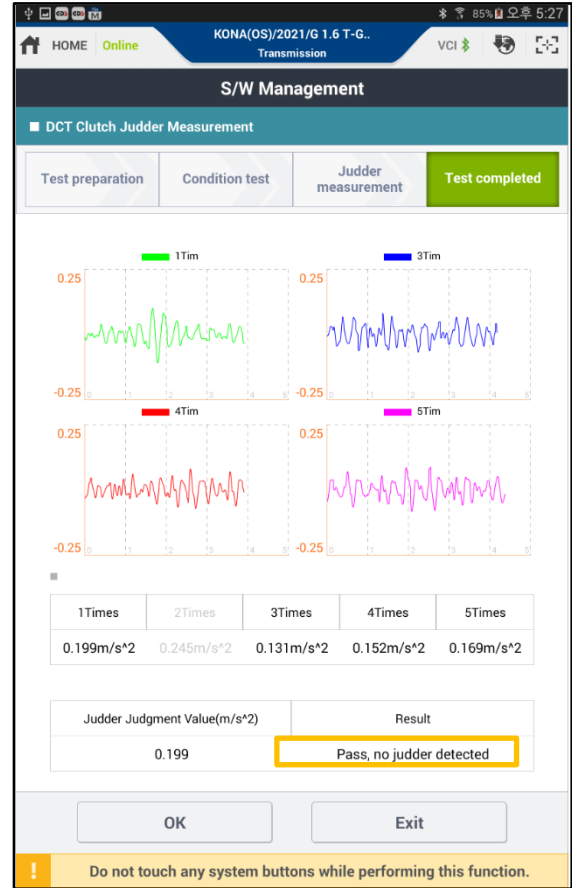
7. If the result is **“PASS, No Judder Detected”**, the service procedure is complete.

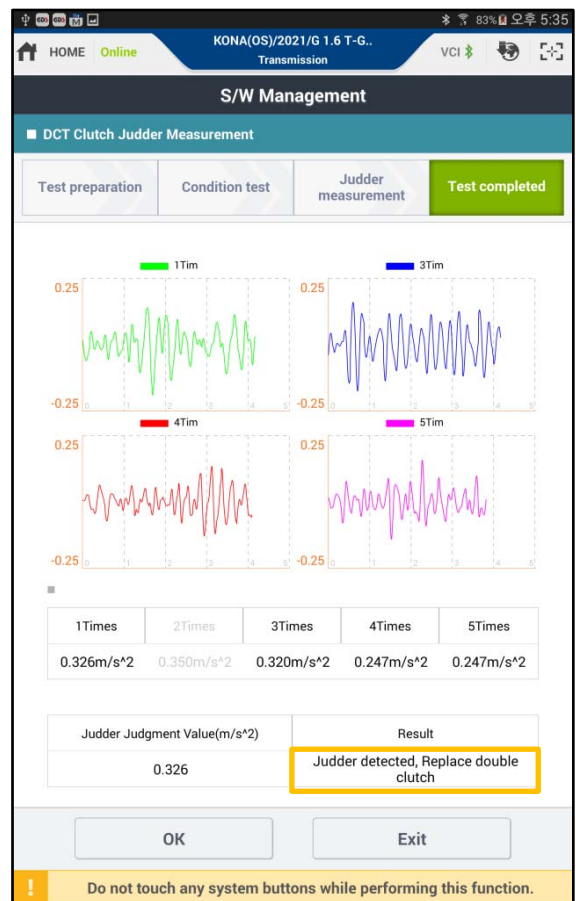
8. If the result is, **“Judder Detected, Replace Double Clutch,”** reflash TCU with latest update by referring to section **B. Automatic TCU Upgrade Procedure**.

Update the TCU with the latest software and retest before replacing the **Double Clutch**.

9. After updating the TCU, retest for Judder following GDS-M Clutch Judder Inspection steps 1-8, starting on Pages 4-7.

If the result is still **“Judder Detected, Replace Double Clutch,”** replace the double clutch assembly by referring to section **D. Clutch Replacement Procedure** on page 13.

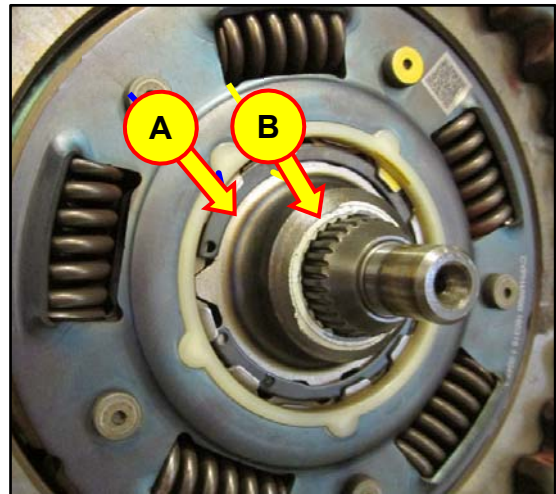
The snap ring can become deformed in the removal process. Do not reuse the existing snap rings when reinstalling the Double Clutch into the transmission.

1. Remove the Dual-Clutch Transmission following the shop manual procedure.
2. Remove the retaining ring (A) (41126-2D100) and the splined hub (B).

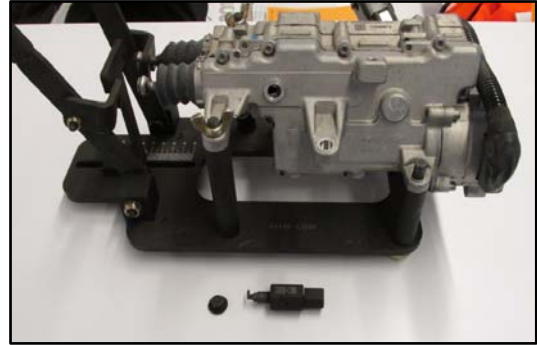
When installing a new Double-Clutch, the clutch actuator rod length must be reset back to the factory zero. If the rod length is not adjusted correctly, the GDS-M DCT relearn procedure will not complete.

7. Follow the service shop manual procedure to initialize the rod length for both odd and even clutch actuator rods.
