Technical Service Bulletin

50 Painted surface of the suspension strut tower is poorly prepared

50 21 07 2064464/1 September 7, 2021.

Model(s)	Year	VIN Range	Vehicle-Specific Equipment
Q5, SQ5	2020 - 2022	All	Not Applicable
Q5 sportback	2022	All	Not Applicable

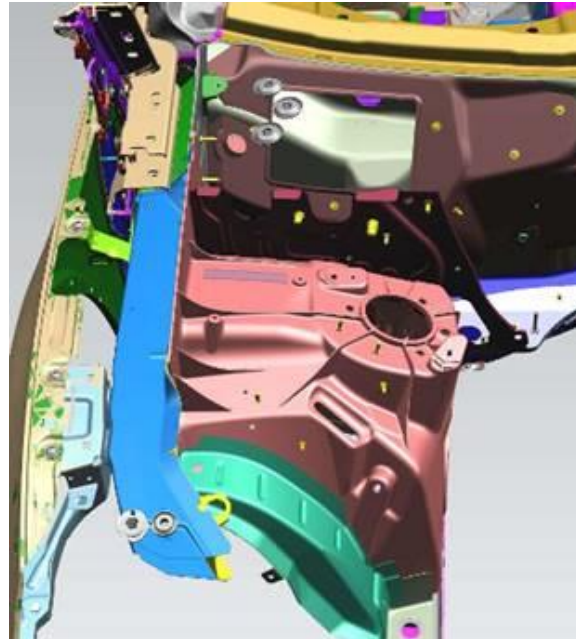
1. In the production process of joining the suspension strut tower to the adjoining structural components weld splatter is created, and after cooling, adheres to the metal surfaces. When the welding process is complete these surfaces are ground and sanded to remove any welding splatter that may have been deposited on the metal surfaces. In some cases this process was not as refined as necessary and visible scoring may appear through the painted top coat (Figure 1).

Figure 1. Area of the suspension strut tower with a poor finish.

Do not repair or file a warranty claim for this condition. It in no way constitutes a structural compromise and is purely cosmetic in nature. Please explain this to the customer.

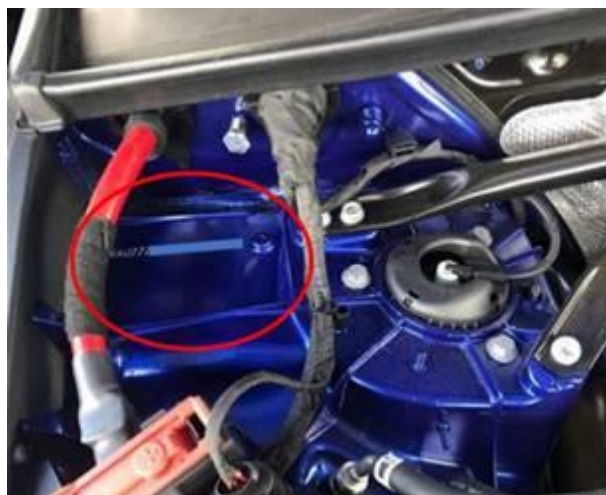
- Figure 2 shows the area of the suspension strut tower where the grinding/sanding marks may be visible. It is near the area where the VIN is stamped.

Figure 2. Area with poor finish near the VIN stamping.

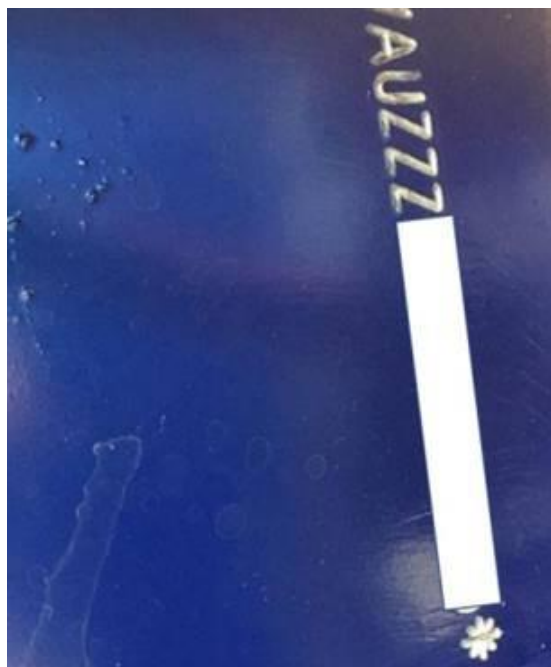
- Figure 3 shows the area with weld splatter that was not completely removed.

Figure 3. Residual weld splatter.

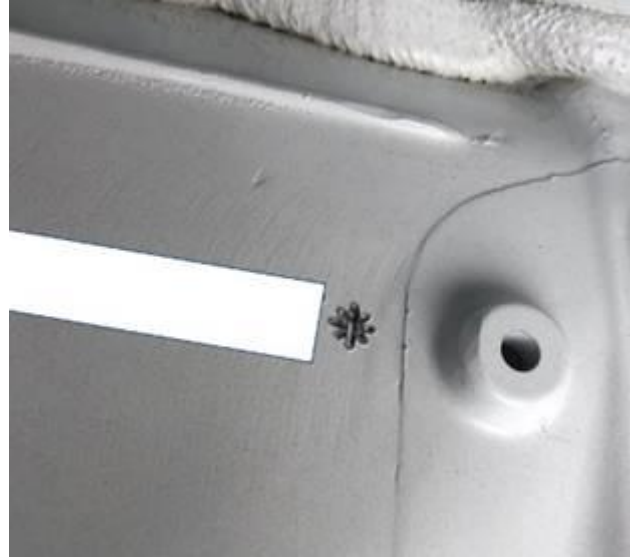
4. Figures 4 and 5 show the grinding/sanding marks still visible after painting.

Figure 4. Visible grinding/sanding marks.

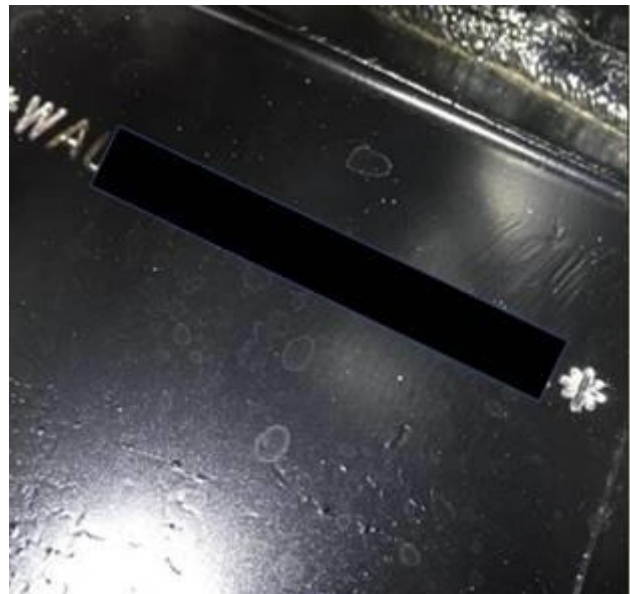
Figure 5. Visible grinding/sanding marks.
