# Service Action

## Code: 40R1

**Subject: Service Action 40R1 - Front Stabilizer Coupling Rod**

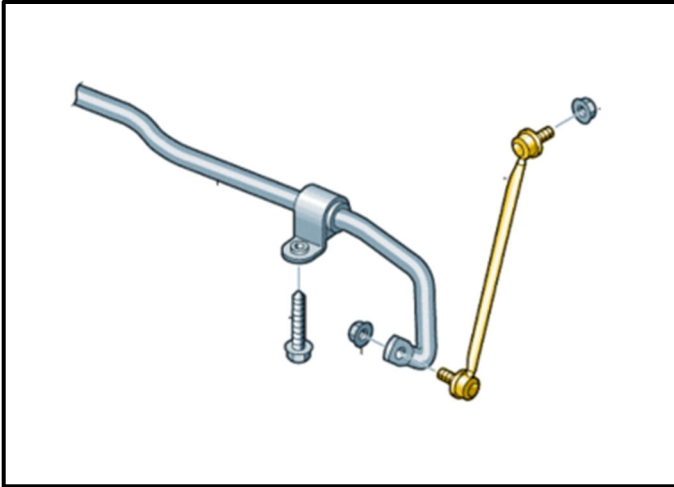
- Inspect front coupling rods and replace if necessary.
- Replace all four front coupling rod nuts.
