Technical Service Bulletin

91 SOS Emergency call function deactivated message in the cluster, DTC U153E00 is stored in the telematics module

91 21 36 2055945/7 September 22, 2021. Supersedes Technical Service Bulletin Group 91 number 21-29 dated September 7, 2021 for reasons listed below.

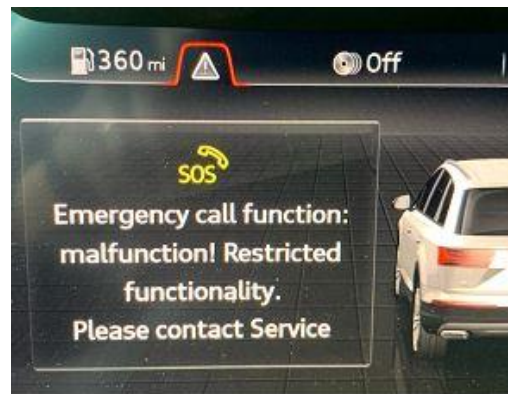
- The warning message “SOS Emergency call function deactivated” is seen in the instrument cluster (Figure 1 or 2).

Figure 2. SOS warning in the instrument cluster.
