Technical Service Bulletin

94 Rear lights do not switch from bumper to hatchgate after closing

94 21 47 2050234/5 September 22, 2021. Supersedes Technical Service Bulletin Group 94 number 18-96 dated January 30, 2018 for reasons listed below.

Model(s)	Year	VIN Range	Vehicle-Specific Equipment
Q5	2018 - 2023	All	Not Applicable
Q5 sportback	2022 - 2023	All	Not Applicable

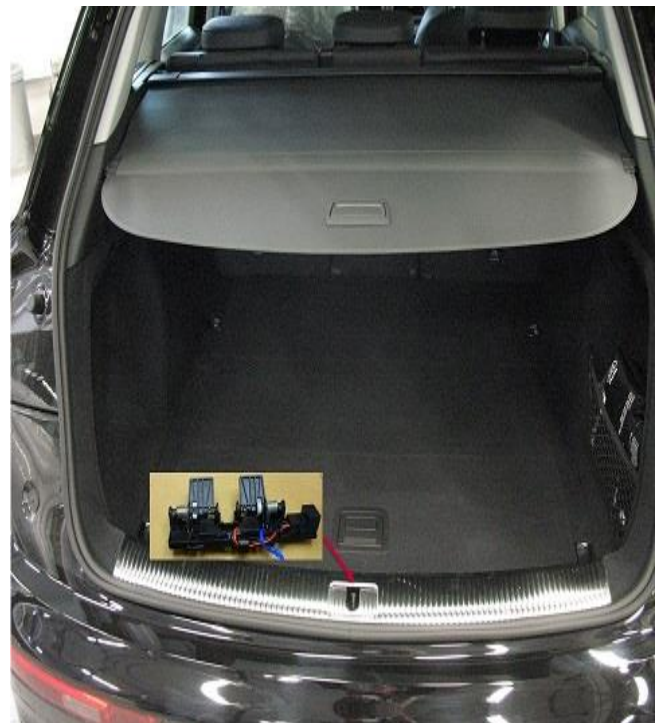
The two micro switches for the reverse light change-over are under the loading sill cover on the rear cross panel and are secured to the striker for the rear lid lock (Figure 1).

1. The paddle on the micro switch was broken due to the adjustment of the rear hatch or the striker in production.
2. Dirt can block one/both paddles on the micro switch, which is fastened to the striker of the rear lid (Figure 2).

Figure 1. Rear lid closed sensor.

3. Replace the rear lid closed sensor if found broken (Figure 1).
4. If debris is found to be obstructing proper switch activation/deactivation, activate the switch paddles using your fingers and remove the debris. Using compressed air is effective.
5. Then check the measuring values for the G525 and G526 switches and replace the rear lid closed sensor if the malfunction persists. Only the improved rear lid closed sensor with the protective enclosure is available.

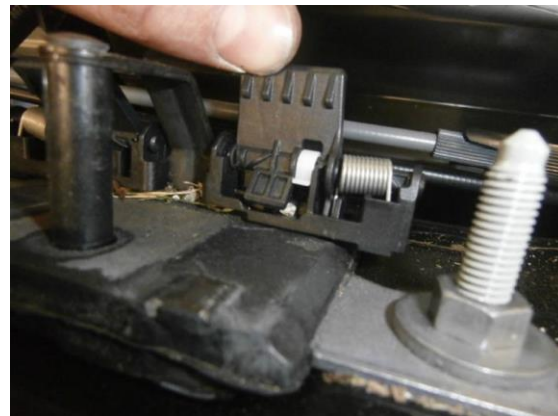
Figure 2. Debris trapped in the rear lid closed sensor.
