Technical Service Bulletin

20 Noises from the fuel line

20 21 37 2059997/3 September 30, 2021. Supersedes Technical Service Bulletin Group 20 number 21-33 dated January 15, 2021 for reasons listed below.

Model(s)	Year	VIN Range	Vehicle-Specific Equipment
Q3	2019 - 2022	All	Not Applicable

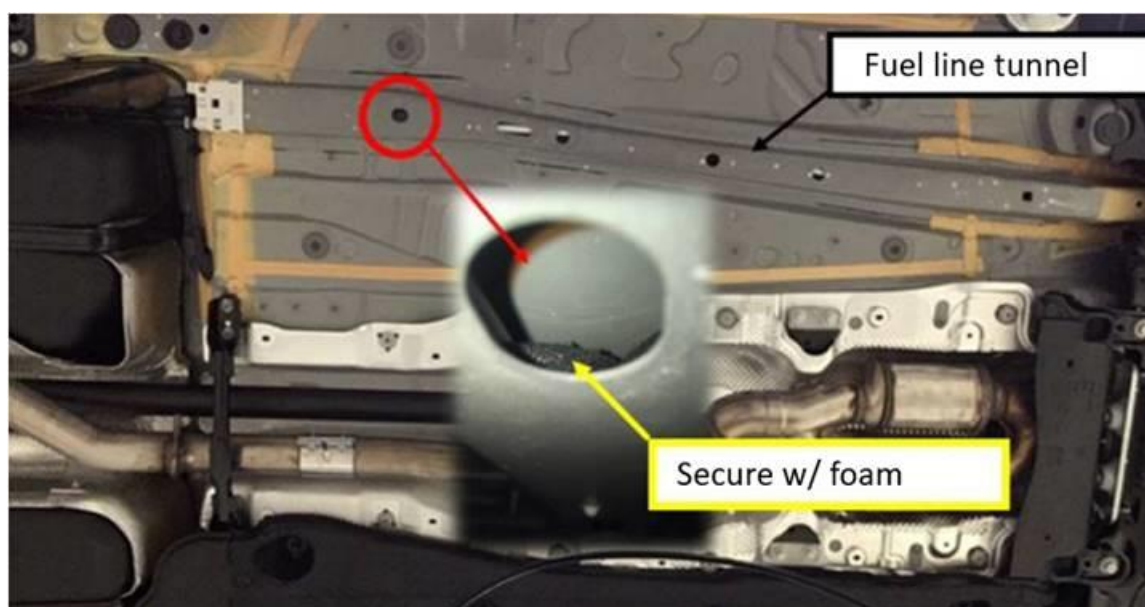
- The fuel/EVAP lines in the longitudinal member start to vibrate in certain operating situations and this creates the noise.

Due to pressure pulsation from the high-pressure pump on engine side the underfloor line in the underbody tunnel vibrates. This vibration causes noise that can also be heard in the vehicle interior.

Figure 1. Location of the vibrating fuel line.

1. Remove the underbody cover.
2. Coat the fuel and EVAP line tunnel or fill the space around the fuel and EVAP line with closed-pore foam (foam that doesn't soak up water) part number 321 201 299. This means the fuel/EVAP line does not have to be removed.

3. Reinstall the underbody cover.
