Technical product information

Topic	Creaking noise from the upper C post trim panel
Market area	Bentley: worldwide (2WBE)
Brand	Bentley
Transaction No.	2061928/2
Level	EH
Status	Approval
Release date

New Flying Spur

Creaking noise from the upper C post trim panel

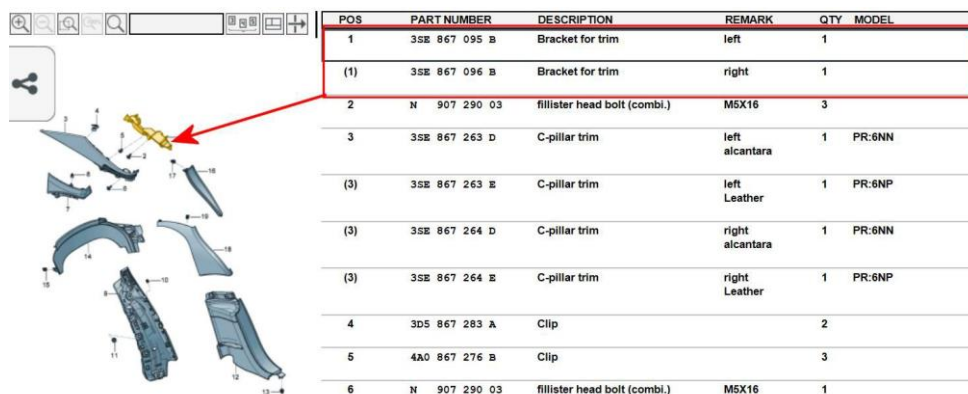
TIP: If the creaking noise occurs only when pressure is applied in this position, the concern is related to the tape specification which is fitted to the applicable upper C post bracket

2) Remove the applicable upper C post trim panel – Refer to Rep.Gr 70 to gain access to the Brackets shown in Figure 1
