## P20EE (diagnostic troubleshooting code) SOLUTION - NOX CONVERSION EFFICIENCY

Prevost vehicles

B13R (9700 us/can)

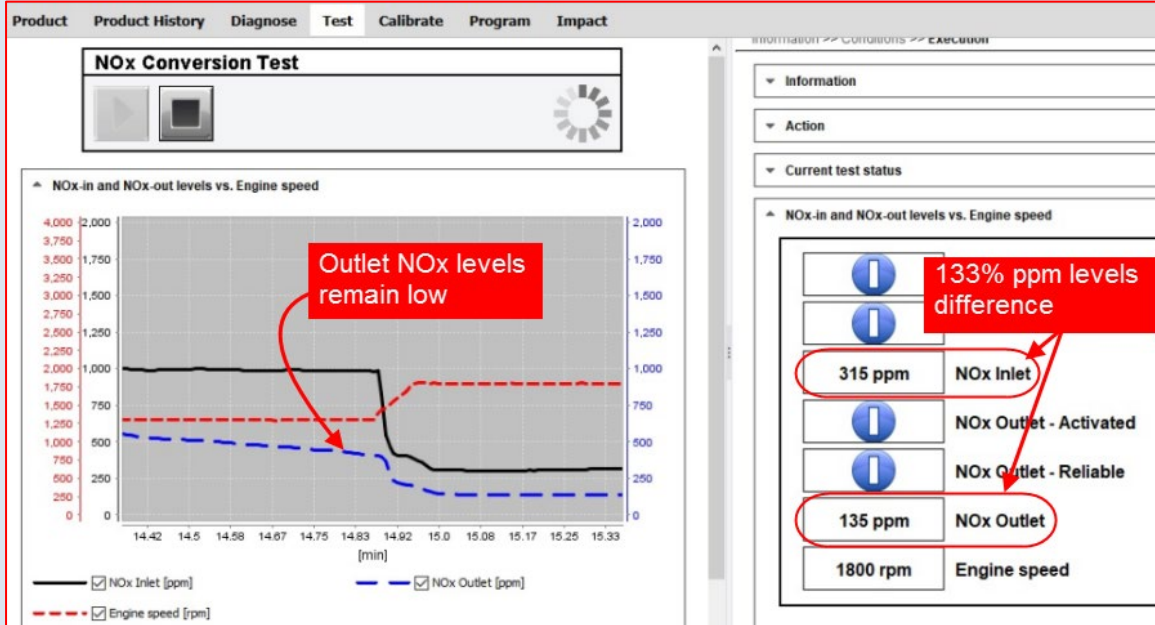
Engine ECU software number 23470183 allows DEF dosing to continue during the last part of the NOx conversion test (just before shutdown). This causes continued low outlet NOx sensor ppm levels, as seen in the example below. **Take screen captures.**

**DIFFERENT BEHAVIOR.** In this example, the NOx sensors ppm levels are not close to each other because DEF is still injected during the last part of the test. **In this instance, review earlier sections of the test** to ensure that both sensors are responding to changes in the same manner. Examples of different stages to review are shown below.

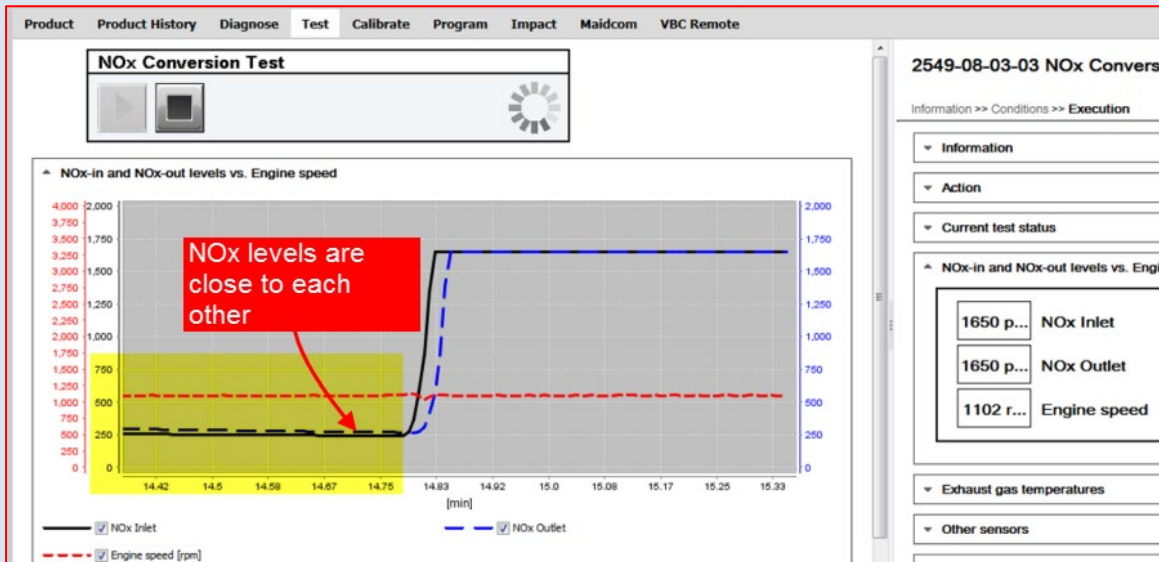
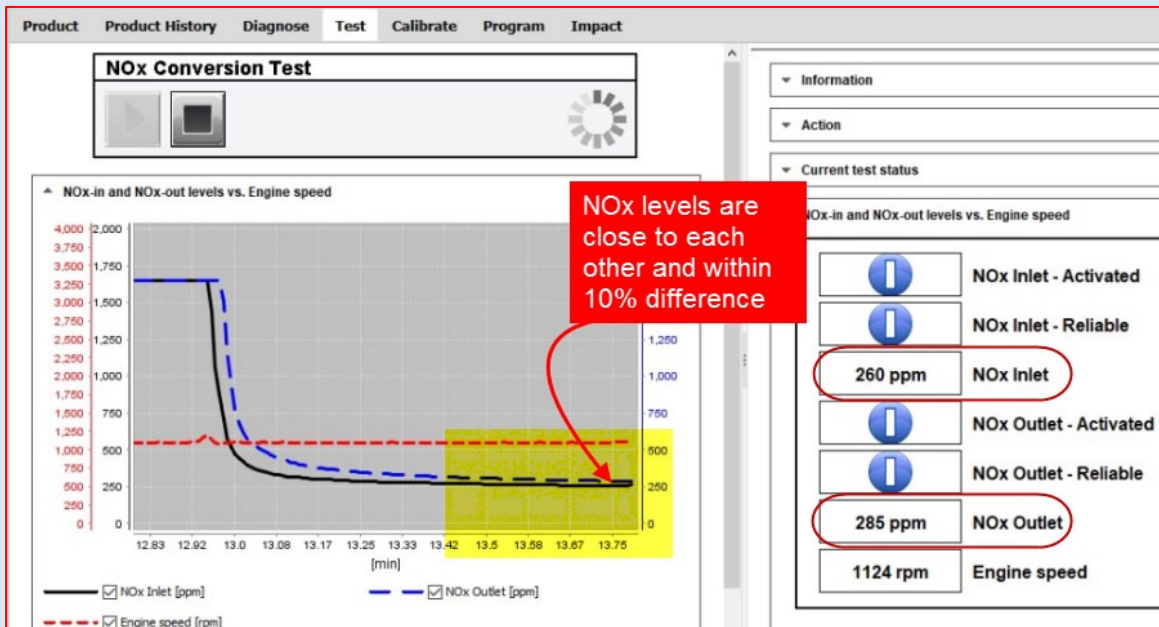
## COMPARISON SHOULD BE DONE WHEN BOTH NOX SENSORS ARE READING BELOW 600 ppm

The NOx sensors levels are close to each but earlier during the test (images above & below).

If both NOx sensor ppm levels are **close to each other** at a point during the test as shown in the examples (image) above, then both NOx sensors are good.

If ppm levels difference is **greater than 10%**, then the sensor reading higher should be considered as defective.

Replace the defective sensor<sup>1</sup> if applicable and then perform a new NOx sensor test once again to make sure that the replacement sensor is good.
