## Tips & Tricks – All Models

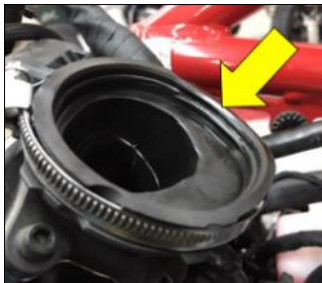
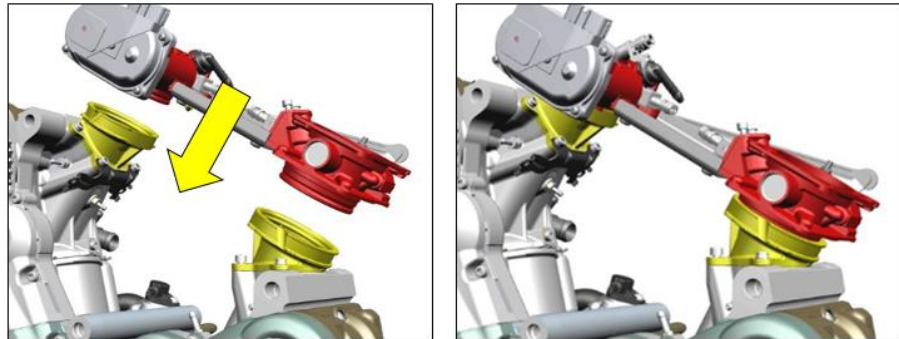
<p>We have received some complaints about a possible engine popping sound during deceleration. The performed analyses have shown that this symptom could be caused by an incorrect installation of the throttle bodies in the relevant intake manifolds (possible deformation of the rubber profile).</p> <p>Therefore, if you find any similar symptoms, we kindly ask you to check the correct installation of the Airbox on the motorcycle and that:</p> <ul style="list-style-type: none"><li>- throttle bodies are correctly inserted inside rubber intake manifolds, along the whole perimeter;</li><li>- the rubber profile of the intake manifolds is not deformed.</li><li>- the 2 fastening ties are correctly positioned in the seat on the intake manifolds.</li></ul> <p>Please be reminded that, to make throttle body insertion easier on rubber intake manifolds, the use of silicone lubricant or similar product is absolutely necessary.</p>

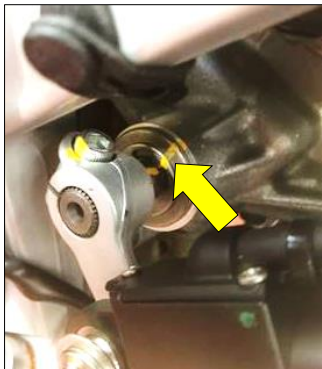
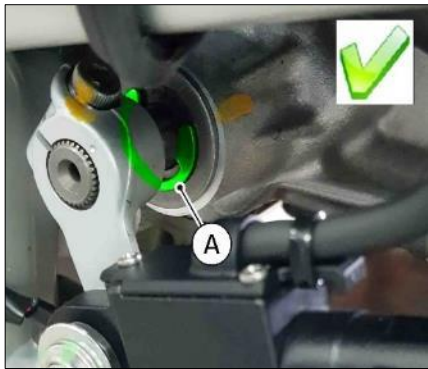
<p>We have received some isolated reports of a possible loss/absence of the <b>snap ring (A)</b> of the gear selector shaft. We would like to inform you that an additional certification on all Desmosedici Stradale engines between snap ring, washer, and crankcase at the outlet of the gear selector shaft has been added along the production line. The first engine serial number with this new certification is ZDM1100WC #001513#.</p> <p>Upon the first workshop service, you are thus invited to check for the presence of the <b>snap ring (A)</b> on all engine serial numbers preceding the one specified above.</p>

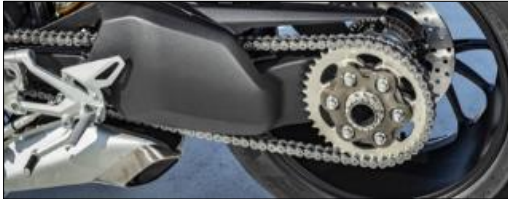
<p>We have received reports of some complaints about rough shifting with DQS, particularly at low rpm. In other words, rough shifting with uncomfortable torque cuts.</p> <p>We have checked that very often <b>the cause is related to an incorrect chain tensioning</b>, especially after the first settling of the chain which takes place at around 200/300 Km (new motorcycle or chain). We therefore invite you to always check the correct tensioning of the final drive chain before making further analysis.</p>

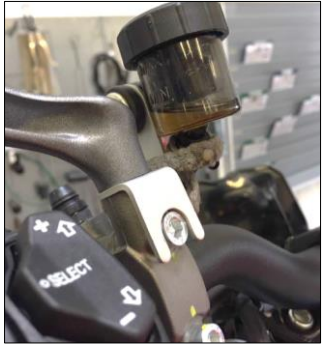
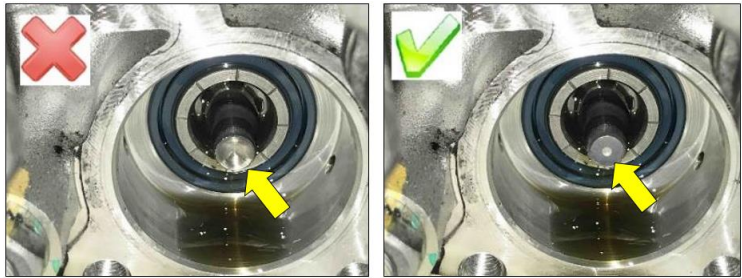
<p>We received a few claims concerning a reduction of the clutch fluid level inside its reservoir. We would like to inform you that it is not sufficient to carry out the bleeding procedure or top up the clutch fluid inside the reservoir. We suggest, at a preliminary stage, to check:</p> <ul style="list-style-type: none"><li>• the play between the clutch master cylinder and the lever</li><li>• if the clutch pushrod is worn or damaged in the area of contact with the clutch slave cylinder (ball)</li><li>• the condition of the clutch slave cylinder protective diaphragm, which must not be torn.</li></ul> <p>According to our analyses, this phenomenon is due to a DOT4 leakage from the primary seal of the clutch slave cylinder (missing fluid in the reservoir builds up in-between the clutch slave cylinder diaphragms); in some cases, this phenomenon is also accompanied by wear of the clutch pushrod. We therefore ask you to replace the slave cylinder with a new <b>part no. 19540091D</b> featuring a new gasket in order to prevent the phenomenon described above.</p> <p>If the clutch pushrod is damaged as shown in the figure, replace it as well.</p> <div data-bbox="1256 727 1995 1005">

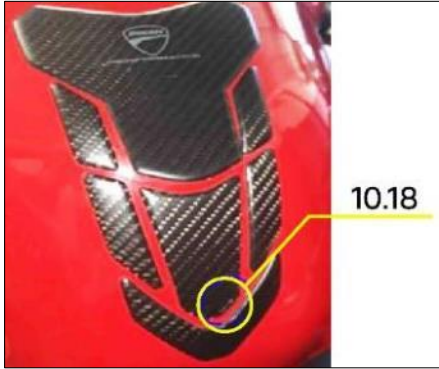
<p>We have received some reports about the detachment of the carbon adhesive protection from the fuel tank. We inform you that the supplier of the component has introduced improvements to avoid the detachment of the protection, since year of manufacture 2019. The lot and the year of manufacture <b>XX-19 (week-year of manufacture)</b> can be identified on the component, like in the example shown in the figure.</p>

<p>In case you still have in stock some carbon tank protectors produced in 2018 you can still sell them to Customers and install them. Should any anomaly occur on the latter, you can manage the replacement of the protection through an accessory warranty. The spare parts in stock have been reclaimed. In any case, it is essential to follow the accessory instructions ISTR-892 ed.01 published in DCS for the application of the tank protection. The cleaning of the tank surface and the use of the template supplied with the protection are essential for a successful application.</p>

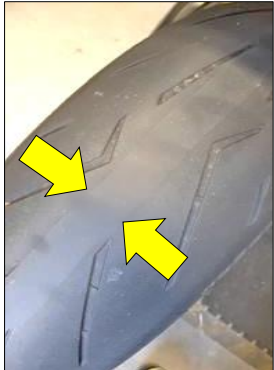
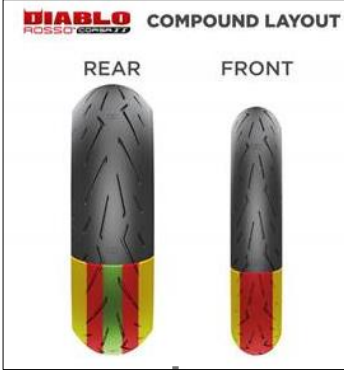
<p>We have received some isolated reports of the appearance of a "band" in correspondence with the central area of the Pirelli Diablo Rosso Corsa II rear tire.</p> <p>We would like to inform you that, since these are extremely sporty tires with 5 different compound zones at the rear, it can happen that, depending on the type of use of the motorcycle, they wear out in a different way causing the above mentioned phenomenon to occur; sometimes this occurs on the shoulder area, sometimes in the central area but, in general, it is a purely aesthetic phenomenon that does not affect the performance of the tire itself.</p>

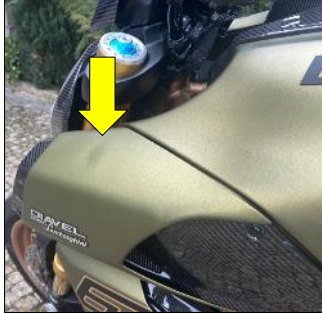
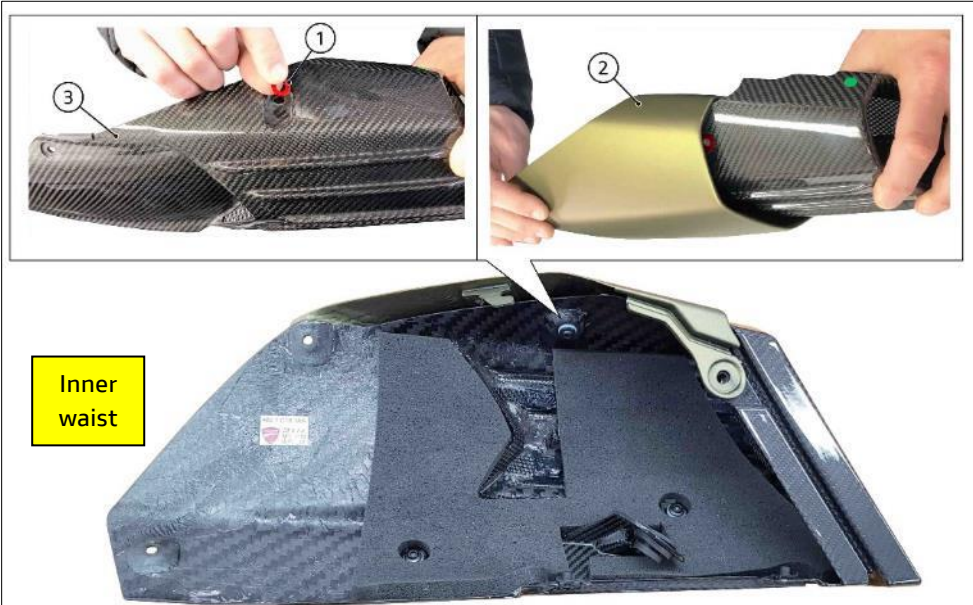
<p>We have received some isolated reports about a possible indentation of the RH and/or LH outer cover of the air conveyor.</p> <p>To avoid this phenomenon, it is necessary to position <b>washer (1)</b> 4x14x1 Part no. 85240171A between <b>outer cover (2)</b> and carbon air <b>conveyor (3)</b> in the upper fixing point, as shown in the figure.</p>

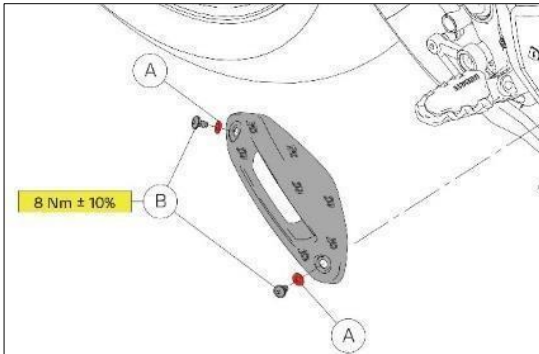
<p>We inform you that the assembly instructions for the carbon horizontal manifold heat guard kit by Ducati Performance part no. 96980251A have been updated. In particular, in order to install the part, <u>you must reuse the 2 washers (A) present on the original heat guard.</u></p> <p>Please always comply with the tightening torque of the 2 screws M6x12 (B) of <b>8 Nm ± 10%.</b></p>

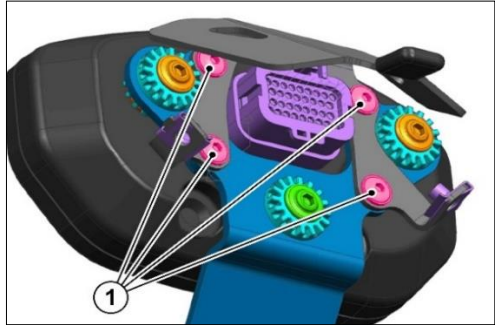
<p>We have received a few reports stating that <b>4 M5x8 screws (1)</b> part no. 77240243C required to fix the headlight fairing support bracket to the instrument panel support bracket are missing from the kit supplied with the motorcycle.</p> <p>We would like to inform you that the kits available in stock have all been sorted out.</p> <p>For the headlight fairing assembly procedure and all Pre-delivery operations, please refer to the model introduction bulletin SRV-SRB-21-022.</p>

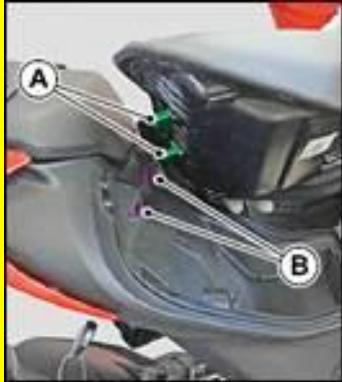
<p>We have received some reports about the possibility of unhooking the rear fasteners of the rider seat (the two <b>pins (A)</b> on the rear end of the underseat plate come out of from their <b>seats (B)</b> on the rear subframe).</p> <p>We would like to inform you that to avoid the phenomenon described above, the underseat plate has been updated by lengthening the rear fasteners; the new specific part numbers for each country version are indicated below:</p> <ul style="list-style-type: none"> <li>• Part no. 595P6961BA: lowered rider seat (country versions Japan, South Korea and Taiwan)</li> <li>• Part no. 595P6801CA: rider seat</li> </ul> <p>The new seats were introduced into production at the end of May and the spare parts warehouse has been rectified with the new part numbers.</p>

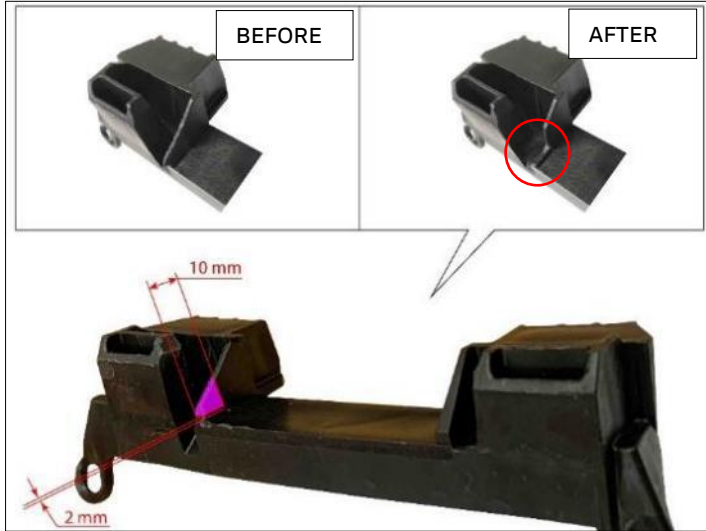
<p>When mounting the rider seat in "high configuration", an excessive gap can be seen between the lower trim and the RH side panel. This is due to interference between the central riser and its support. To avoid such interference and therefore improve the coupling between the rider seat and the side panel, it is necessary to:</p> <ol style="list-style-type: none"> <li>1) Remove the center riser from the seat;</li> <li>2) Working on the RH side support, remove the excess material with a cutter, as shown in the figure.</li> <li>3) Reinstall the center riser to the seat.</li> </ol>

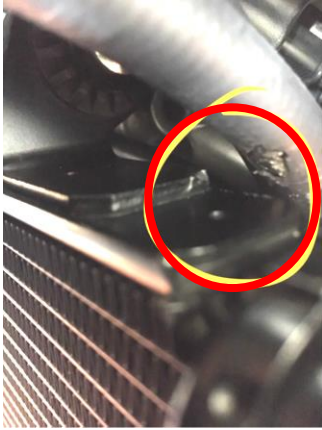
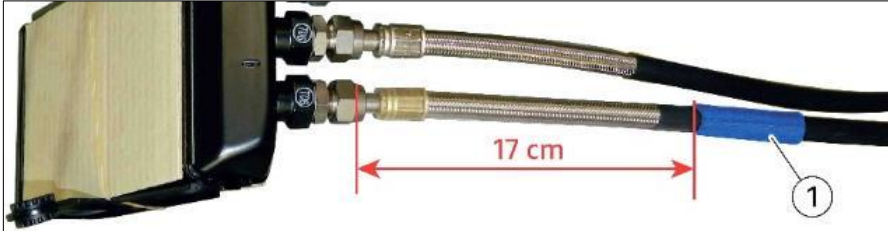
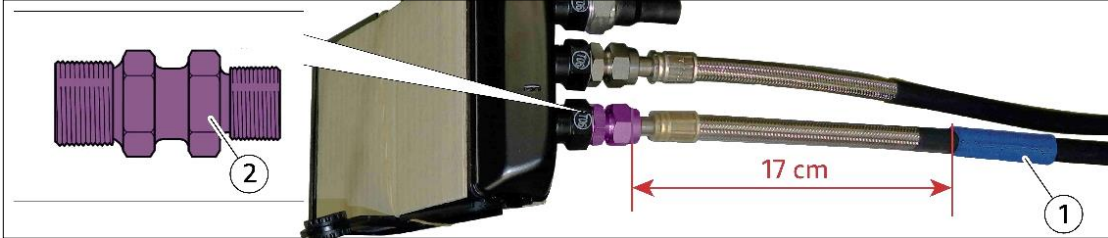
<p>We have received some isolated reports of possible surface damage to the oil cooler return pipe due to rubbing with the top of the coolant radiator, over time. <u>This phenomenon is purely aesthetic and does not affect the correct operation of the system.</u> We inform you that for the models:</p> <p>a) <b>Multistrada 1260:</b>  starting from the frame number ZDMAC03AAAKB011354 (on 27/05/2019) the <b>anti-abrasion sheath (1)</b> part no. <b>4601H701A</b> has been introduced on the oil cooler return pipe, positioned at a distance of <b>17 cm</b> measured from the upper end of the fitting. (This solution is also applicable to all Multistrada 1200 versions Model Year 2015-2017).</p>

<p>b) <b>Multistrada 950:</b></p> <ul style="list-style-type: none"> <li>- starting from the frame number ZDMAD00AAKB002259 (on 10/05/2019) the <b>anti-abrasion sheath (1)</b> part no. <b>4601H701A</b> has been introduced on the oil cooler return pipe, positioned at a distance of <b>17 cm</b> measured from the upper end of the fitting;</li> <li>- starting from the frame number ZDMAD00AALB005691 (on 12/03/2020) the longer fitting (2) part no. <b>81510391A</b> has been introduced at the oil return pipe outlet from the cooler.</li> </ul>

<p>We ask you to always check the condition of the oil cooler return pipe, and to replace it <b>ONLY</b> if the rubber sheath is damaged and the metallic braided hose can be seen. Follow the assembly notes indicated above according to the reference model. The spare part catalogue has been updated.</p>

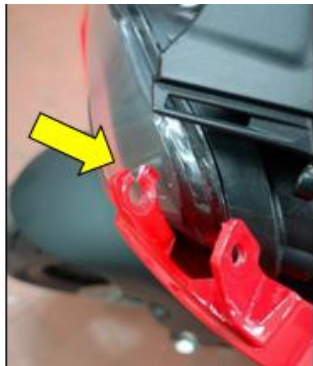
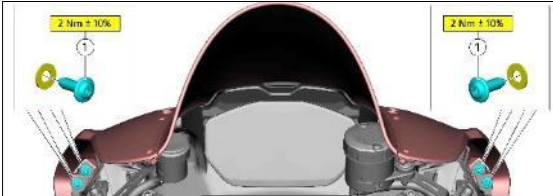
<p>We received some isolated claims about the possible breakage of the top fastener retaining the LH side half-fairing to the headlight fairing.</p> <p>During PDI and whenever removing the side half-fairings, we remind you to pay utmost attention to the tightening of the <b>2 screws M5x0.8 (1)</b> retaining the upper LH and RH half-fairings to the headlight fairing; always comply with the specified tightening torque of <b>2 Nm ± 10%</b>.</p>

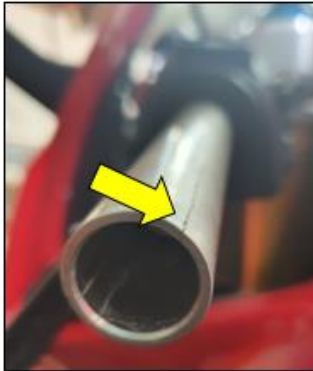
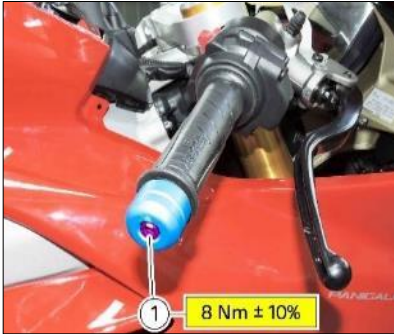
<p>We received some isolated claims about the possible triggering of a longitudinal crack on the handlebar, on balancing weight side. Our laboratory analyses found that said crack is due to an excessive tightening torque applied when installing the balancing weights.</p> <p>When installing balancing weights on the handlebar, please comply with the tightening torque specified for the M6x55 screw of <b>8 Nm ± 10%</b>, as indicated on the bulletin introducing the model and on the Workshop Manual.</p>

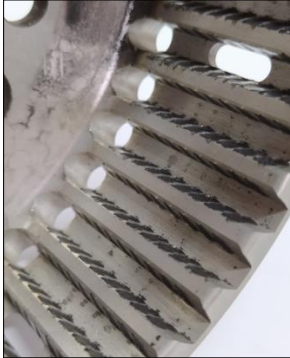
<p>We have received some isolated reports of possible clutch slipping, due to clutch housing indentation, which does not allow the drive and driven plates to come back into contact with each other correctly. This phenomenon depends on the use of the motorcycle and the user, therefore for racing use we suggest replacing the plates approximately every 5000km,.</p> <p>We would like to inform you that the new clutch housing with deep anodizing <b>part no. 19810671C</b>, replacing the natural grey one, is available as a spare part; this treatment improves the reliability of the clutch housing reducing the damaging of the drive plates on its contact surface.</p>
18	<p><u>ONLY</u> <b>Panigale V4 MY21</b></p> <p>Error "P0919 - Gear sensor plausibility" with MIL warning light turning on and/or failed display of the engaged gear on the instrument panel</p>	Error "P0919 - Gear sensor plausibility"	-	<p>If the error "P0919 - Gear sensor plausibility" occurs, <b><u>do NOT replace the gear sensor.</u></b></p> <p>It is necessary to check that the engine control unit software version is updated, then access the "Settings" section and activate the "<b><u>Reset of the final drive adaptive parameters</u></b>".</p> <div data-bbox="1767 679 2213 1046" style="border: 1px solid black; padding: 5px;"> <ul style="list-style-type: none"> <li>CCP Enabling/Disabling</li> <li>DQS adaptives reset</li> <li>Idle control adaptives reset</li> <li>Idle speed engine operation mode</li> <li>Knock sensor adaptives reset</li> <li>Reset gears</li> <li style="border: 2px solid red; padding: 2px;">Reset of the transmission adaptive values</li> </ul> </div>

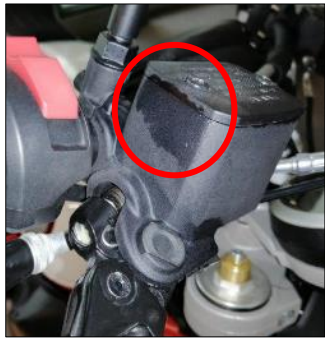
<p>We inform you that in case of complaints from Customers about a possible oozing out of front brake fluid from the relevant reservoir, This condition does not affect the operation of the brake system. it is possible to order the following kit part no. 89340331A as spare part to avoid the symptom in question.</p> <p>The kit part no. 89340331A includes:</p> <ul style="list-style-type: none"> <li>• 2 screws (1)</li> <li>• Cover (2)</li> <li>• Membrane (3)</li> <li>• Baffle (3)</li> </ul>

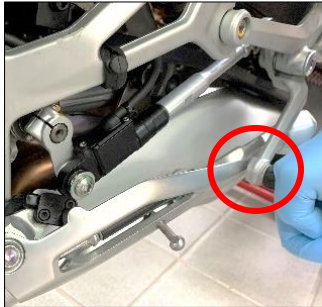
<p>As a result of continuous quality tests on the product, we have found a slight interference between the gear shift control lever and the side stand. This contact is very slight, does not give rise to functional or aesthetic problems and can only occur in the overtravel phase, when engaging the first gear.</p> <p>We inform you that no corrective actions are available so far.</p>
3	Assembly precautions for the complete titanium exhaust system <b>part no. 96481652AA</b>	Complete titanium exhaust system <b>part no. 96481652AA</b>

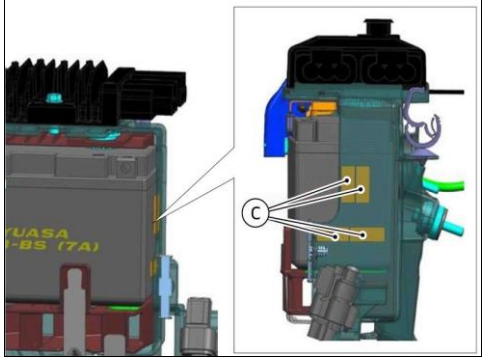
<p>The ongoing tests on the product have revealed the possibility of contact between the battery and its support, which causes marks on both surfaces due to vibration. These marks do NOT affect the correct operation of the electric system and therefore of the vehicle.</p> <p>In order to prevent such marks, <b>4 adhesive pads (C)</b> in rubber 9X23X1.4 part no. 86612791A have been introduced in the production line to be applied inside the battery support.</p>
