Technical product information

Topic	Audible creak from the lower/central A Post when opening and/or closing the front door/s
Market area	Russische Föderation (5RU),Australia E04 Bentley rest Asia and Australia (6E04),China 796 VW Import Comp. Ltd (Vico), Beijing (6796),Germany E02 Bentley rest Europe (6E02),Japan E03 Bentley Japan (6E03),Korea, (South) E08 Bentley South Korea (6E08),United Arab Emirates E06 Bentley Middle East and Africa (6E06),United Kingdom E01 Bentley UK (6E01),United States E05 Bentley USA and rest America (6E05)
Brand	Bentley
Transaction No.	2064482/1
Level	EH
Status	Approval
Release date

Bentayga

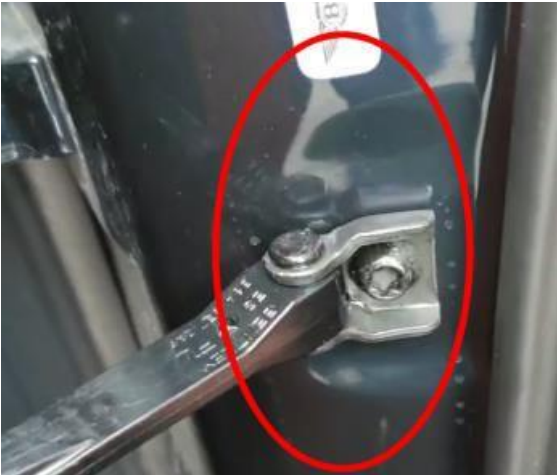
Figure 1

Audible creak coming from the lower/central A Post in the vicinity of the check strap fixing point (Figure 1) during the opening and/or closing of the driver/passenger door

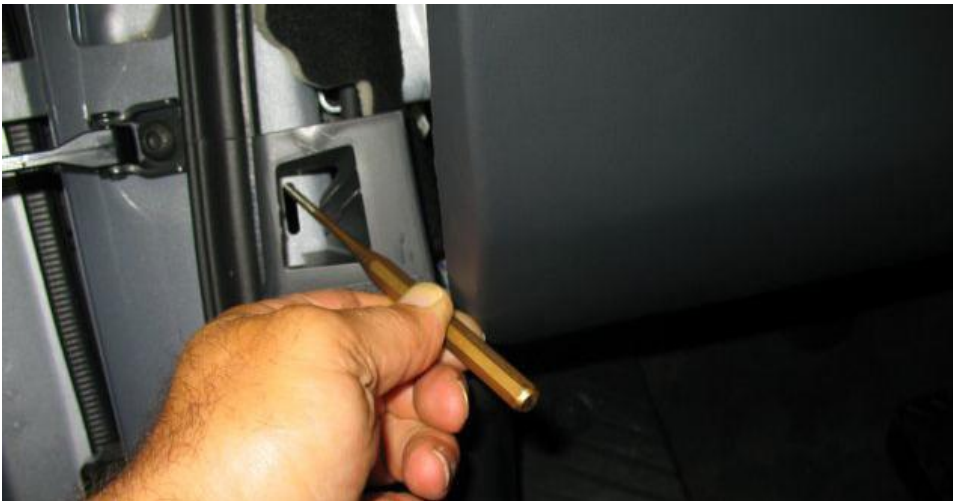
TIP: This creates enough space between the hinge reinforcement panel and the inner face of the A Post panel, the two panels can no longer rub against each other when opening and/or closing the door

4) Referring to Figure 4 - Place a suitable drift with a diameter of 4mm onto the hinge reinforcement panel as shown

- Using a suitable hammer in conjunction with the drift - Relocate the hinge reinforcement panel forward by 10 mm
