Technical product information

Topic	Rotating screen alignment
Market area	Bentley: worldwide (2WBE),Hongkong-Macau (5HK)
Brand	Bentley
Transaction No.	2051526/7
Level	EH
Status	Approval
Release date

New Continental GT - New Continental GTC and New Flying Spur

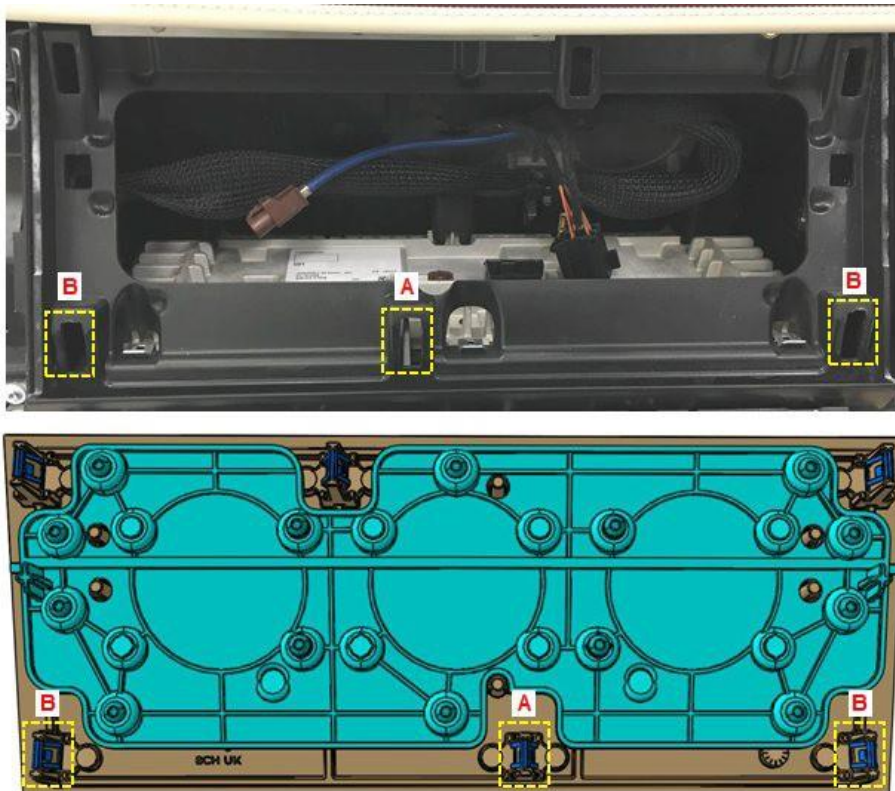
Figure 1

The veneer face fascia panel is fixed to the “BRD” by six locator pins and receiving holes. See Figure 1.

The following locator pins (A & B) control the position of the fascia panel as follows:

A = Side to side axis

B = Up and down axis

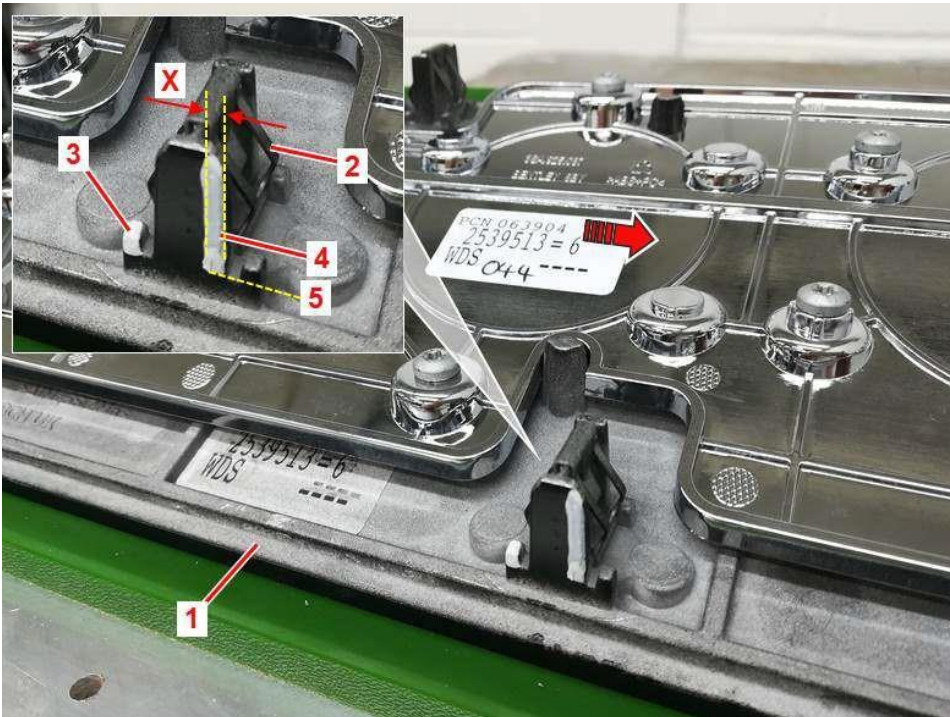
Figure 3

Place the veneer face fascia panel (1) face down on a soft, clean and protective work surface and mark accordingly the direction in which the panel needs to move (arrow). See Figure 3.

i Only the centre lowermost locator pin shown governs the side to side movement of the fascia panel. Only this locator pin will require modifying.

Remove the spring retaining clip (2) from the lowermost locator pin. If the fascia panel requires moving by 0.5mm then remove the same amount of material (X) from the appropriate side of the lower centre locator pin (4) as shown on the aluminium substrate casting. In addition, file the trailing RPS point (3) flat, level with the recess. See Figure 3.

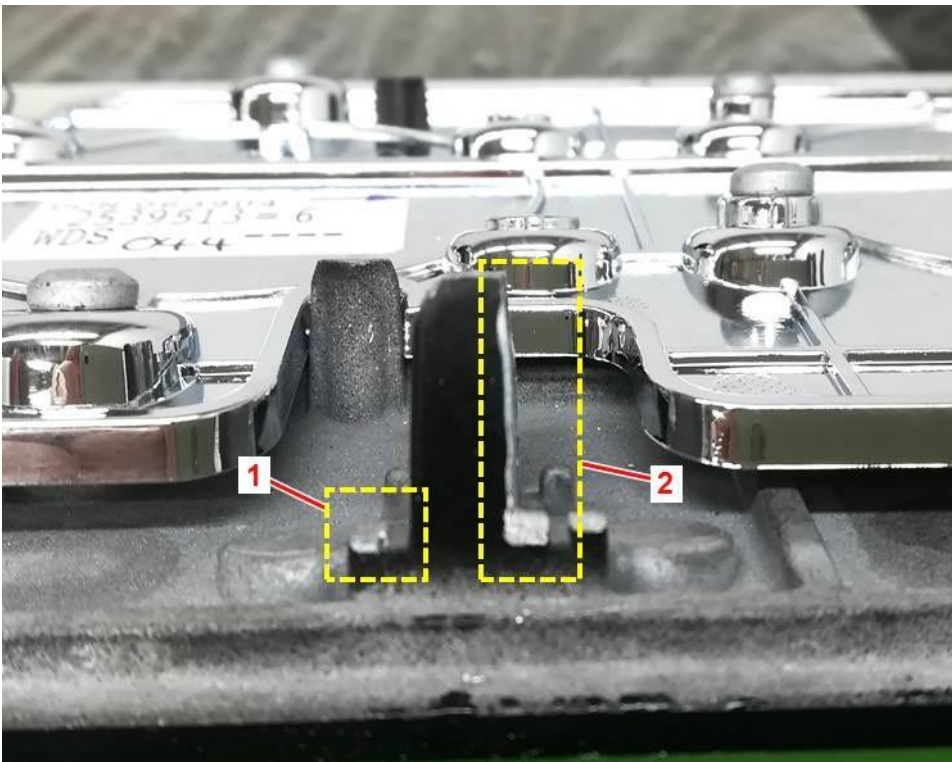
Figure 4 shows what the central locator pin should reflect after filing. The RPS point (1) being filed flat level with the recess. The side of the locator pin (2) being filed to remove the correct amount of material, again down to the level of the recess.

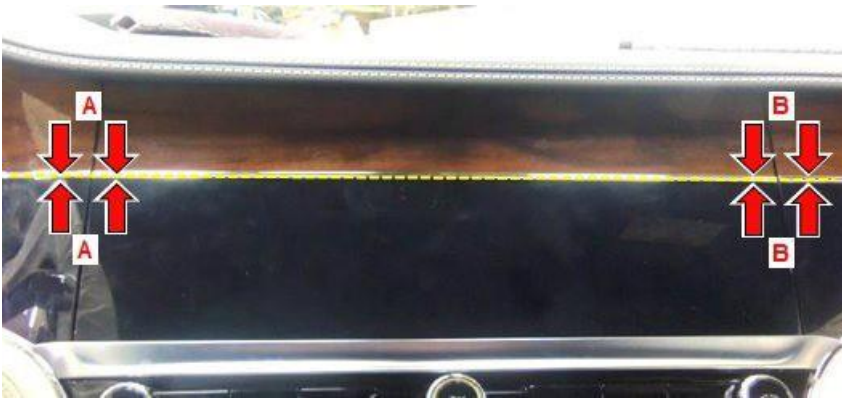
Figure 7

Visually check that the chrome brightware strip on the "veneer face" fascia panel is aligned with the chrome strips at points A & B on the passenger and drivers side fascia panels. See Figure 7.

The specified tolerance in the vertical plane (A & B) is 0.5mm.

If the chrome brightware strip on the "veneer face" fascia panel is out of line, carry out the following to adjust the panel.

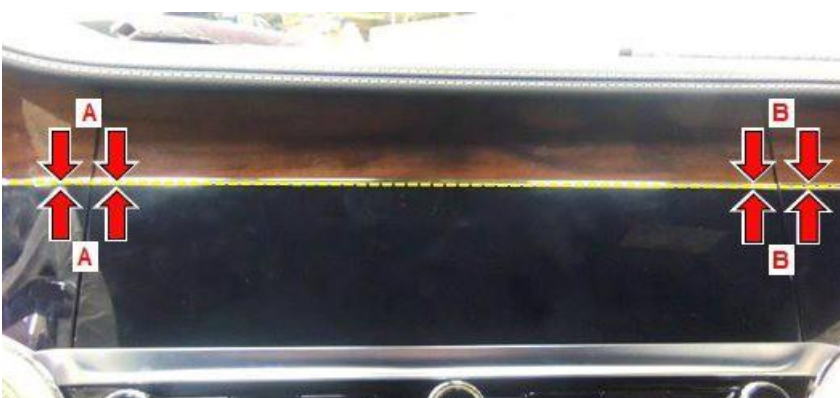
Figure 10

Visually check that the chrome brightware strip on the "veneer face" fascia panel is aligned with the chrome strips at points A & B on the passenger and drivers side fascia panels. See Figure 10.

The tolerance in the vertical plane (A & B) is 0.5mm.

If the chrome brightware strip on the “vener face” fascia panel is still out of line, and is not within the specified tolerance then add/remove anti-creak tape to adjust accordingly.

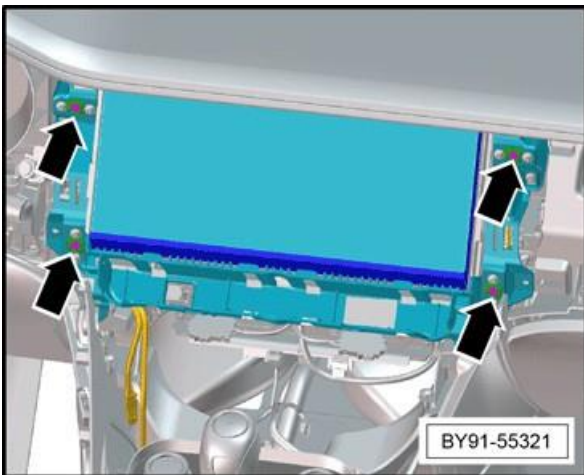
Figure 11

Under no circumstances should any attempt be made to adjust the “BRD” module inboard or outboard by adjusting any of the four setting screws (arrows) shown in Figure 11.

The setting screws (arrows) are factory sealed and any attempt to make adjustments via these four screws may result in failure of the rotating display and/or information display touch screen.

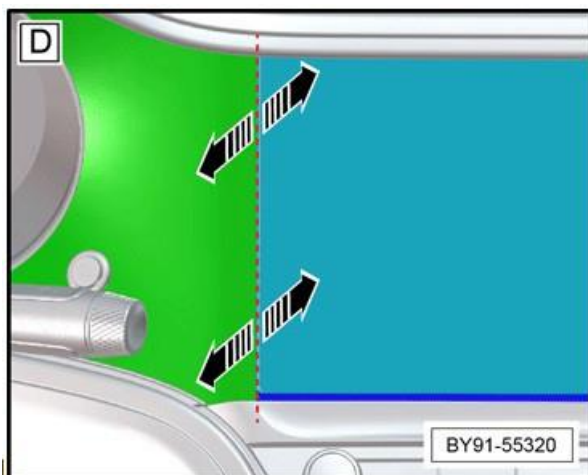
Measure the profile (D) between the “BRD” veneer face fascia panel and the passenger and drivers side fascia panels. See Figure 12

The specified setting dimension for the “BRD” fascia panel is -0.5mm (under flush) +/- 0.5mm tolerance and MUST be equal on both sides.

If either of the passenger and drivers side fascia panels are out of tolerance and require adjustment, make a note of which point requires adjustment and by how much on each panel.

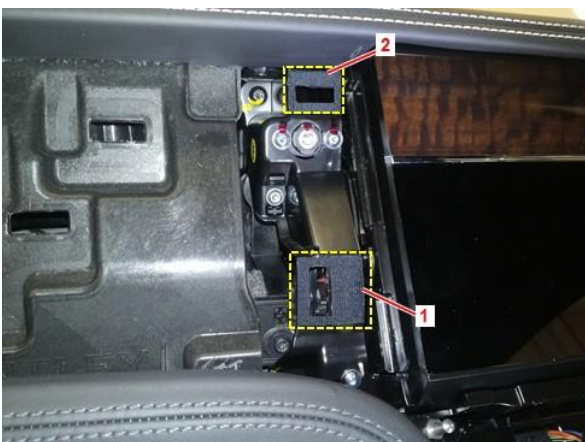
Figure 15

i Note. Several layers of anti-creak tape may be required in order to push the fascia panel out to the required amount. Position (1) to push the bottom of the fascia panel out and position (2) to push the top of the fascia panel out.

With the fascia panel removed, apply anti-creak tape around the entire perimeter of the opening section of the appropriate receiving hole as shown in Figure 15.

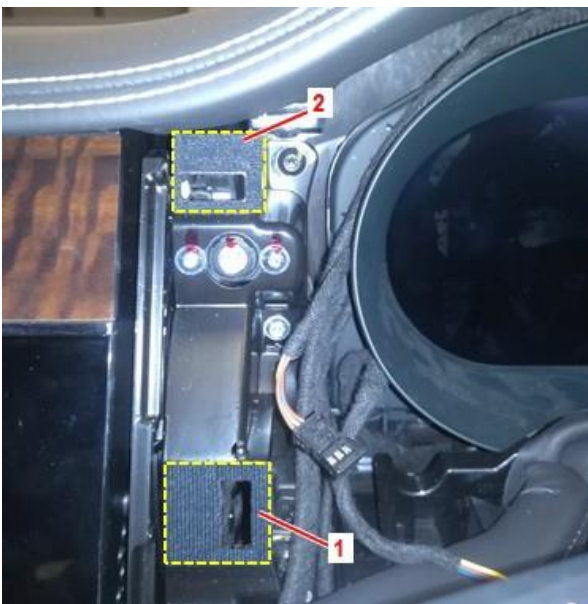
Figure 18

*Note. Apply anti-creak tape at position (1) to push the bottom of the fascia panel out and position (2) to push the top of the fascia panel out. See Figure 18.*

With the fascia panel removed, apply anti-creak tape around the entire perimeter of the opening section of the appropriate receiving hole as shown in Figure 18.
