SANICON TURBO MACERATOR DIAGNOSIS MY2016-2022

Bulletin Type:	SRP	Publication Date:	September 2021
Bulletin #(s):	21-035	Make(s):	Entegra
Job Code(s):	<i>If affected unit has warranty remaining, submit your claim following the normal process</i>	Model(s):	Embark, Reatta, Reatta XL, Aspire, Anthem, Cornerstone
Flat Rate(s):		Model Year(s):	2016-2022

Incident:	THE MACERATOR WILL NOT RUN OR RUNS BUT WILL NOT PUMP.
Affected Units:	2016-2022 Entegra Embark & Reatta & XL & Aspire & Anthem & Cornerstone
Parts List:	1 EA THETFORD: PUMP (PART #0303362) 1 EA MACERATOR THETFORD SANI-CON TURBO MODEL #97646 WIWHT 30' HOSE/SLEEVE
Misc. Tools & Supplies:	N/A
Parts Return Information:	N/A

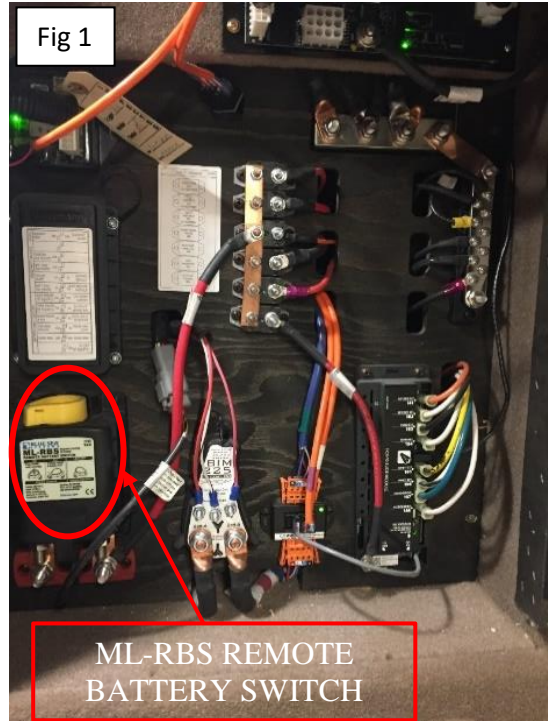
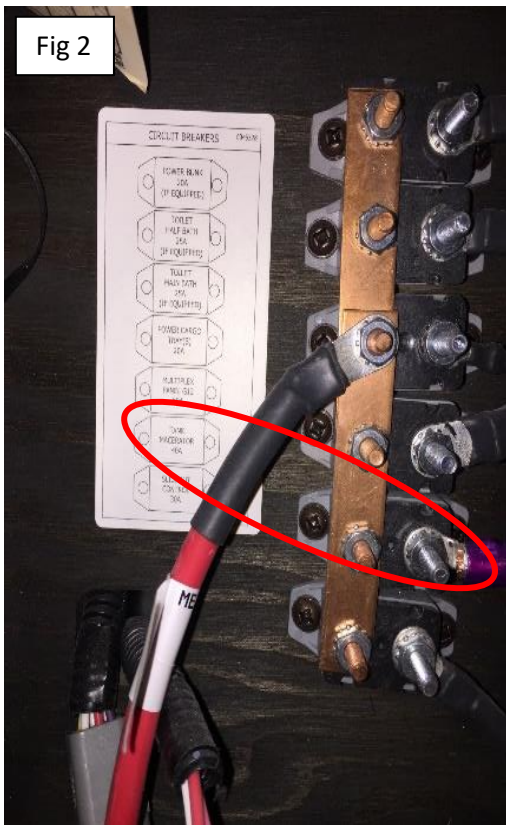
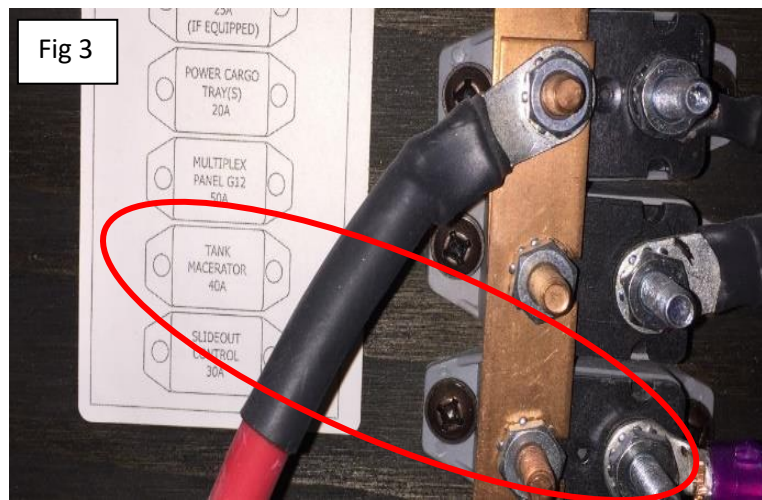
- **Correction for Cause 1: MY21:** The macerator is fed from the ML-RBS remote battery switch (shown in Fig 1). (House 12V Main Power)
- The macerator connection continues through a 40 amp auto resetting mini breaker (shown in Fig 2 & Fig 3) to the macerator relay in the wet bay on the driver side of the unit.
- Confirm the switch is on and power is being fed to the bus bar and breakers attached.
- Test the auto resettable breaker for power on both terminals (Fig 2 & 3).

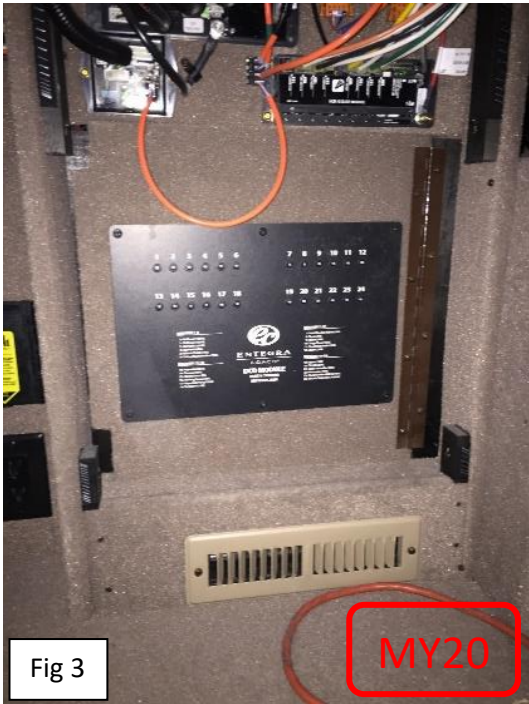
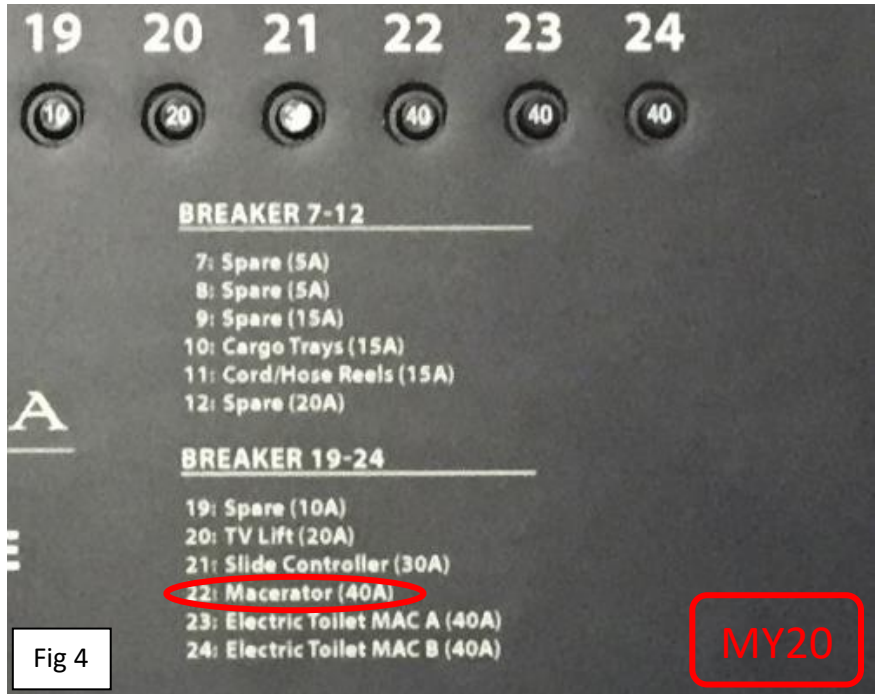
2. **Correction for Cause #1: MY 19 & 20:** The breaker for the macerator in MY 19 & 20 is tripped off at the DCD board on the passenger side battery compartment shown in Fig 3 & Fig 4.

a. Correction for MY 19 & 20: Check and push #22 to reset breaker if it is tripped.

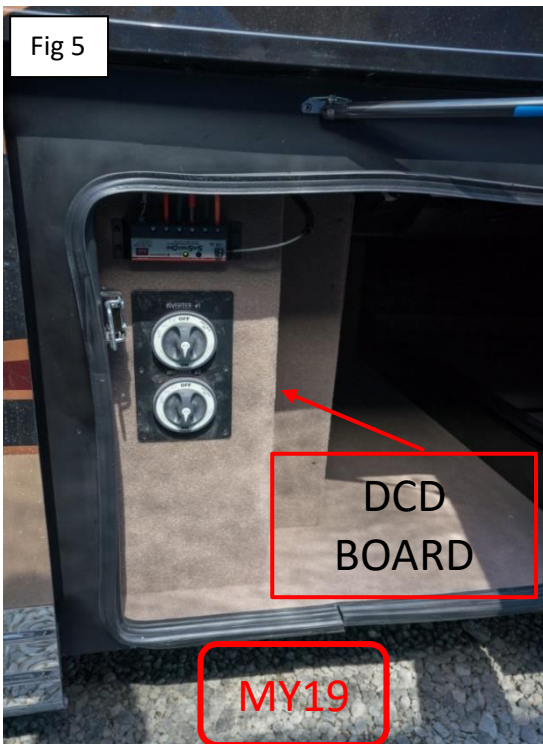
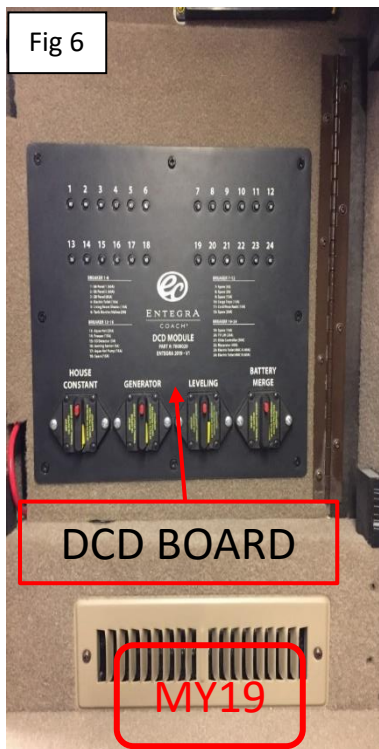
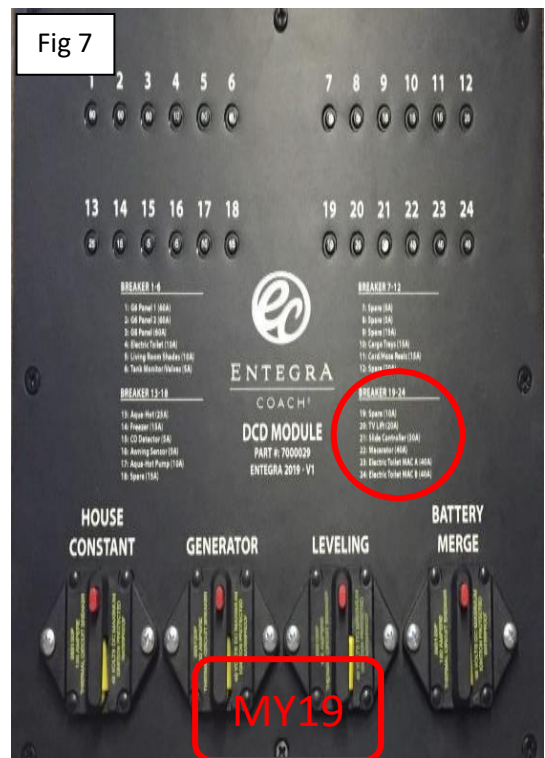
3. **Correction for Cause #1: MY19** The breaker for the macerator in MY19 is tripped off at the DCB board on the passenger side, rear bulkhead, behind the carpeted panel shown in Fig 5-7.

a. Correction for MY 19 & 20: Check and reset breaker if it is tripped.

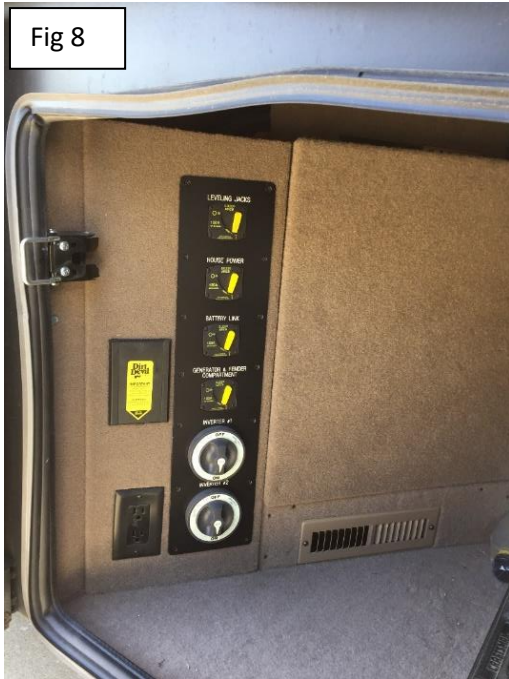
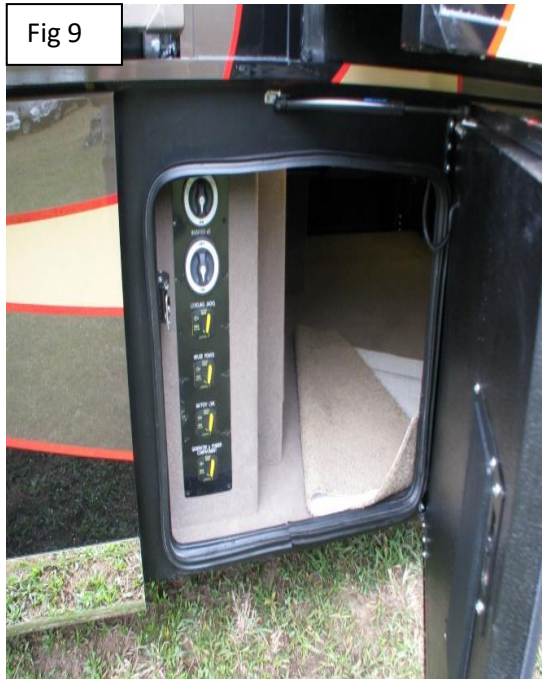
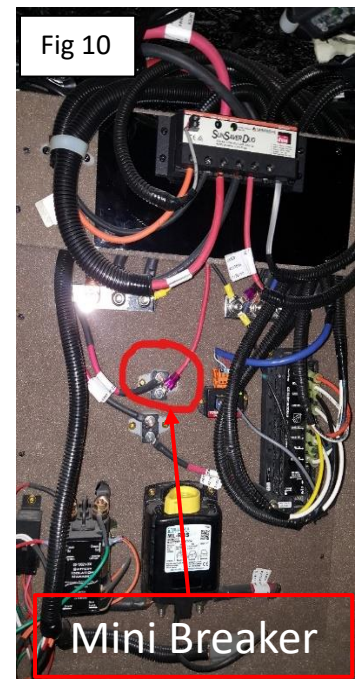
4. **Correction for Cause #1: MY17 & MY18:** Check for power at the mini breaker shown with a red circle in Fig 10 located on the passenger side, rear bulkhead, behind the Velcro carpeted panel shown in Fig 8 & 9. Confirm all yellow levers are engaged/on, if auto resetting mini breaker has no outgoing power, replace mini breaker.

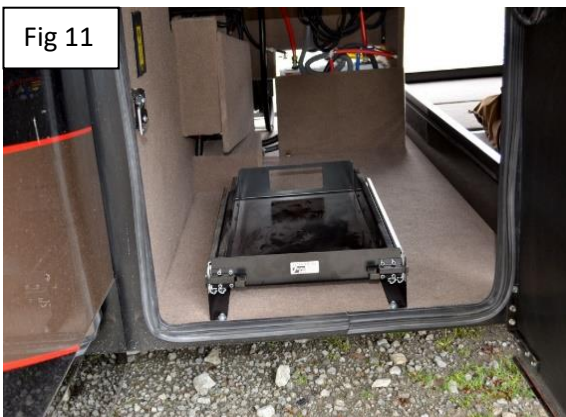
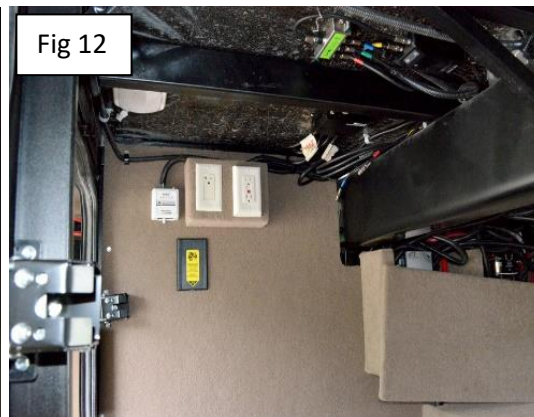
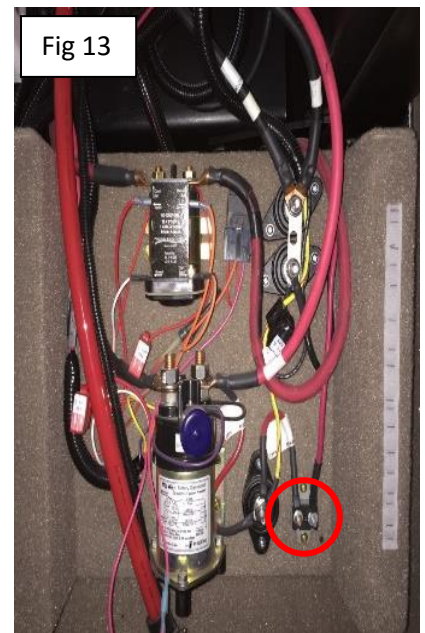
5. **Correction for Cause #1: MY16:** Check for power at the mini breaker shown in Fig 13 with the red circle located on the passenger side, rear bulkhead, behind the Velcro removable carpeted panel shown in Fig 11 & 12.

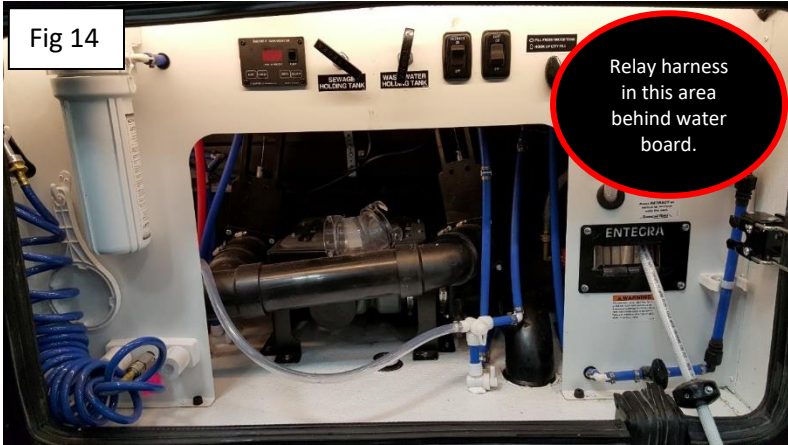
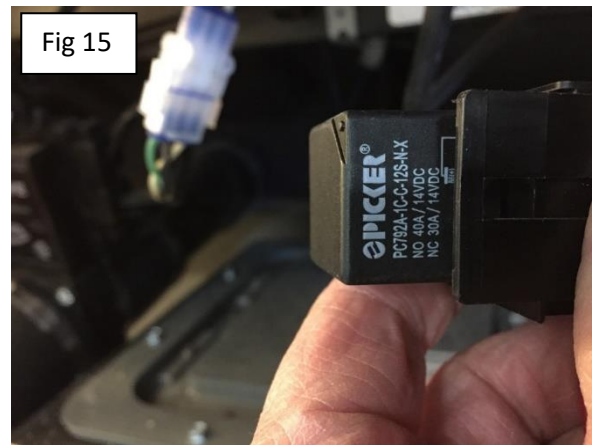
6. **Correction for Cause #2: MY16-2021:** The relay in the wet bay has failed and only clicks without sending power to macerator motor. Test power at relay input and output to the macerator. Replace the relay as needed. See "System Schematic", Fig 16 & 17 for test information.
- a. The relay shown in Fig 15 is located on the right side on the wet bay by behind the cover board shown in Fig 14 near the water hose reel.

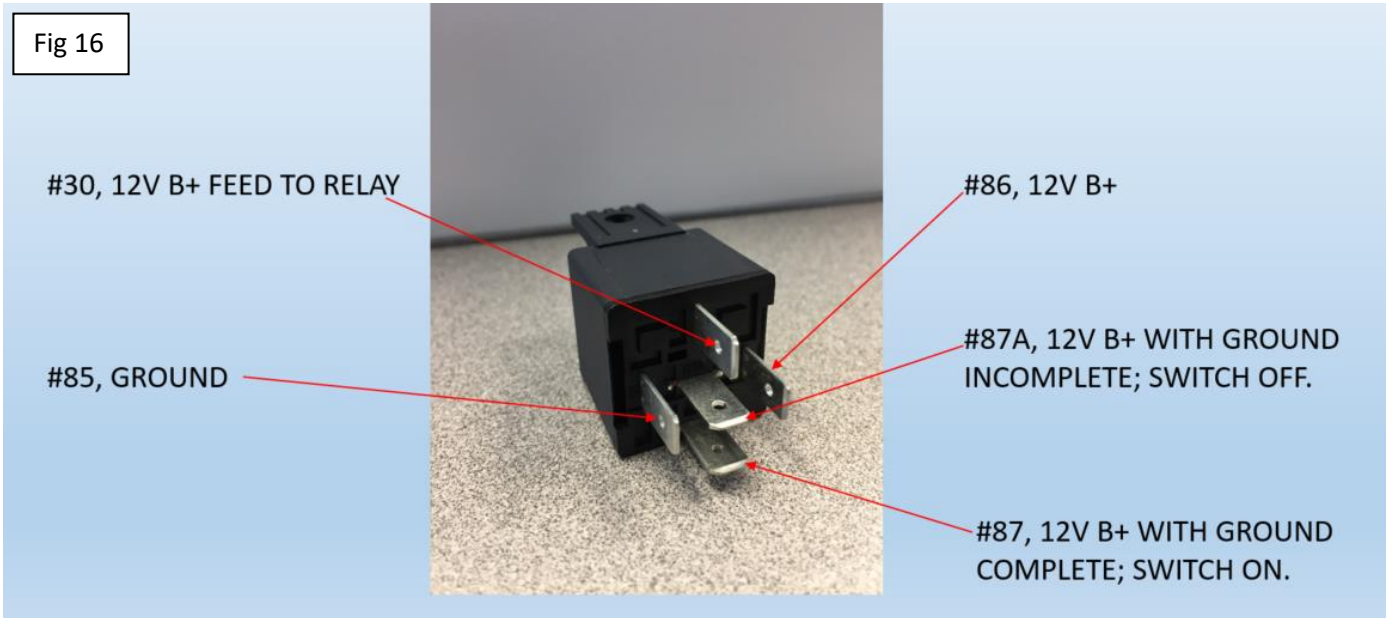
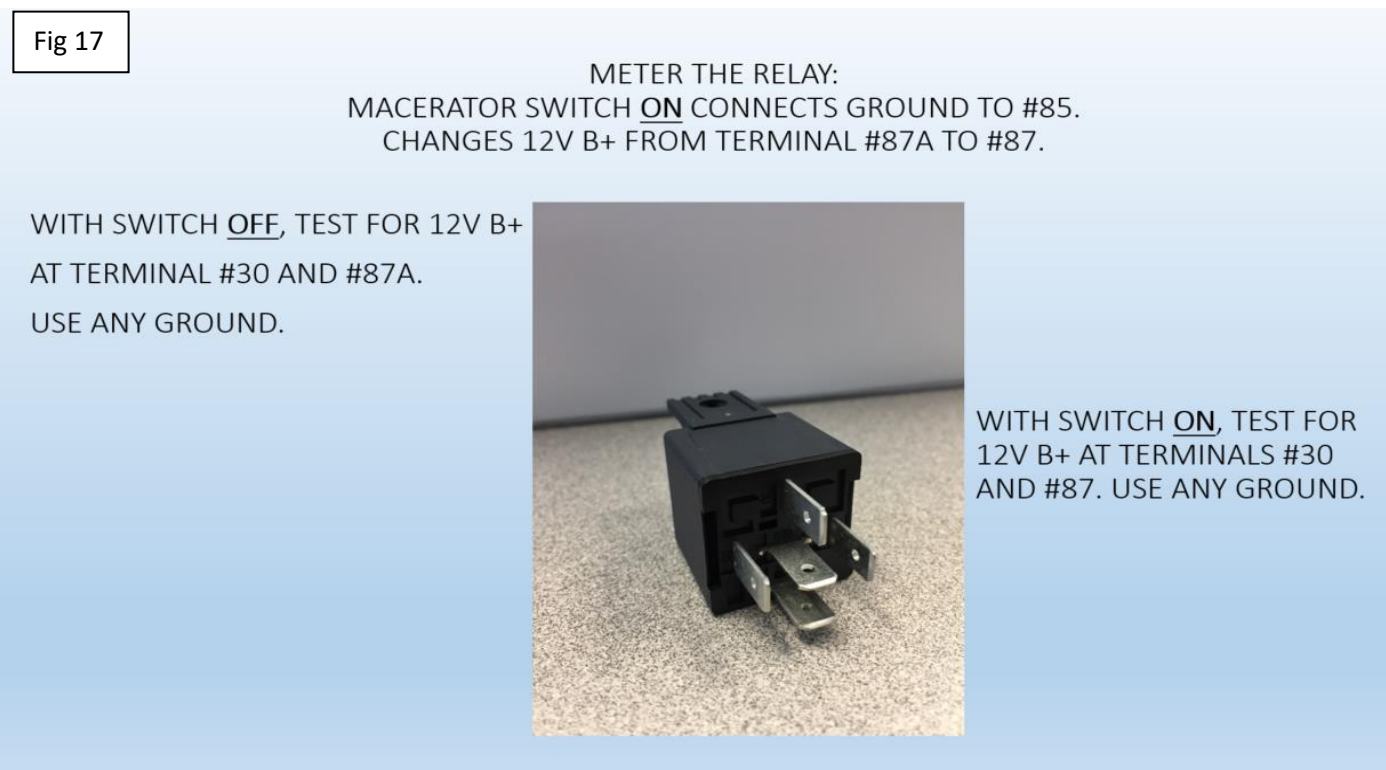
System Schematic

7. Spade Terminal layout in Fig 16 & Fig 17.
8. Meter the relay:
 - a. Macerator switch on connected ground to #85.
 - b. Changes 12V B+ from terminal #87A to #87.

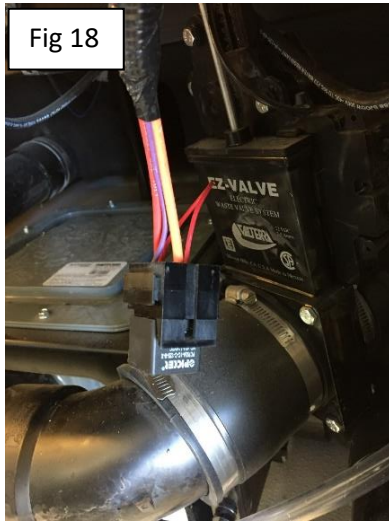
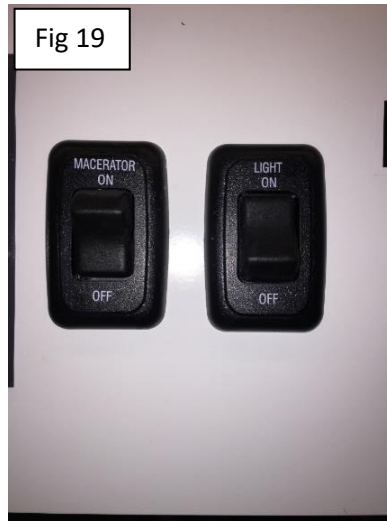
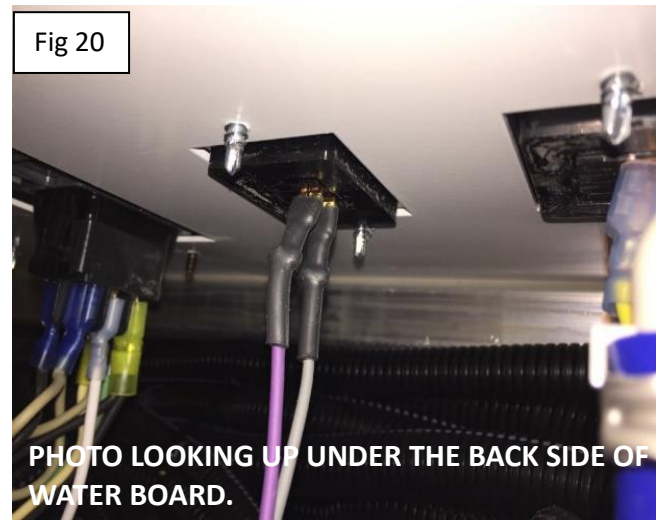
Correction for Cause #3:MY16-21: The macerator switch has failed or wires have lost connection at the switch or the relay in the wet bay. Check wire connections on the relay and switch in water bay board shown in Fig 18-20.
