Technical product information

| Topic | Buzzing/vibration from the left and/or right headlamp and/or DTC's C119C01-C119D01 stored - Matrix beam headlamp only |
| Brand | Bentley |
| Transaction No. | 2059246/3 |

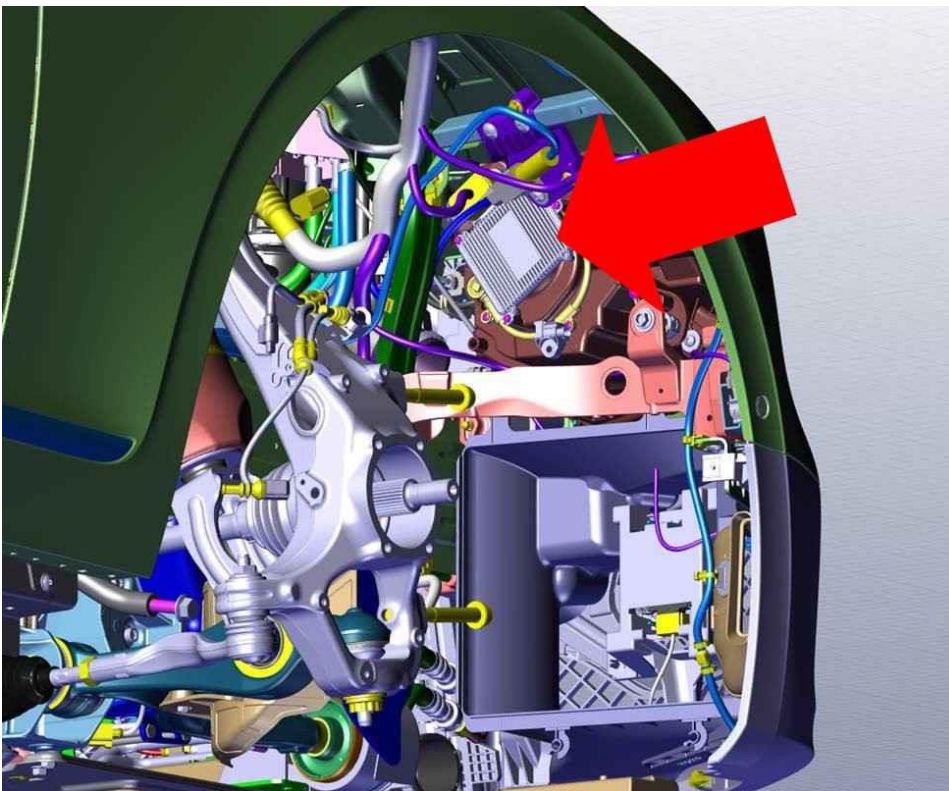
- Remove the applicable front wheel arch liner - Rep.Gr 66
- Locate the module at the rear of the applicable headlamp as Figure 1

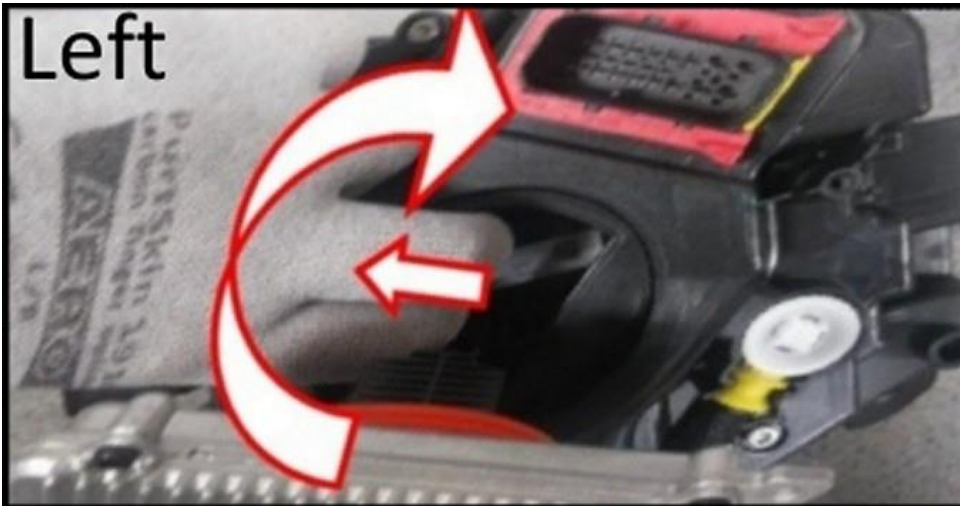
Wiring harness routed incorrectly within the headlamp module at the rear of the headlamp, the noise and DTC's are evident due to the harness contacting the headlamp cooling fan

5) Referring to Figure 5 (left hand module) – Gently push the harness to the desired position away from the cooling fan and pushing the harness up to create a loop between the main connector and the unit
