# Technical product information

<b>Topic</b>	New Continental GT / GTC and New Flying Spur - Exhaust Flap - Diagnostic Trouble Code
<b>Market area</b>	Russische Föderation (5RU),Australia E04 Bentley rest Asia and Australia (6E04),China 796 VW Import Comp. Ltd (Vico), Beijing (6796),Germany E02 Bentley rest Europe (6E02),Japan E03 Bentley Japan (6E03),Korea, (South) E08 Bentley South Korea (6E08),United Arab Emirates E06 Bentley Middle East and Africa (6E06),United Kingdom E01 Bentley UK (6E01),United States E05 Bentley USA and rest America (6E05)
<b>Brand</b>	Bentley
<b>Transaction No.</b>	2060432/3
<b>Level</b>	EH
<b>Status</b>	Approval
<b>Release date</b>

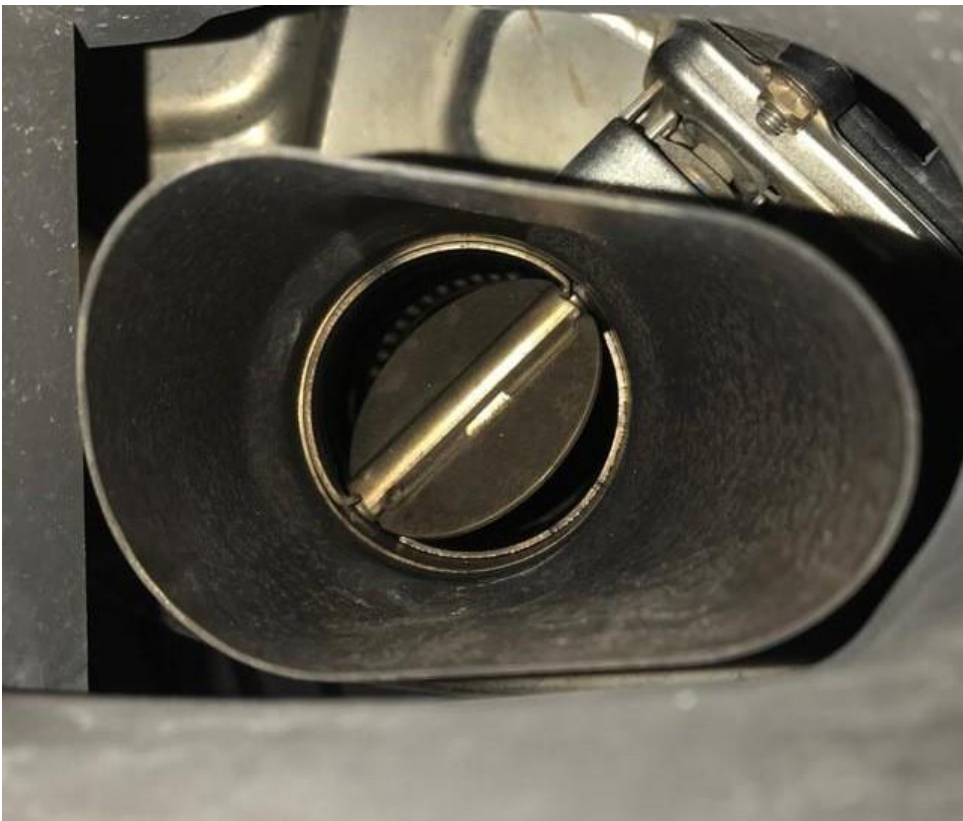
Figure 1.

The root cause of Exhaust Flap Control Unit malfunction is electrical 'shorting' of the commutator segments, this is caused by an accumulation of "Sludge" within the Control Unit. A DTC is stored when the respective Control Unit does not move through its full range of motion.

If an Exhaust Flap is stuck in an open, closed, partially closed position or does not achieve a full range of motion continue to follow the instructions within this Technical Product Information (TPI) document – figure 1.

Remove the suspected Exhaust Flap Control Unit – Refer to *Repair Group. 26 Exhaust system – Exhaust flap control units (J883, 945) – To remove and fit.*

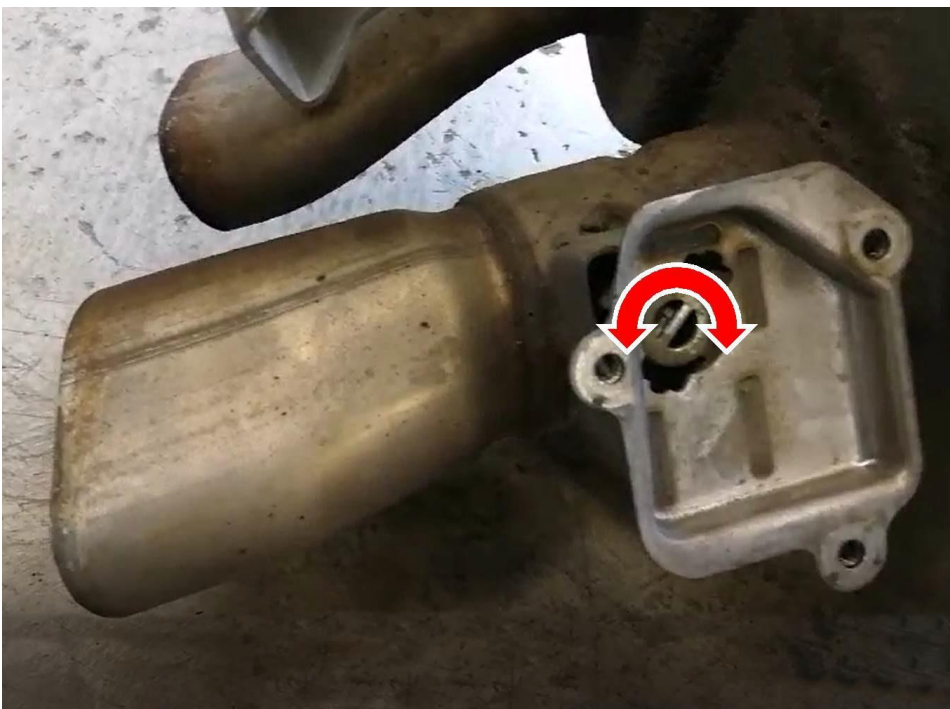
Check and confirm the Exhaust Flap spindle is free to open and close by hand - Figure 2.

If no issue is evident and the Exhaust Flap oscillates freely by hand - replace the defective Exhaust Flap Control Unit, refer to *Repair Group. 26 Exhaust system – Exhaust flap control units (J883, 945) – To remove and fit.*
