Technical Service Bulletin

Topic	Telephone interference
Market area	China 796 VW Import Comp. Ltd (Vico), Beijing (6796),United States E05 Bentley USA and rest America (6E05)
Brand	Bentley
Transaction No.	2056950/6
Level	EH
Status	Released for publishing

Condition

When using a mobile telephone via a Bluetooth connection the audio quality is poor due to interference

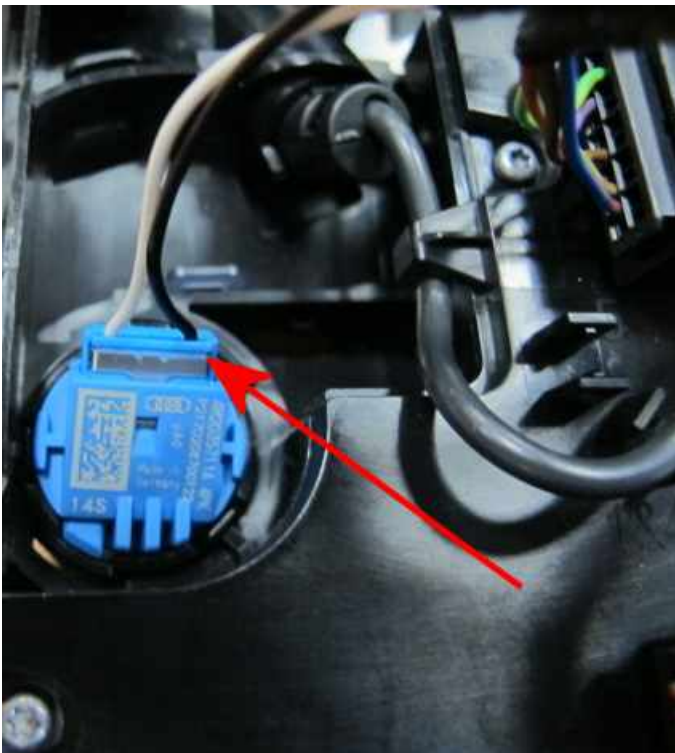
Figure 1

Customer complaint of poor audio quality due to interference when using a mobile telephone via a Bluetooth connection, the original right hand side (Passenger) microphone should be replaced for an omni-directional microphone, a software update to 5F - Infotainment control unit 1 must also be conducted after the replacement microphone is fitted

- 1) Remove the Front roof console – Refer to Repair manual - Rep.Gr70
- 2) Disconnect the right hand side microphone electrical connection (Figure 1)
