Technical product information

Topic	Rear centre armrest lid - Poor magnetic retention
Market area	Bentley: worldwide (2WBE)
Brand	Bentley
Transaction No.	2061343/2
Level	EH
Status	Approval
Release date

New Flying Spur

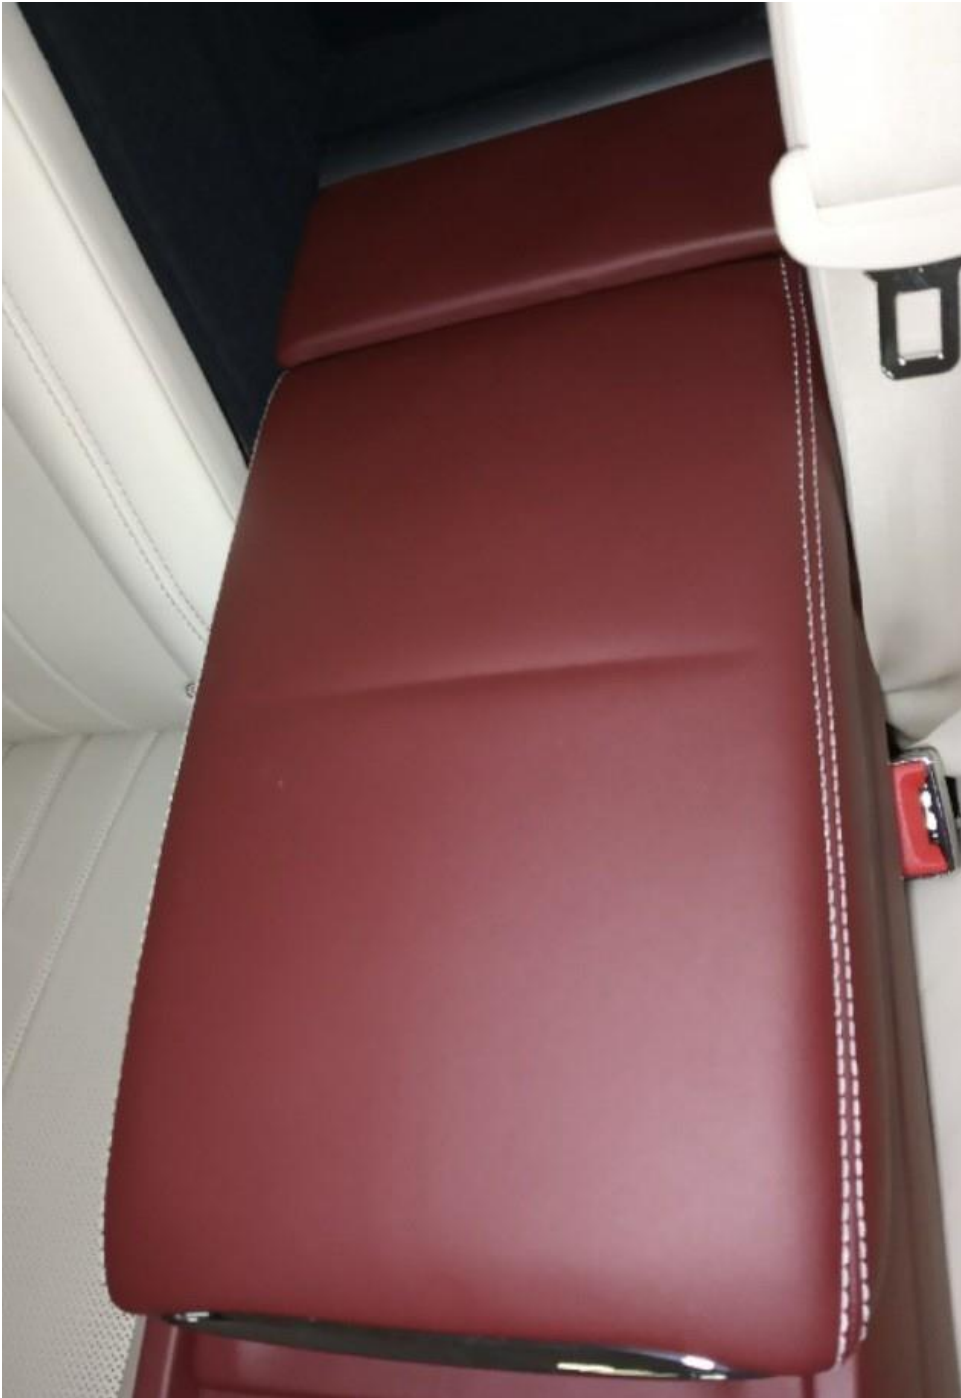
Figure 1

Rear centre armrest lid has poor magnetic retention to the main armrest, this can lead to a crease in the leather (Figure 1)

Rear centre armrest lid has poor magnetic retention to the main armrest

3) Improve the condition of the trim – Refer to the repair instructions within Rep.Gr 74 Seat trim repairs - Best practice guide - Finishing/reworking – Minor creases/wrinkles

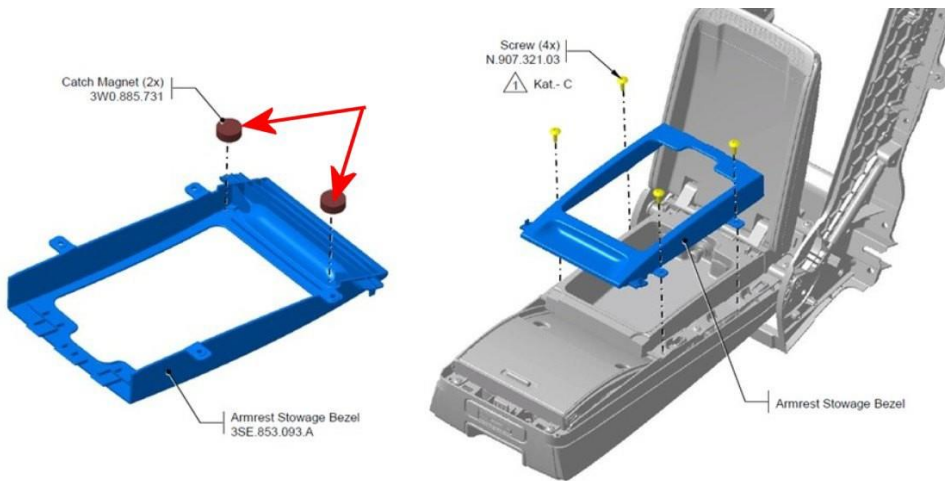
Figure 2

- Check/confirm that both magnet pairs are positioned in the correct polarity to attract each other
- The two catch magnets are located in the armrest stowage bezel (Figure 2)

1) Perform a check of the magnets to confirm the following:

- Check/confirm that no magnets are missing

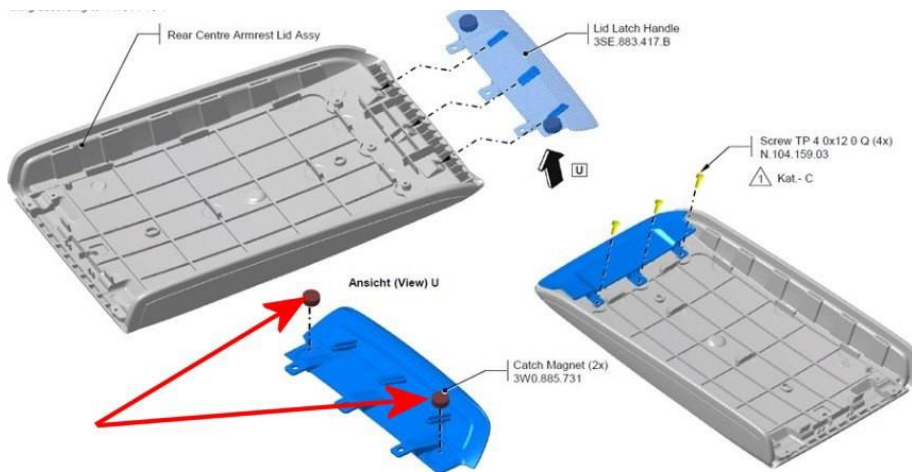
Figure 3

- The two opposing catch magnets are located in the latch handle of the armrest lid

2) Check the polarity of each magnet pair. If they are opposing each other, swap the magnet around so it changes the polarity.
