**AMA2 - Replacing Seat Occupancy Detection System for Passenger Seat (USA/Canada)  
(Recall Campaign)**

Model Year: **As of 2015 up to 2018**

Model Line: **Macan**

Concerns: **Seat occupancy detection system for passenger seat**

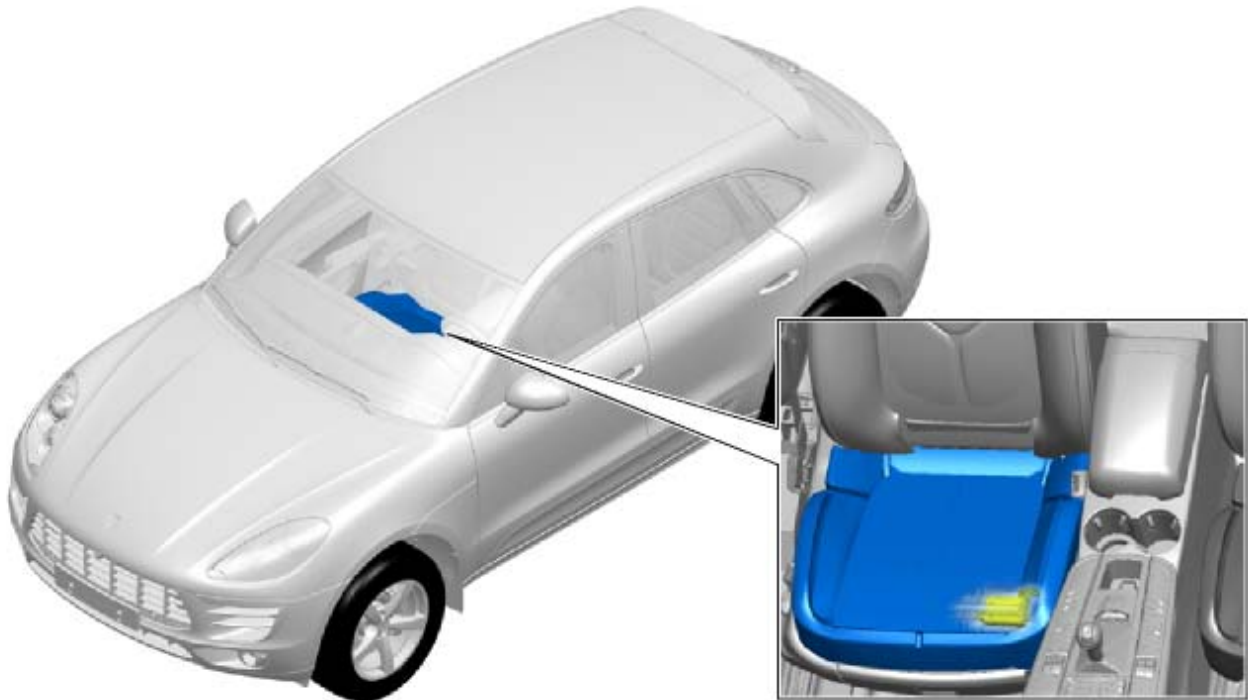
*Installation position of seat occupancy detection system for passenger seat*

- 3 Replace padding for front seat including sensor mat. ⇒ *Workshop Manual '741055 Replacing padding for front seat'*
- 4 Replace occupant detection control unit. ⇒ *Workshop Manual '696819 Removing and installing occupant detection control unit'*

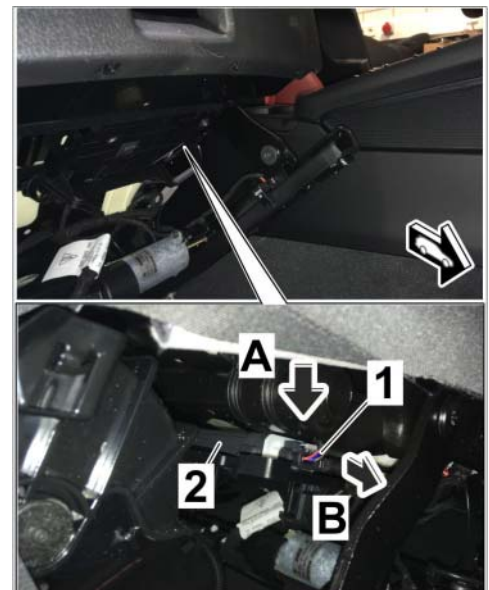
Re-programming control unit

- 1 – Start button
- 2 – LED display

- 6.5 Unlock the secondary locking of the plug connection ⇒ *Re-programming control unit -1-* on the occupant detection control unit ⇒ *Re-programming control unit -2-* (⇒ *Re-programming control unit -arrow A-*) and unplug the plug ⇒ *Re-programming control unit -arrow B-*.

- 6.6 Connect the cable set for the programming box to the occupant detection control unit and to the cigarette lighter in the centre console.
  - 6.7 Switch on the ignition and reprogram the occupant detection control unit in the vehicle according to the instructions on the programming box.
