Technical Service Bulletin

| Topic | Driver/Passenger door latch creak on close |
| Transaction No. | 2052394/14 |

New Continental GT/GTC - New Flying Spur and Bentayga

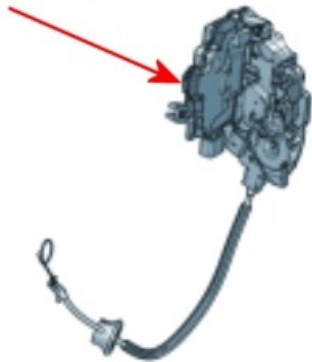
Driver or Passenger door creak during the "Close" function

Figure 1 shows an example of the door latch

- Only replace the door latch which is exhibiting the symptom

- 1) Obtain video's clearly showing the date of manufacture or take a photograph of the manufacture date of each applicable power latch motor that is faulty. The operative MUST save each video and/or picture as they will be required later within this procedure
- 2) Replace the faulty/creaking latch - Refer to Rep.Gr 57 (Front) or Rep.Gr 58 (Rear)
- 3) Open a Non technical/For information only DISS query
 - Attach the applicable videos/photo to the open DISS query (No evidence of the power latch date of manufacture will result in claim refusal)
 - Submit the DISS query
