# Technical product information

<b>Topic</b>	New Continental GT, GTC, New Flying Spur - Blind spot monitors not functional DTC C1114F3 logged in address 003C or 00CF
<b>Market area</b>	Russische Föderation (5RU),Australia E04 Bentley rest Asia and Australia (6E04),China 796 VW Import Comp. Ltd (Vico), Beijing (6796),Germany E02 Bentley rest Europe (6E02),Japan E03 Bentley Japan (6E03),Korea, (South) E08 Bentley South Korea (6E08),United Arab Emirates E06 Bentley Middle East and Africa (6E06),United Kingdom E01 Bentley UK (6E01),United States E05 Bentley USA and rest America (6E05)
<b>Brand</b>	Bentley
<b>Transaction No.</b>	2062884/3
<b>Level</b>	EH
<b>Status</b>	Approval
<b>Release date</b>

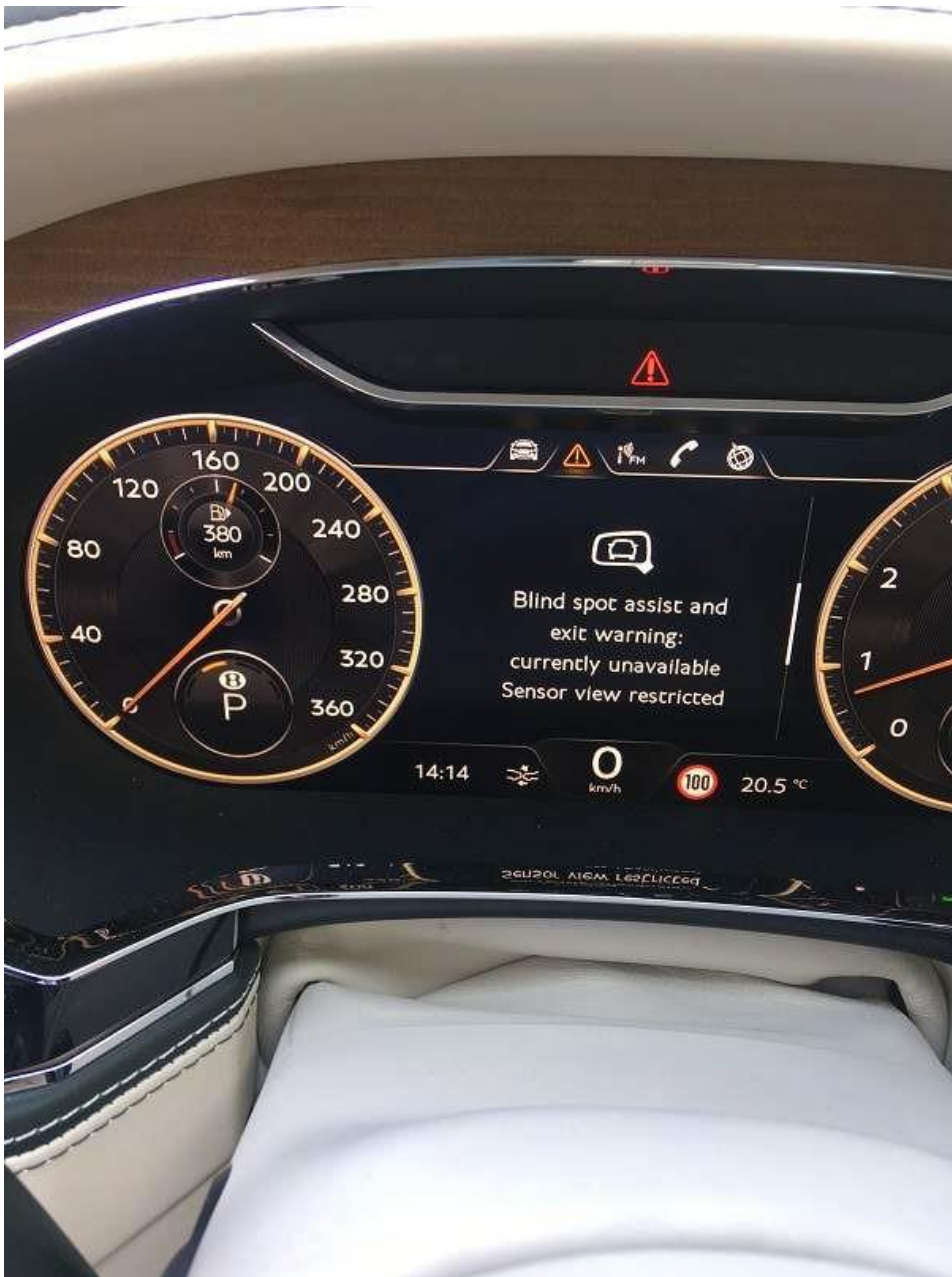
Figure 1

Blind spot monitors (Wing mirror illuminations) are not functional in conjunction with sporadic Bentley assist warnings present in the DIP (Figure 1)

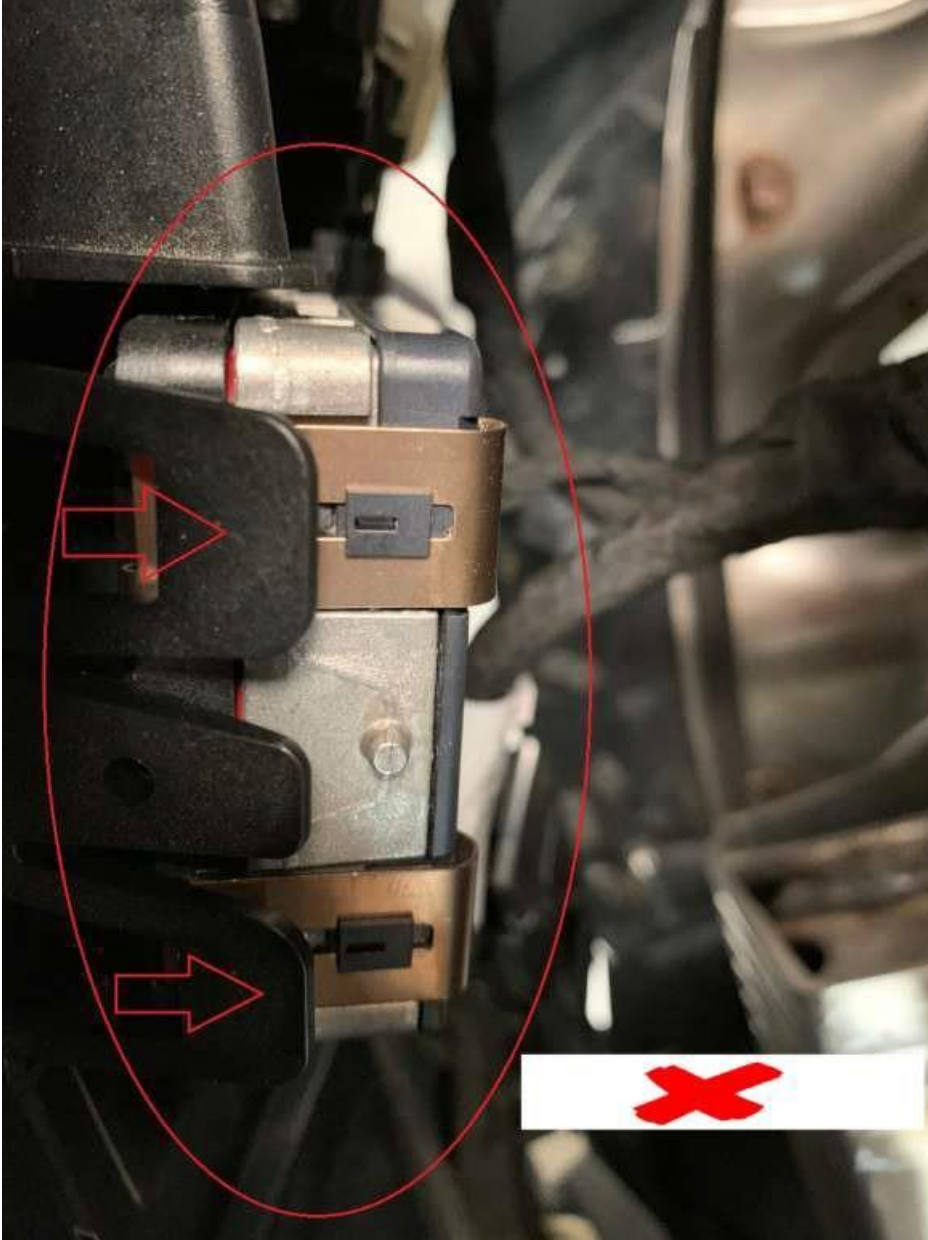
Figure 2

Master or slave rear radars are not fitted correctly (unclipped or poorly installed)

Diagnostic Trouble Code (DTC) C1114F3 - Lane change assistance control module restricted view, logged with address 003C or 00CF

3) In the event one or both control units are loose/detached - Refer to Figures 2 (Before adjustment) and 3 (After adjustment) and also reference Rep.Gr - 44 Lane change assist control units (J769 and J770) - To remove and fit
