Technical product information

Topic	Headlamp operation issues
Market area	Bentley: worldwide (2WBE),Hongkong-Macau (5HK)
Brand	Bentley
Transaction No.	2054599/8
Level	EH
Status	Approval
Release date

New Continental GT and New Continental GTC

Headlamp operation issues

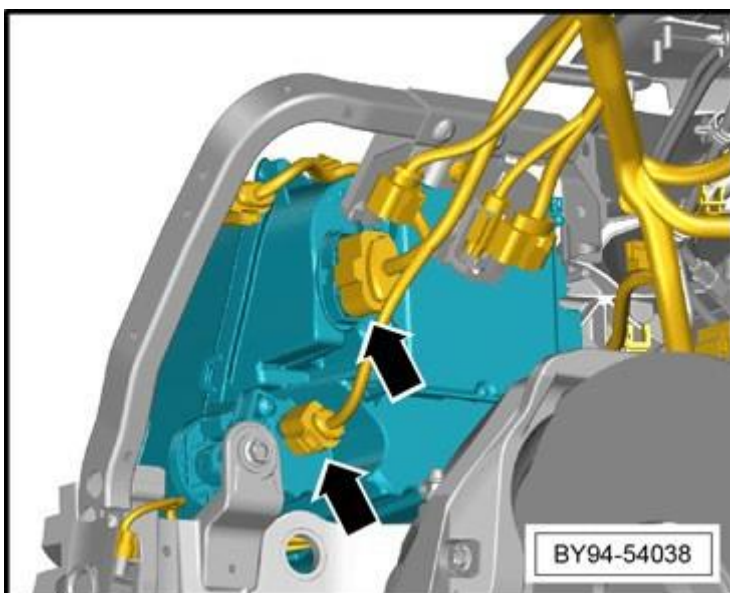
Figure 1

Disconnect the applicable headlamp plugs (right and/or left hand side) - During disconnection look out for any abnormalities for example a plug which is loose/broken or is easily disconnected

- 3) Check the condition of the headlamp plug and terminals
- 4) Check the condition of the headlamp assembly connection pins
- 5) Using the applicable Elsa pro wiring diagrams – Check the electrical integrity of the complete headlamp circuit

- Should ANY concerns be found within steps 2,3,4 or 5 - The operative must rectify accordingly and once rectified – Carry out the remaining instructions
