Technical product information

Topic	Rear window blind/s do not fully retract (Jammed)
Market area	Russische Föderation (5RU),Australia E04 Bentley rest Asia and Australia (6E04),China 796 VW Import Comp. Ltd (Vico), Beijing (6796),Germany E02 Bentley rest Europe (6E02),Japan E03 Bentley Japan (6E03),Korea, (South) E08 Bentley South Korea (6E08),United Arab Emirates E06 Bentley Middle East and Africa (6E06),United Kingdom E01 Bentley UK (6E01),United States E05 Bentley USA and rest America (6E05)
Brand	Bentley
Transaction No.	2064469/1
Level	EH
Status	Approval
Release date

Bentayga

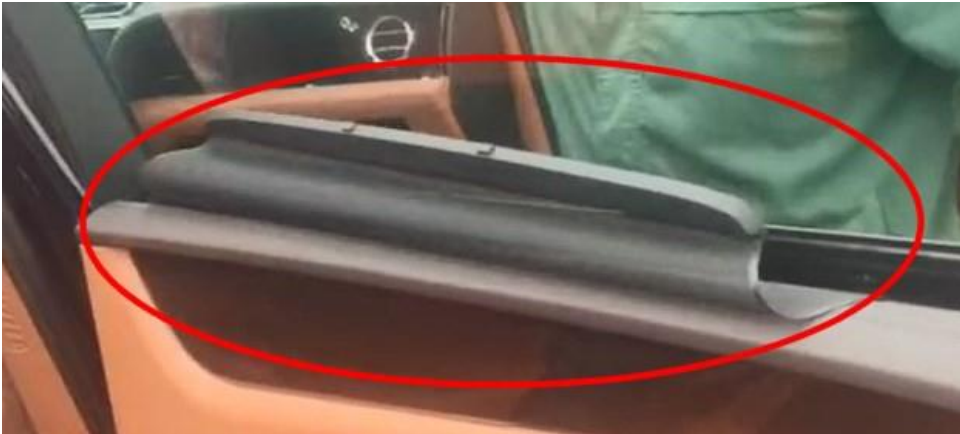
Rear side window blind/s do not fully retract (Jammed) as shown in Figure 1

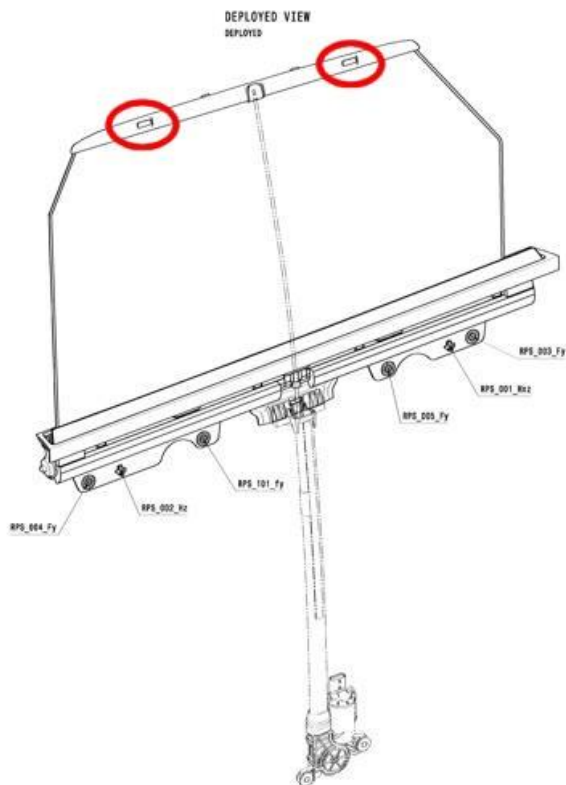
Figure 1

- 1) Open the affected rear blind door (by hand)
- 2) Referring to Figures 1 and 2 - Locate the flocked sliders (x2)

- With care - Visually check the position of the flocked sliders
- Check for any signs of slider wear

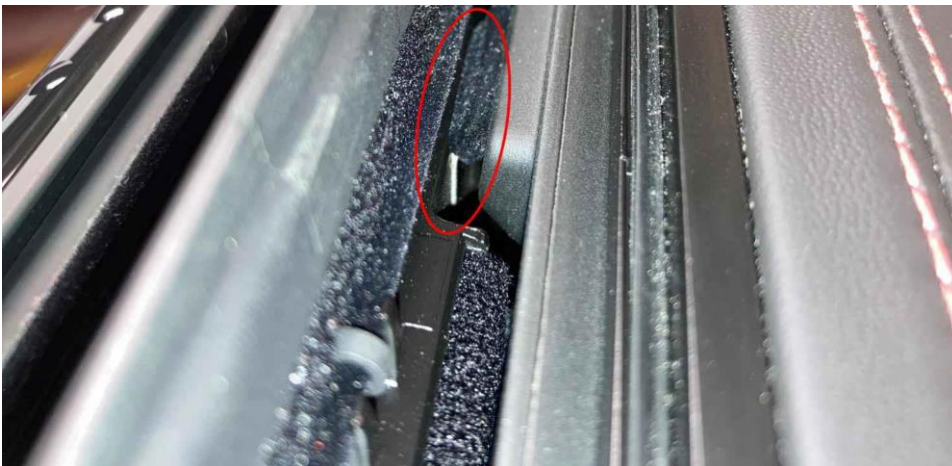
NOTE: Figure 3 shows an example of slider displacement (circled)

-
- IMPORTANT: Displacement can stop the blind from returning to its home position
- 3) Record all observations and take clear photographs/videos of the issues found
- In the event the flocked sliders are displaced, the operative should attempt to push the sliders inboard (into the hanger)
 - Retest the functionality of the affected blind
- 4) Should no other issues be found the vehicle can be returned to the customer
-
- Any additional actions beyond the above must be authorised / approved by Bentley Product Support via an open DISS query
- NOTE: Ensure all applicable supporting information is attached (Photographs/videos)
