Field campaign

Topic	Transmission control module update during PDI (SC 21/34)
Market area	United States E05 Bentley USA and rest America (6E05)
Brand	Bentley
Transaction No.	2064350/1
Campaign number	EC16
Note	
Type	
US code

New Flying Spur - W12

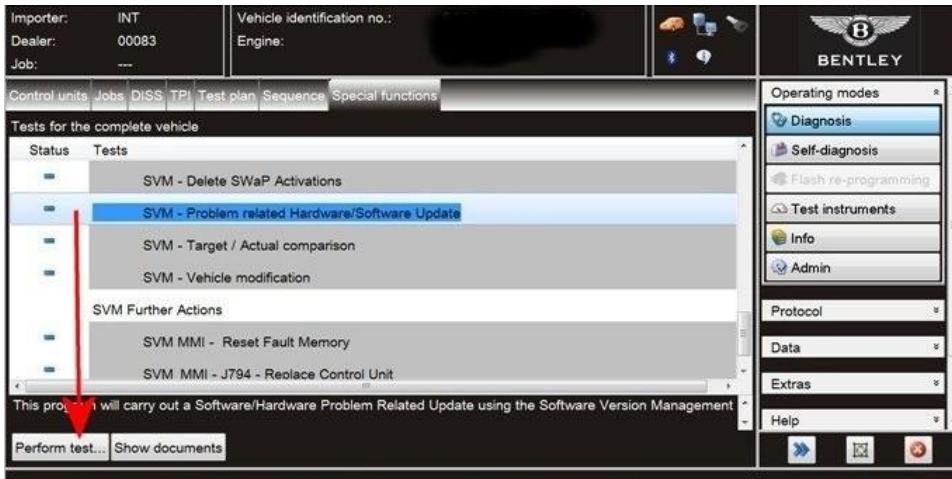
Figure 1

- Within the Special functions tab select *SVM – Problem related Hardware/Software update* then select Perform test (Figure 1)

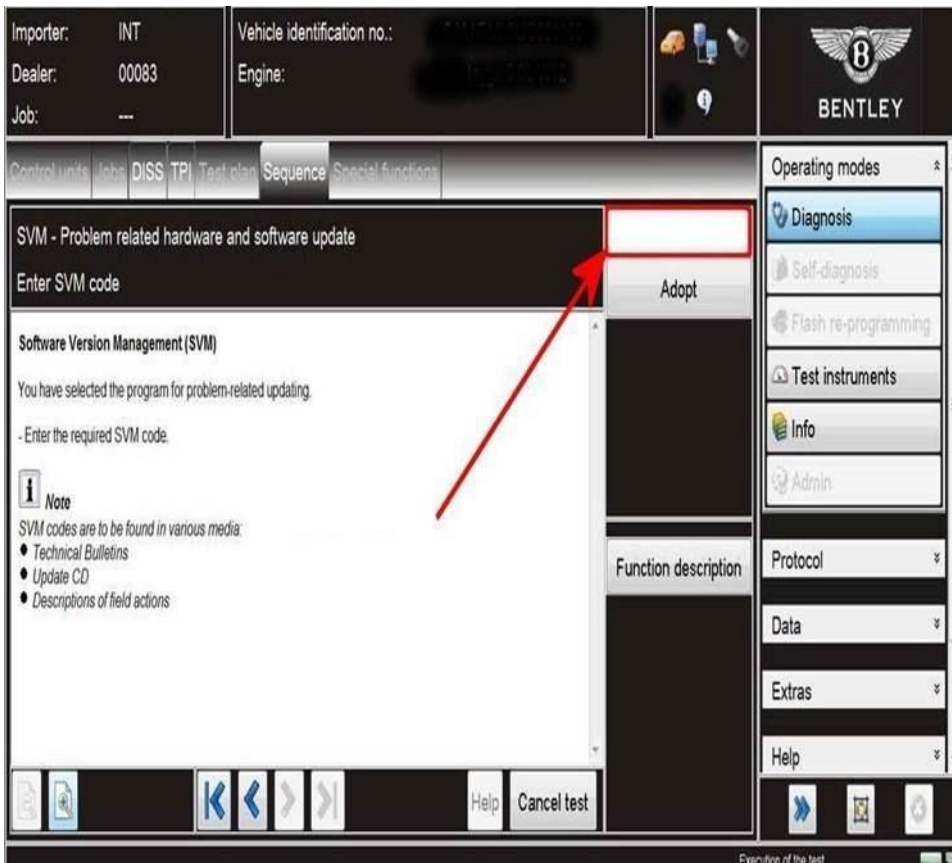
Figure 2

2) On the next screen enter SVM code 37102GB01 (Figure 2)

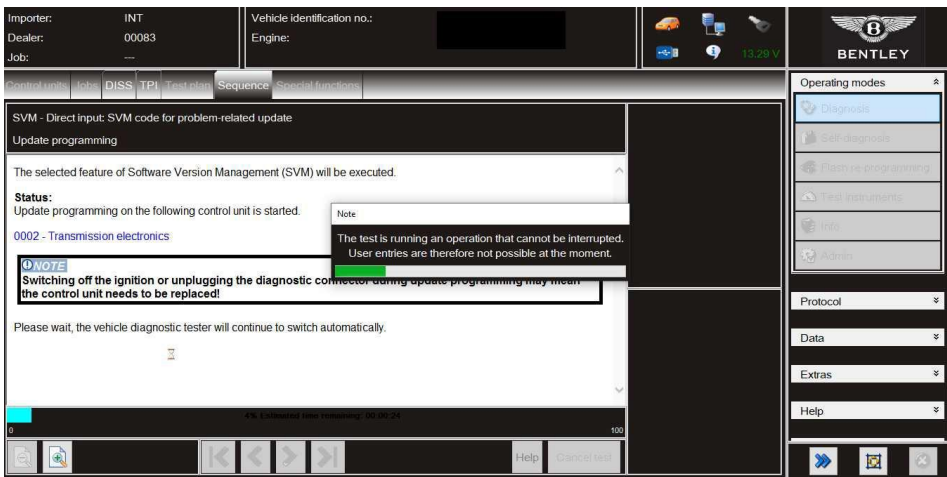
Figure 3

- All control modules will now be interrogated
- The software update will then be suggested
- The software of *02 – Transmission Control Module (Figure 3)* will be updated

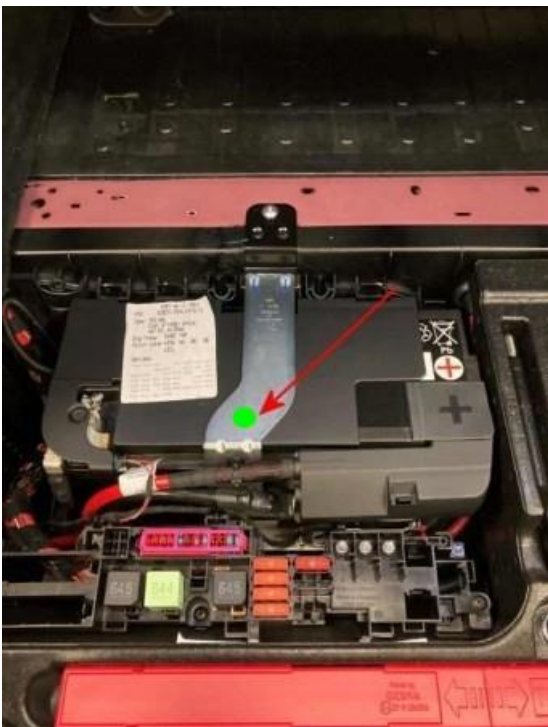
Green paint completion mark on the 12 volt battery retaining bracket

6) Apply a green paint completion mark as shown in the Identification section
