Technical Service Bulletin

Topic	Headlamp operation issues
Market area	Bentley: worldwide (2WBE),Hongkong-Macau (5HK)
Brand	Bentley
Transaction No.	2054599/7
Level	EH
Status	
Release date

Headlamp operation issues

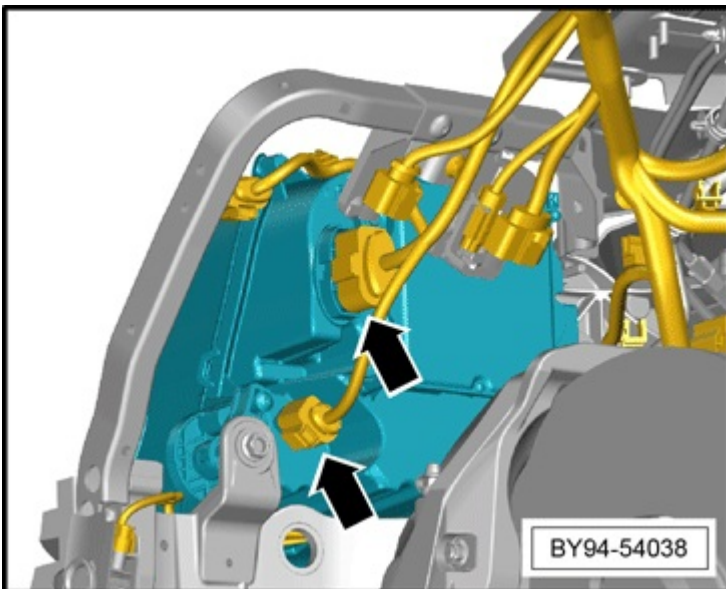
Figure 1

DTC's evident within the left light control unit (Diagnostic address D6) and/or the right light control unit (Diagnostic address D7)

2) Referring to the examples shown in Figures 1 and 2

Disconnect the applicable headlamp plugs (right and/or left hand side) - During disconnection look out for any abnormalities for example a plug which is loose/broken or is easily disconnected
