## X540 Panoramic roof inoperable

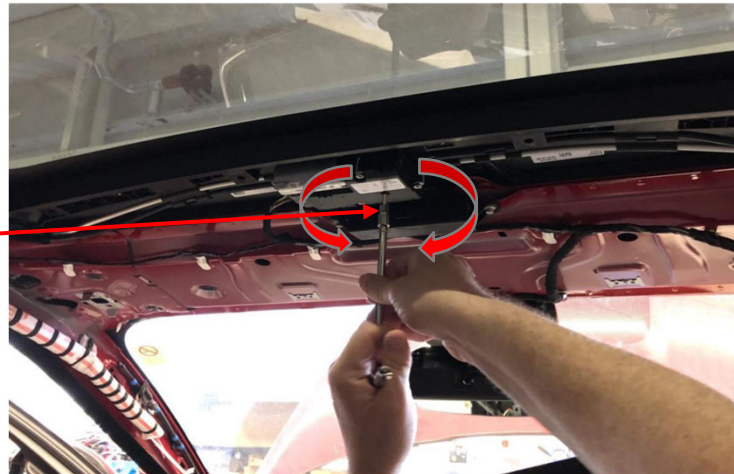
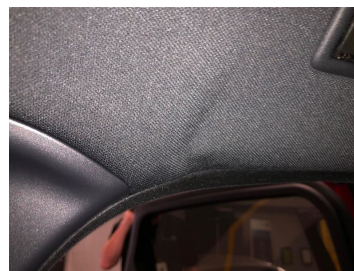
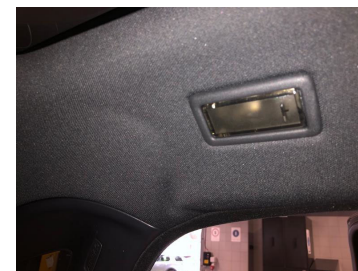
If a X540 Panoramic roof sunblind becomes inoperable, lower overhead console and headliner to gain access to sunblind motor.

\*\* Care point head liner creasing when lowering for access to the sunblind motor.

Insert 4mm Allen key into emergency operation slot, rotate half turn clockwise and then half turn anti clockwise.

Then operate normally by button.  
Re calibrate Panoramic roof then operate approx. 7 full cycles.

Refit overhead console and headliner as per TOPIx process.
