CAMPAIGN BULLETIN

PG7BS Clock Spring Cable/Steering Column Bushing Campaign Quality Review

Reference: PC833
Date: August 27, 2021

PC833 – 2017-2018 QX30 STEERING COLUMN BUSHING

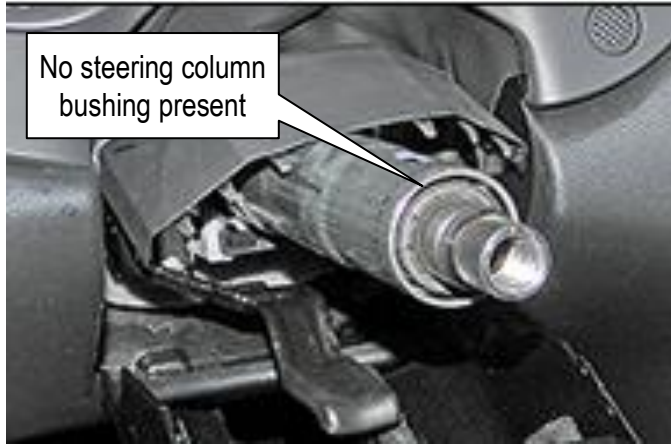
Figure 17

NOTE: The steering column may, or may not have an existing steering column bushing (refer to Figures 17 and 18). If a bushing is present, discard it and continue to Step 19 to replace it with a new one.
