Service Action

Code: 92E3

Subject Heated Washer Jet Wiring Harness

Release Date October 12, 2021

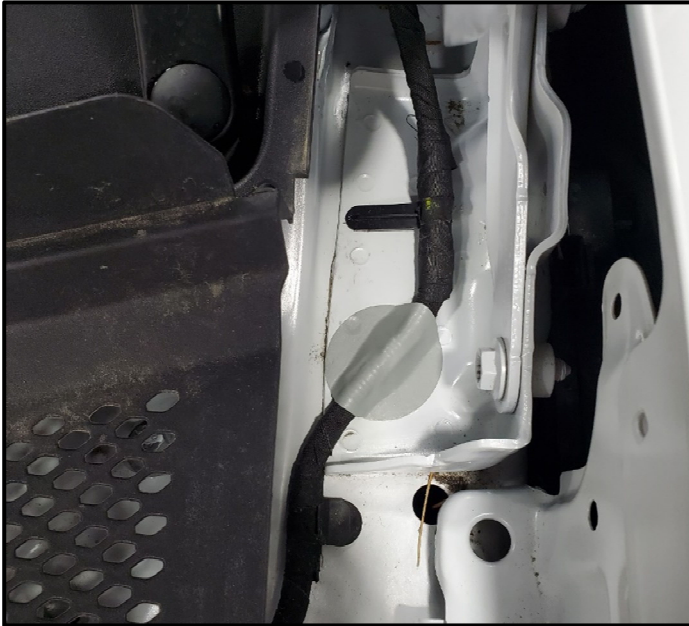
Repair Overview

In certain vehicles, it may be possible for the wiper arms to make contact with the wiring harness and water line for the washer jets, potentially causing damage to the wiring harness. If this happens, over time the heated washer jets may stop working or cause washer fluid to splash on the windshield.

- Reroute wiring harness for the heated washer jets.

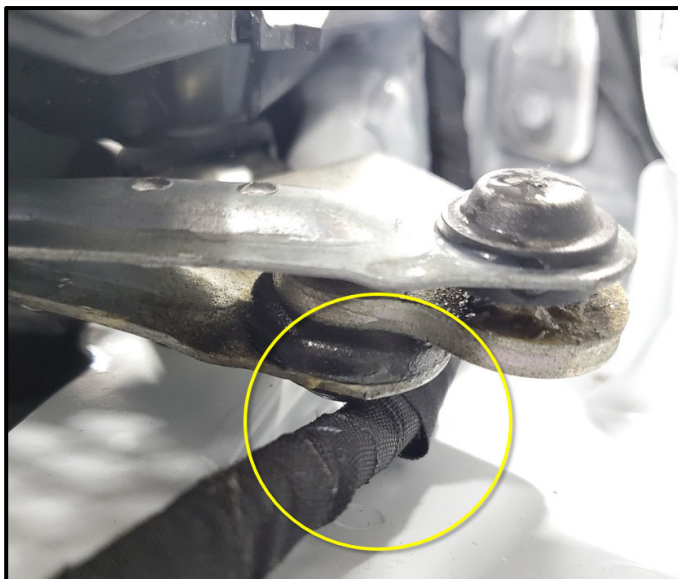
If damage to the wiring or washer fluid hose is found due to contact with the wiper linkage, the damage must be repaired:

- U.S. dealers: Provide a photo and submit a campaign authorization request for consequential damage through WISE.
