SERVICE BULLETIN

Classification: AN21-019	Reference: NTB21-085	Date: September 13, 2021
-----------------------------	-------------------------	-----------------------------

SOFTWARE UPDATE FOR INFOTAINMENT ISSUES

APPLIED VEHICLES: 2021 Rogue (T33)
APPLIED GRADE: S grade only

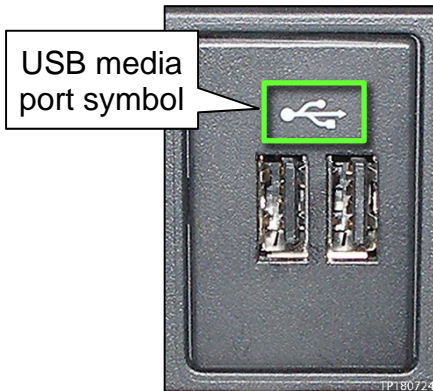
Figure 12

16. Insert the USB drive with the infotainment update-software into the vehicle's USB media port (Figure 12).

Do not insert the USB drive into a charging port. If used, the update-software and/or USB drive may become damaged. Only insert the USB drive in a USB media port.

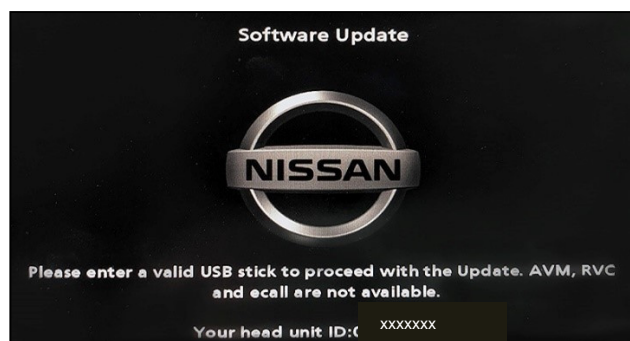
- The screen in Figure 15 may briefly appear. **Do not remove the USB drive.** The audio system will detect the USB and continue the update.
