# CAMPAIGN BULLETIN

## Rear Window Defogger Dealer Inventory

Reference: PC814

# PC814 – 2021 ROGUE REAR WINDOW DEFOGGER INSPECTION

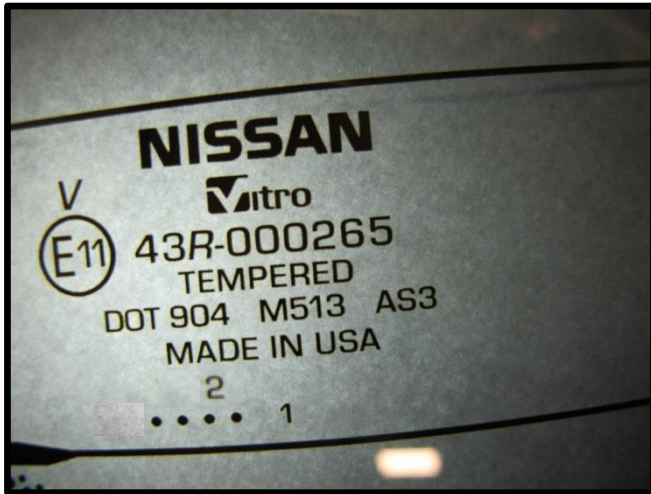
Figure 4

- **03/02/21** (March 2, 2021) (As Shown in Figure 4)
- **03/09/21** (March 9<sup>th</sup>, 2021) (As Shown in Figure 5)
  - **YES** > Proceed to Step 4 to inspect for rear window defogger heating wire transfer.
  - **NO** > The back door glass is **GOOD**. Proceed to Step 12.

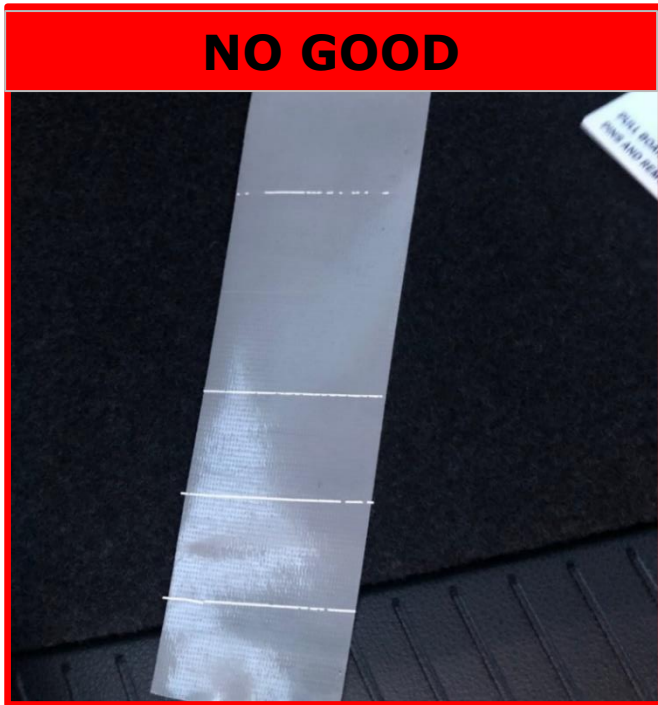
Figure 10

8. Pull the tape off then inspect the tape and the back door glass to verify if heating wires have transferred to the tape. Refer to Figures 10, 11, 12, and 13 below.

<p>9. Did the heating wires pull off the glass and transfer to the tape? (Refer to Figures 10 and 12)</p> <ul style="list-style-type: none"> <li>➤ <b>YES</b> &gt; The back door glass is <b>NO GOOD</b>. Proceed to Step 10 to replace the back door glass and both side air spoiler extensions.</li> <li>➤ <b>NO</b> &gt; The back door glass is <b>GOOD</b>. Proceed to Step 12.</li> </ul>
<p>10. Replace the back door glass and both side air spoiler extensions per the Electronic Service Manual (ESM): BODY EXTERIOR, DOORS, ROOF &amp; VEHICLE SECURITY – GLASS &amp; WINDOW SYSTEM – REMOVAL AND INSTALLATION – BACK DOOR WINDOW GLASS – Removal and Installation</p>
<p>11. Turn the ignition off and close the back door.</p>
<p>12. Submit warranty claim per the CLAIMS INFORMATION and release the vehicle.</p>
