Bulletin No.: PIP5806D

PIP5806D Intermittent Extended Crank No Start And A Possible DTC P0341 Set

Brand:	Model:	Model Years:	VIN:		Engine:	Transmissions:
			from	to		
Chevrolet	Silverado	2020 - 2021	All	All	LM2	All
GMC	Sierra	2020 - 2021	All	All	LM2	All

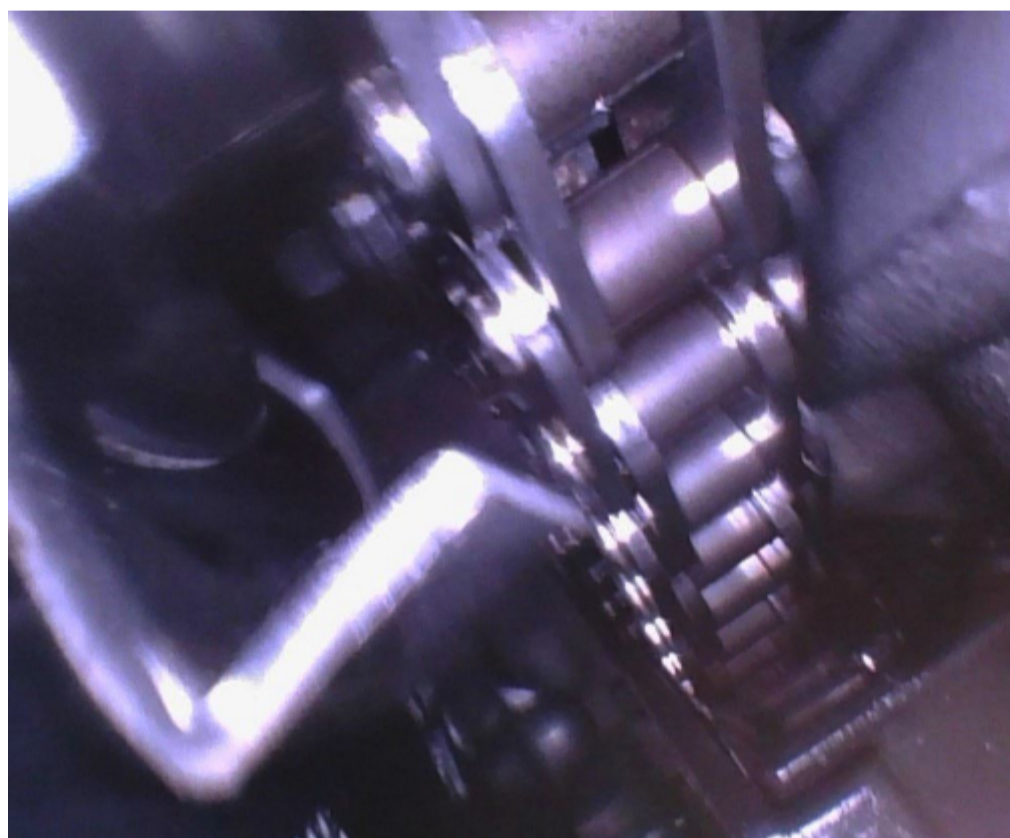
It is necessary to roll the engine over by hand (up to two revolutions) to inspect each wheel segment. See the picture below:

Remove the camshaft position sensor and use a borescope to inspect the camshaft trigger wheel for coming in contact with the timing chain. If the trigger wheel is coming into contact with the timing chain at any point, it will be necessary to replace the trigger wheel.

If the camshaft trigger wheel is not coming into contact with the timing chain at any point, Install a .5mm shim to the camshaft position sensor, P/N 12565102.

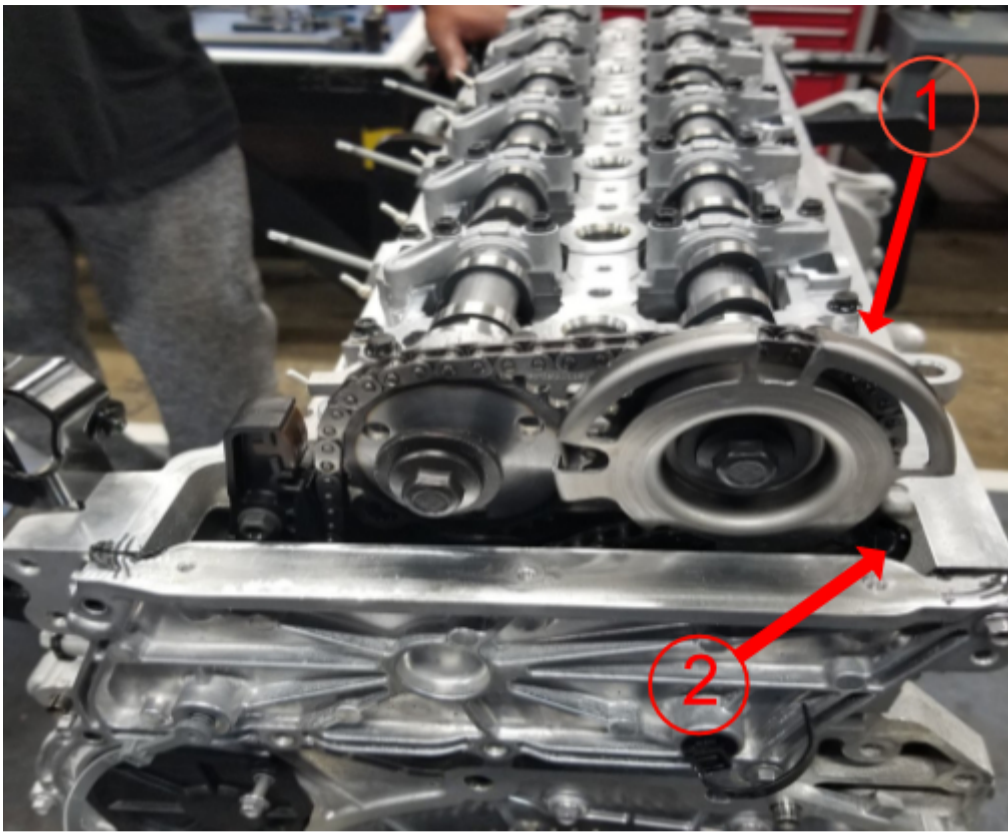
Below are reference pictures of a good trigger wheel and chain:

1. Camshaft Position Reluctor Wheel

2. Camshaft Position Sensor

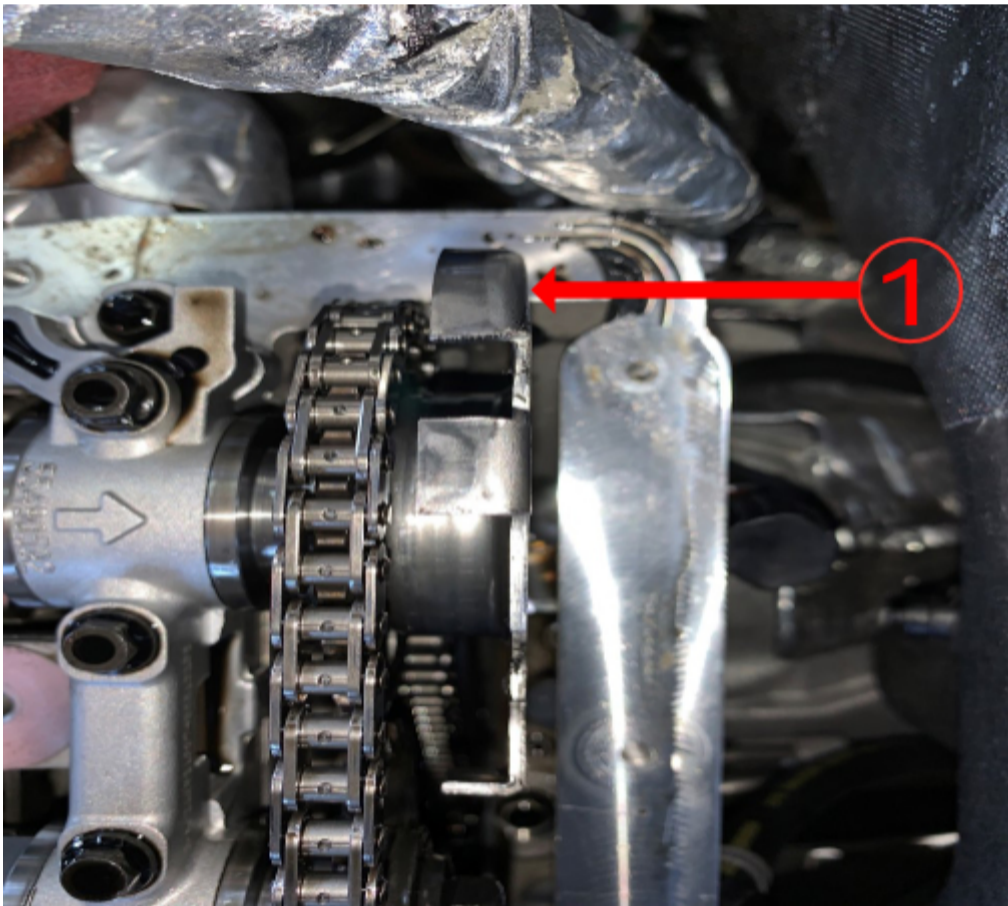
1. Camshaft Position Reluctor Wheel
