# News Channel Update | Vans Customer Service and Parts

Campaign No. 2021070031, August, 2021

SUBJECT: **Model 907 Sprinter, Model Year 2019-2021  
Inspect Swivel Seat Wiring Harness Routing**

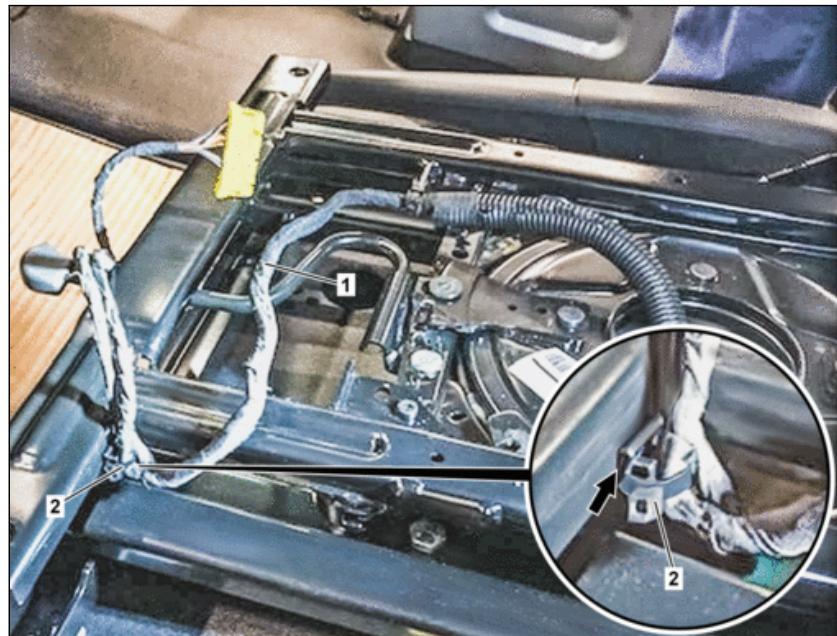
D91.10-A026-76

**Shown on driver's seat with code SF1 (Electrically adjustable driver's seat) and code SR8 (Driver's seat rotating frame)**

1 Wiring harness

2 Cable tie with retaining clip

3	<p>Subsequently adapt line installation and attachment of wiring harness (1) to respective rotating seat.</p>	<p><b>i</b></p> <p>To do so, check if the wiring harness (1) is correctly fastened to the respective rotating seat frame using a cable tie with retaining clip (2).</p> <p>The wiring harness (1) must be positioned in the corner (arrow) of the rotating seat frame, as shown in the picture, and fixed in place using a cable tie with retaining clip (2).</p> <p>If cable tie with retaining clip (2) is not present,</p> <p style="text-align: center;">↓</p> <p>subsequently fasten wiring harness (1) to rotating seat frame using retaining clip (2). To do so, position wiring harness (1) along cable tie with retaining clip (2) in corner (arrow) of rotating seat frame. See figure.</p> <p>If cable tie with retaining clip (2) is present,</p> <p style="text-align: center;">↓</p> <p>position wiring harness (1) correctly on rotating seat frame. To do so, position wiring harness (1) along cable tie with retaining clip (2) in corner (arrow) of rotating seat frame. See figure.</p>

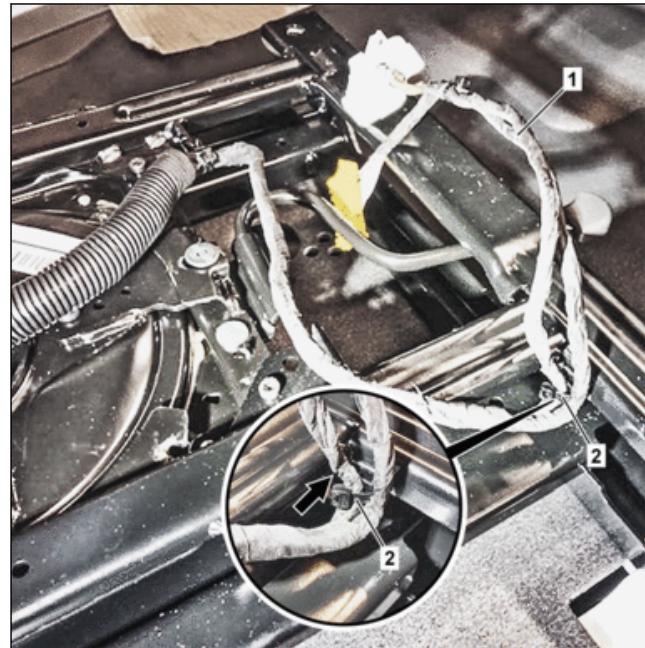
D91.10-A027-82

**Shown on driver's seat with code SF2 (Electrically adjustable front passenger seat) and code SR9 (Front passenger seat rotating frame)**

- 1 Wiring harness
- 2 Cable tie with retaining clip
