TO: Mercedes-Benz Principals, General Managers, Sales Managers, Service Managers, Parts Managers	FROM: Anthony Washington, Department Manager, Regulations and Certifications
<b>Re: Recall Campaign Launch Notification</b> <b>Model 907 (Sprinter)</b> <b>Model Years 2019-2021</b> <b>Inspect Swivel Seat Wiring Harness Routing</b>	DATE: August, 2021

Campaign No. 2021070031, August, 2021

SUBJECT: **Model 907 Sprinter, Model Year 2019-2021**  
**Inspect Swivel Seat Wiring Harness Routing**

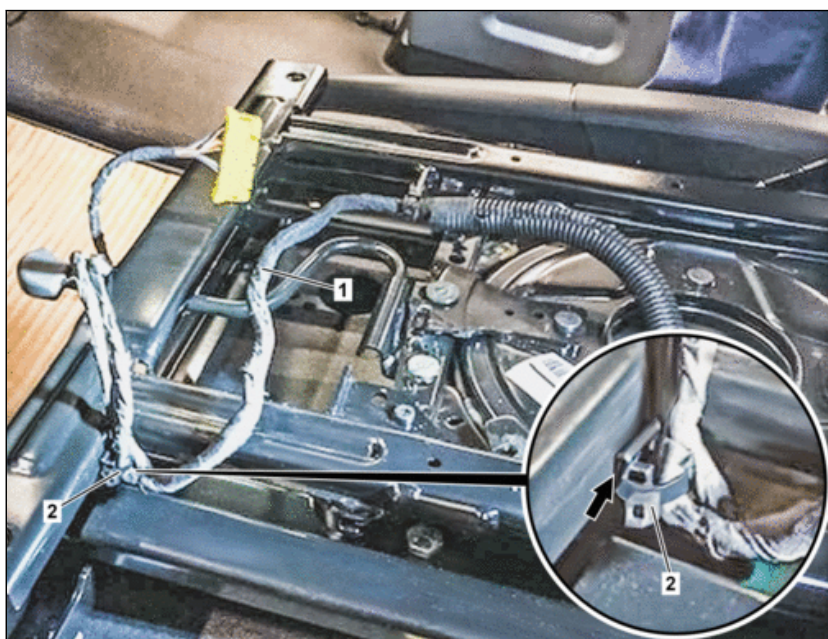
D91.10-A026-76

Mercedes-Benz AG (“MBAG”), the manufacturer of Mercedes-Benz and Freightliner vans, has determined that on certain Mercedes-Benz Sprinter vehicles of Platform 907 (VS30) equipped with electrically adjustable front swivel-seats, the seat wiring harness may be improperly routed or mounted within the swivel-seat frame and could become pinched and damaged during the electric adjustment of the seat position. If the wiring harness becomes pinched and damaged during adjustment of the swivel seat, in a worst case scenario the operation of the seat-mounted side airbag may not operate properly and the side airbag may either deploy inadvertently or may not deploy as designed in the event of a crash. This condition could increase the risk of injury in the event of a crash.

**Shown on driver's seat with code SF1 (Electrically adjustable driver's seat) and code SR8 (Driver's seat rotating frame)**

- 1 Wiring harness
- 2 Cable tie with retaining clip

3	Subsequently adapt line installation and attachment of wiring harness (1) to respective rotating seat.	<p><b>i</b></p> <p>To do so, check if the wiring harness (1) is correctly fastened to the respective rotating seat frame using a cable tie with retaining clip (2).</p> <p>The wiring harness (1) must be positioned in the corner (arrow) of the rotating seat frame, as shown in the picture, and fixed in place using a cable tie with retaining clip (2).</p> <p>If cable tie with retaining clip (2) is not present,</p> <p style="text-align: center;">↓</p> <p>subsequently fasten wiring harness (1) to rotating seat frame using retaining clip (2). To do so, position wiring harness (1) along cable tie with retaining clip (2) in corner (arrow) of rotating seat frame. See figure.</p> <p>If cable tie with retaining clip (2) is present,</p> <p style="text-align: center;">↓</p> <p>position wiring harness (1) correctly on rotating seat frame. To do so, position wiring harness (1) along cable tie with retaining clip (2) in corner (arrow) of rotating seat frame. See figure.</p>

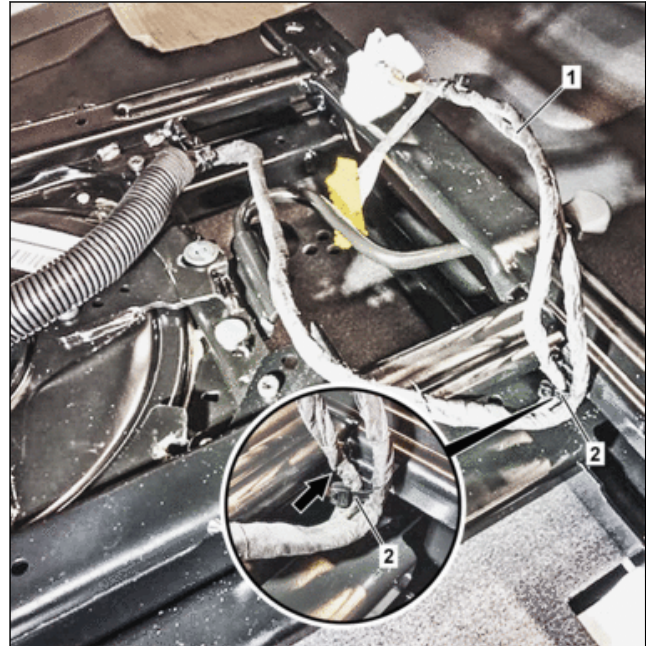
D91.10-A027-82

Shown on driver's seat with code SF2 (Electrically adjustable front passenger seat) and code SR9 (Front passenger seat rotating frame)

- 1 Wiring harness
- 2 Cable tie with retaining clip

If rotating seats are installed on the driver and passenger side, then the line installation of both rotating seats must be checked and adapted, if necessary.
