Technical Service Bulletin

01 Car jerks/bucks or hesitates while driving DTCs P023600 and/or P010600 are stored in the ECM

01 21 13 2062323/2 October 20, 2021. Supersedes Technical Service Bulletin Group 01 number 21-98 dated February 18, 2021 for reasons listed below.

Model(s)	Year	VIN Range	Vehicle-Specific Equipment
A6	2018 - 2022	All	2.0TFSI

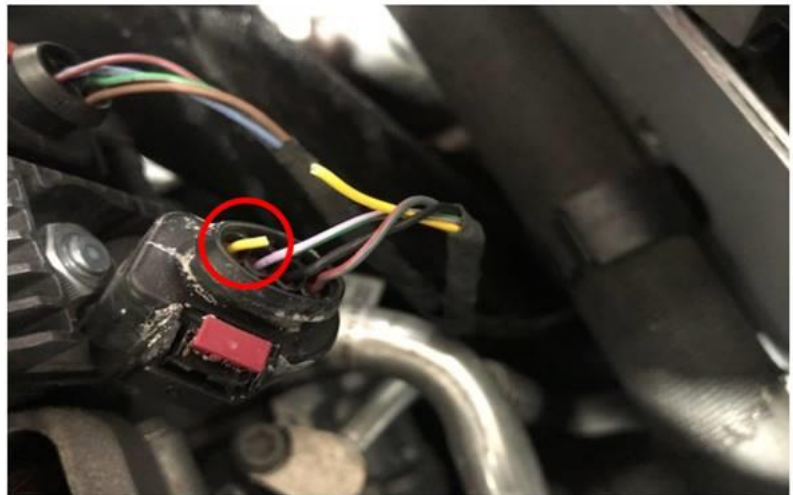
- The yellow wire on the electrical connector of the charge pressure sender is damaged.

Due to the routing of the wiring and the length of wiring that is uncovered, the wiring may become damaged due to vibrations.

Figure 1. Wire is broken at G31 sensor.

1. If damage is found to the pins or wire at the G31 boost pressure sensor, repair the harness using VAS 1978B (Figure 1).

Please use gold-plated contacts to repair the damaged wire(s) (000 979 025 EA).

Ensure there is sufficient slack in the harness to prevent future issues.

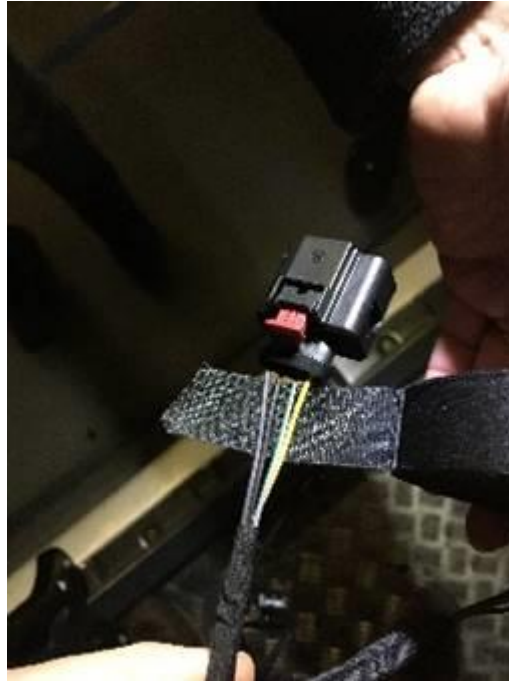
Figure 2. Harness is wrapped using textile tape 105 920 02.

2. Following repairs, the harness must be wrapped with textile tape **N 105 920 02**.

Apply the textile tape starting at the wiring below the connector. Ensure the wires are kept flat to avoid over stressing the pins (Figure 2).

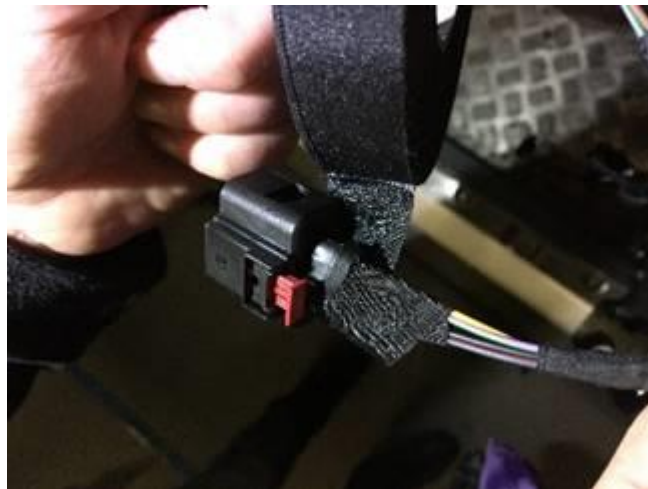
Figure 3. Wrapping the connector base.

3. Wrap the tape in the direction of the connector keeping it **flat** (Figure 3).

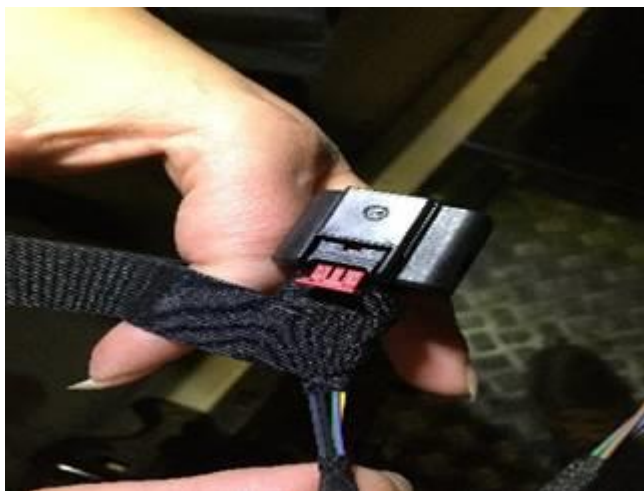
Figure 4. Wrapping the connector base part 2.

4. The tape must extend far enough to cover the connector base (Figure 4).

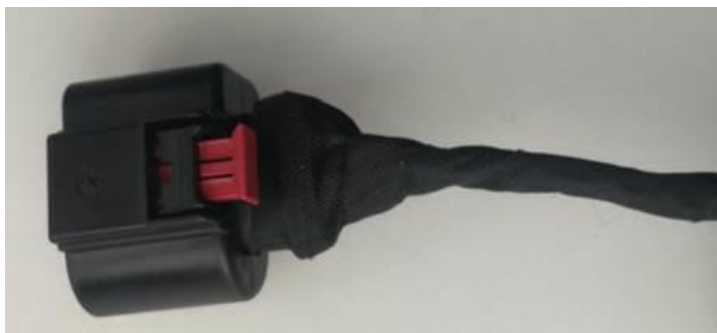
Figure 5. Completed harness wrapping.

5. Continue to wrap the exposed wires down the harness and slightly overlap the existing harness tape (Figure 5).
