57 Bonded outer door seal is detached from the door

57 21 85 2064183/2 October 21, 2021. Supersedes Technical Service Bulletin Group 57 number 21-81 dated July 28, 2021 for reasons listed below.

Model(s)	Year	VIN Range	Vehicle-Specific Equipment
Audi e-tron quattro	2019 – 2022	All	Not Applicable
Audi e-tron sportback quattro	2020 – 2022	All	Not Applicable

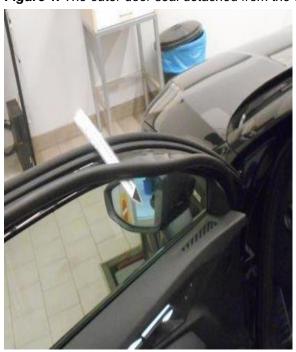
Various factors such as pressure, temperature, and contamination in the bonding area can influence the adhesive bond between the outer door seal and the door.

The adhesive bond for the outer door seal can come loose in the entire area where the outer door seal makes contact with the door (Figures 1 - 4).

Figure 1. The outer door seal detached from the door.

1. Replace affected door seals as described in the Elsa Repair Manual.

- The vehicle and the seal must be at room temperature.
- The bonding surfaces must be free of dirt and grease.
- Do not stretch the seal during installation.
- To prevent the outer door seal from becoming detached or misaligned, the door must not be closed for at least 30 minutes.
- If the door seal has been removed, use the routing of the outer door seal on the opposite side as a guide when positioning the outer door seal.
- Remove any remaining adhesive tape from the door using adhesive strip remover VAS 6349.
- Clean the bonding surface on a painted surface with cleaning solution D 009 401 04 and let it dry.

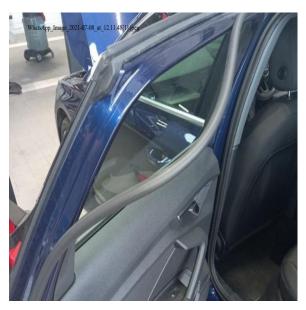
Figure 2. The outer door seal detached from the door.

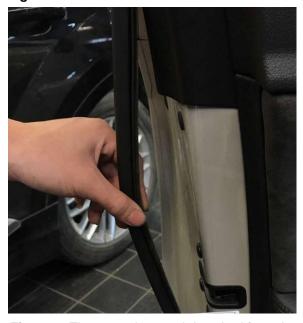
Figure 3. The outer door seal detached from the door.
