Technical Service Bulletin

PSS 91 MIB3: MMI display turns blue

91 21 40 2063702/2 October 13, 2021. Supersedes Technical Service Bulletin Group 91 number 21-09 dated June 21, 2021 for reasons listed below.

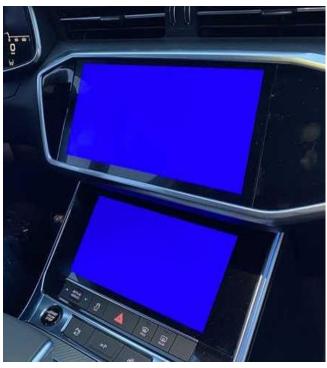
The MMI display turns completely blue (Figures 1 - 2).

Figure 1. Dual screen vehicle.

An issue in the display driver can cause the displays to turn blue.

- 1. **Workaround**: Reset the MMI by pushing the On/Off/Volume button for 10 seconds or more. The MMI will reboot and should work normally afterward.
- Explain to the customer that a permanent solution is forthcoming for the 1st quarter of 2022 and that no repairs are necessary at this point. Do not replace any components for this condition since this will not resolve the customer's concern.
- 3. Create a PSS record in the PSS application through the Pending Service Solutions (PSS) link in AccessAudi (under *Related Links >> Service*), or through the Technical Assistance page in Elsa.
