# Technical Service Bulletin

**COOLANT LEAKS AT CYLINDER HEAD**

Bulletin No.: 01-013/21

Last Issued: 10/15/2021

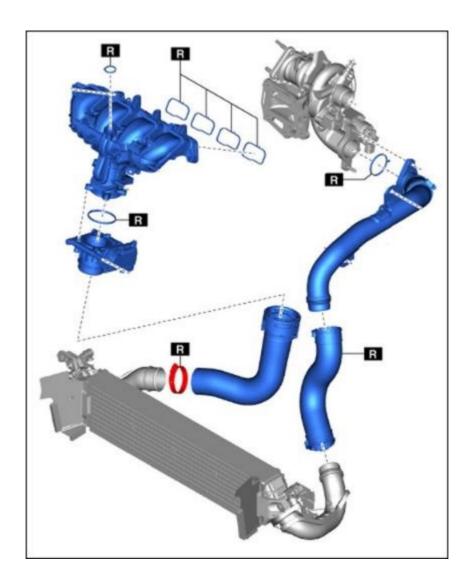
· Gaskets for intake-air system

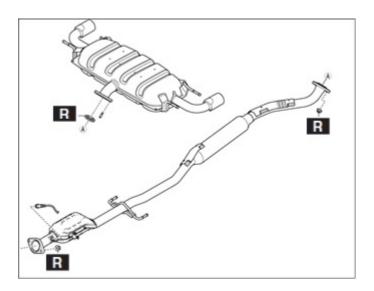
· Gasket and nuts for TWC

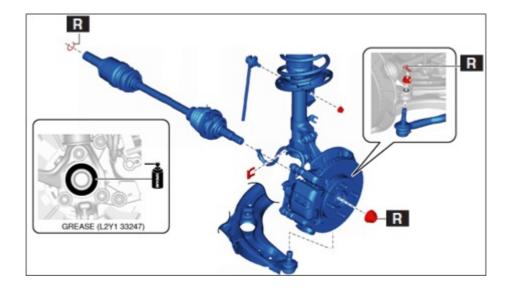
- · Snap pin for Tie-rod end
- · Lock nut for Driveshaft
- Clip for Drive shaft (LH)
- Grease (L2Y1-33-247) for knuckle

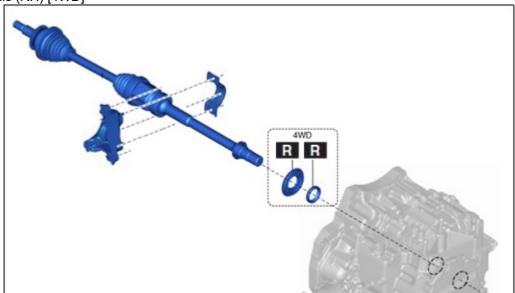
• Transfer oil seals (RH) [4WD]

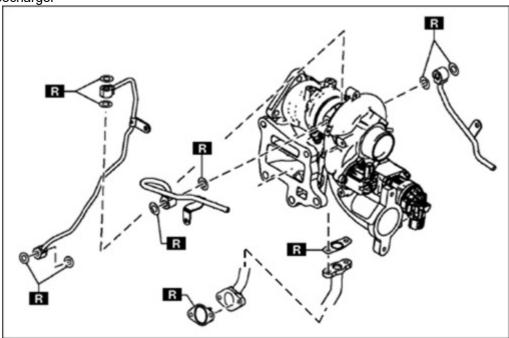
• Gaskets for turbocharger

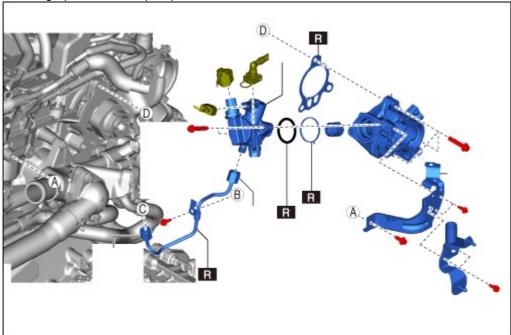
· Gaskets and pipe for high pressure fuel pump

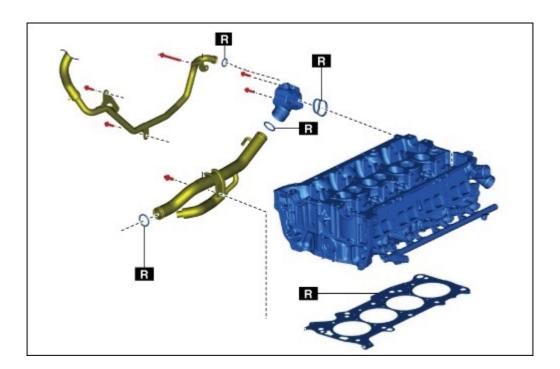
Gasket and O-rings for water pipes and cylinder head gasket
