Technical Service Bulletin

55 Status of the charging port door(s) is displayed incorrectly

55 21 64 2064953/2 October 31, 2021. Supersedes Technical Service Bulletin Group 55 number 21-63 dated October 26, 2021 for reasons listed below.

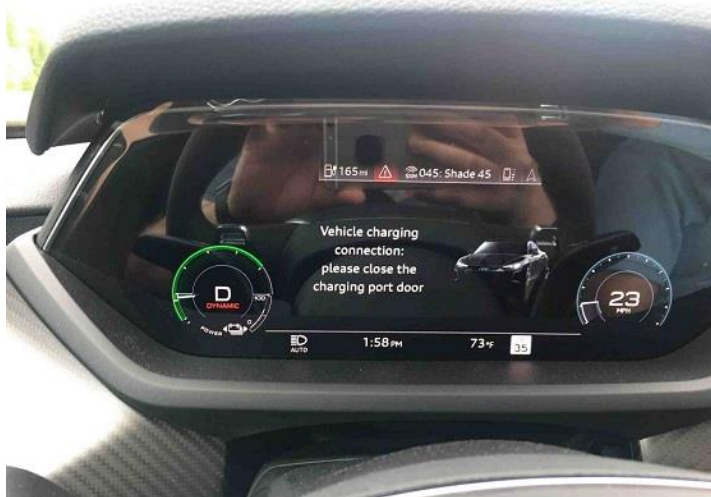
- The status of one or both charging port doors is not detected correctly. The charging port door actuator(s) is defective.

Oxidation and/or contamination of the charging port door actuator can lead to this concern.

The DIS in the Audi virtual cockpit displays the message that the charging port door needs to be closed (Figure 1).

Figure 1. DIS message incorrectly requesting to close the charging port door.

Replace both charging port door actuators (left + right) according to the Elsa Repair Manual
