Technical product information

Topic	Driver/Passenger door creak on close
Market area	Russische Föderation (5RU),Australia E04 Bentley rest Asia and Australia (6E04),China 796 VW Import Comp. Ltd (Vico), Beijing (6796),Germany E02 Bentley rest Europe (6E02),Japan E03 Bentley Japan (6E03),Korea, (South) E08 Bentley South Korea (6E08),United Arab Emirates E06 Bentley Middle East and Africa (6E06),United Kingdom E01 Bentley UK (6E01),United States E05 Bentley USA and rest America (6E05)
Brand	Bentley
Transaction No.	2061605/3
Level	EH
Status	Approval
Release date

New Continental GT - New Continental GTC and New Flying Spur

Driver or Passenger door creak during close

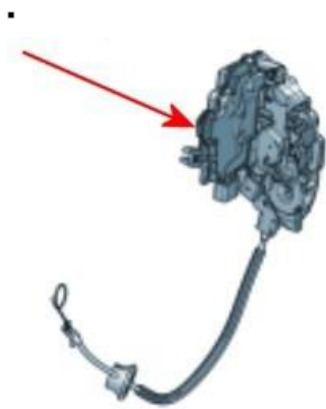
Figure 1

Refer to the vehicle repair history to check/confirm if any previous work which has been conducted regarding door latch replacement (Figure 1)

In the event the door latch date of manufacture is unknown (No notes within the vehicle repair history) the date of manufacture of each door latch must be confirmed
