# **Technical product information**

Торіс	Oil leaking from tell tale hole - CDA actuator fixings or Fuel rail fixings or Vacuum assembly fixings
Market area	Russische Föderation (5RU),Australia E04 Bentley rest Asia and Australia (6E04),China 796 VW Import Comp. Ltd (Vico), Beijing (6796),Germany E02 Bentley rest Europe (6E02),Japan E03 Bentley Japan (6E03),Korea, (South) E08 Bentley South Korea (6E08),United Arab Emirates E06 Bentley Middle East and Africa (6E06),United Kingdom E01 Bentley UK (6E01),United States E05 Bentley USA and rest America (6E05)
Brand	Bentley
Transaction No.	2064679/1
Level	EH
Status	Approval
Release date

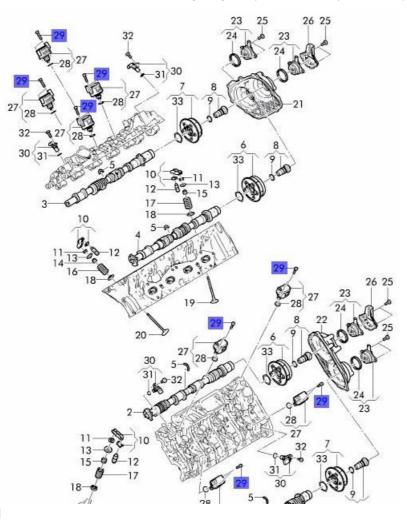
Figure 1 Or

• CDA activation/ deactivation solenoid fixings - Figure 1 (Item 29 - Quantity of 16 in total)

• In the event that x1 (or more) of the CDA solenoid fixing/s are leaking – <u>All 16 CDA solenoid fixings MUST BE REPLACED as a</u> <u>complete set</u> - Refer to Rep. Gr 15 - Ensuring the procedure is followed to enable access to all CDA solenoid fixings

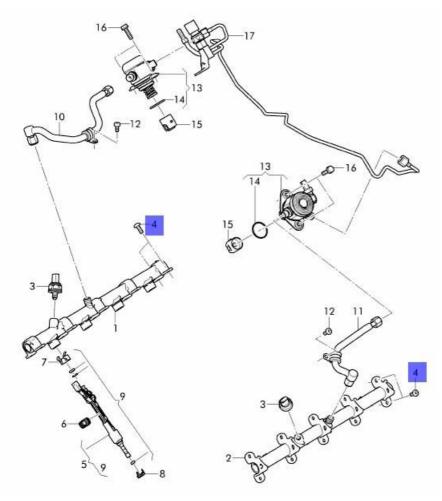
## Figure 2

<sup>•</sup> Fuel rail fixings - Figure 2 (Item 4 - Quantity of 20 in total)

• Refer to Rep. Gr24 - Fuel rails to remove and refit - Ensure the procedure is followed to enable access to the fuel rail fixings on both Banks 1 and 2 - Replace all 20 fixings

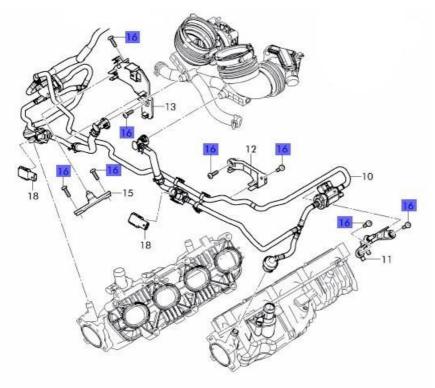
## Figure 3

• Fixings for the vacuum system assembly - Figure 3 (Item 16 – Quantity of 8 in total)

1) To gain access to the fixings, the Operative should refer to extracts from the following procedures to replace the fixings:

• Rep.Gr20 - Evaporative Emission Purge Valve and Rep.Gr28 - Ignition coil replacement

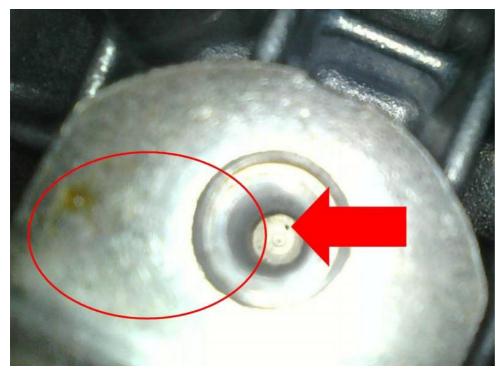
#### Figure 4

Figure 4 shows oil leaked which had leaked from the tell tale hole at the top of the fixing (Arrow)

Upgraded fixings prevent oil leaks from the tell hole
