## Technical product information

<b>Topic</b>	Driver/Passenger door creak on close
<b>Market area</b>	Russische Föderation (5RU),Australia E04 Bentley rest Asia and Australia (6E04),China 796 VW Import Comp. Ltd (Vico), Beijing (6796),Germany E02 Bentley rest Europe (6E02),Japan E03 Bentley Japan (6E03),Korea, (South) E08 Bentley South Korea (6E08),United Arab Emirates E06 Bentley Middle East and Africa (6E06),United Kingdom E01 Bentley UK (6E01),United States E05 Bentley USA and rest America (6E05)
<b>Brand</b>	Bentley
<b>Transaction No.</b>	2061605/4
<b>Level</b>	EH
<b>Status</b>	Released for publishing
<b>Release date</b>	13-Oct-2021

### New Continental GT - New Continental GTC and New Flying Spur

Driver or Passenger door creak during close

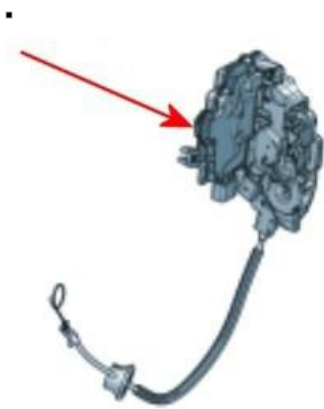
Figure 1

Refer to the vehicle repair history to check/confirm if any previous work which has been conducted regarding door latch replacement (Figure 1)

In the event the door latch date of manufacture is unknown (No notes within the vehicle repair history) the date of manufacture of each door latch must be confirmed

**VERY IMPORTANT:** All 22 M/Y vehicles are fitted with the latest specification parts therefore the requirement to confirm the manufacturing date of the latch as detailed in steps 1 and 2 is not required, in this scenario the faulty door latch should be replaced

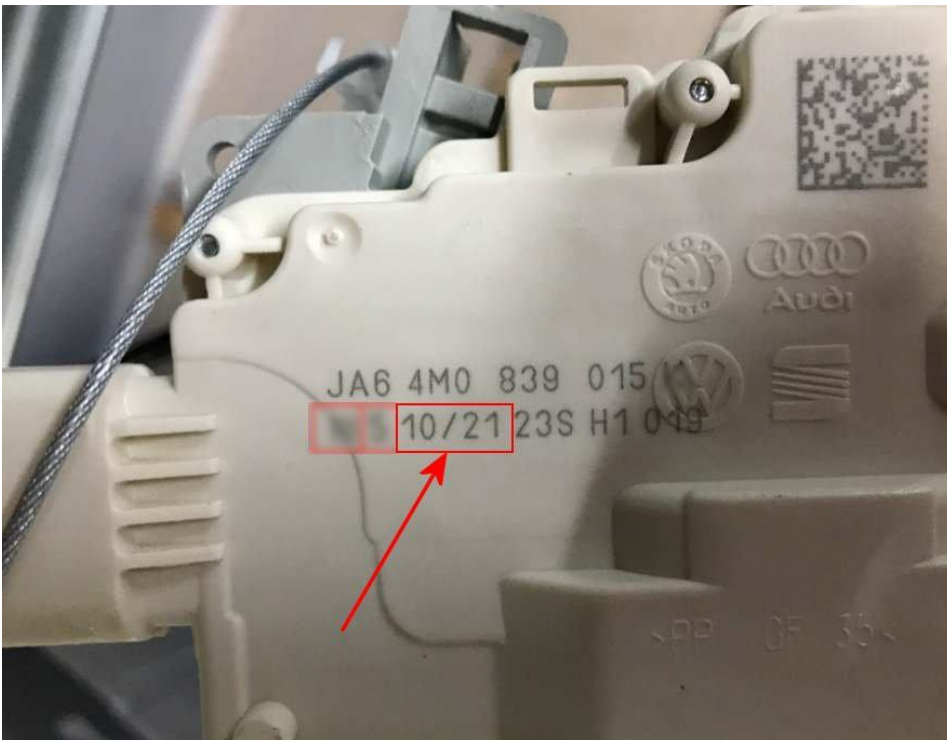
- 1) Referring to the applicable Rep.Gr - Remove the front and rear door trims
- 2) Referring to Figure 2 - Check the date of manufacture in the location shown

[Latch manufacturing date code prior to 10/21](#)

- Referring to the applicable Repair Group - Replace all latch motors to latest specification

[Latch manufacturing date code post 10/21 or 22 Model year](#)

- Referring to the applicable Repair Group - Replace the affected door latch only
