Technical product information

Topic	Rotating Display - Fault Diagnosis
Market area	Bentley: worldwide (2WBE),Hongkong-Macau (5HK)
Brand	Bentley
Transaction No.	2055580/7
Level	EH
Status	Approval
Release date

New Continental GT

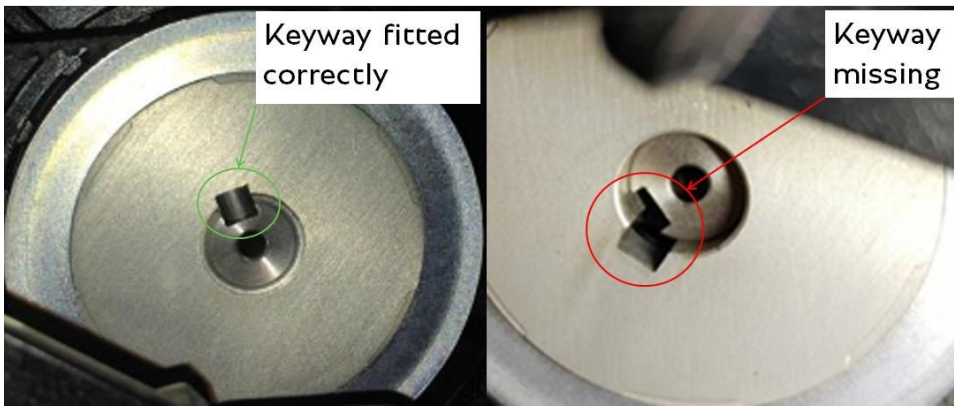
Figure 1

Check pulley wheel for looseness and ensure the keyway is present and fitted correctly (Figure 1).

If either defect is present raise a DISS technical query with photos attached, do not follow any more steps at this point.

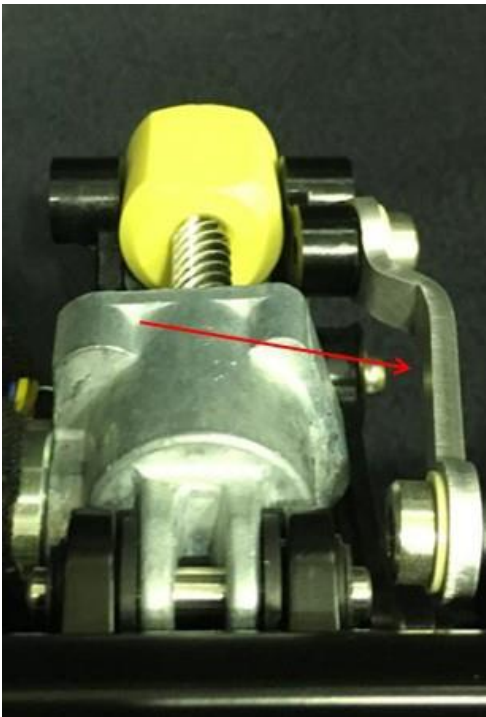
Figure 2

Check link bar for deformation (Figure 2).

If the link bar is deformed or bent, remove the link bar and attempt to straighten then refit the link bar. Refit the rotating display to a state that it can be tested then carry out re-initialisation and retest. Should this not be successful raise a DISS technical query with photos attached, do not follow any more steps at this point.

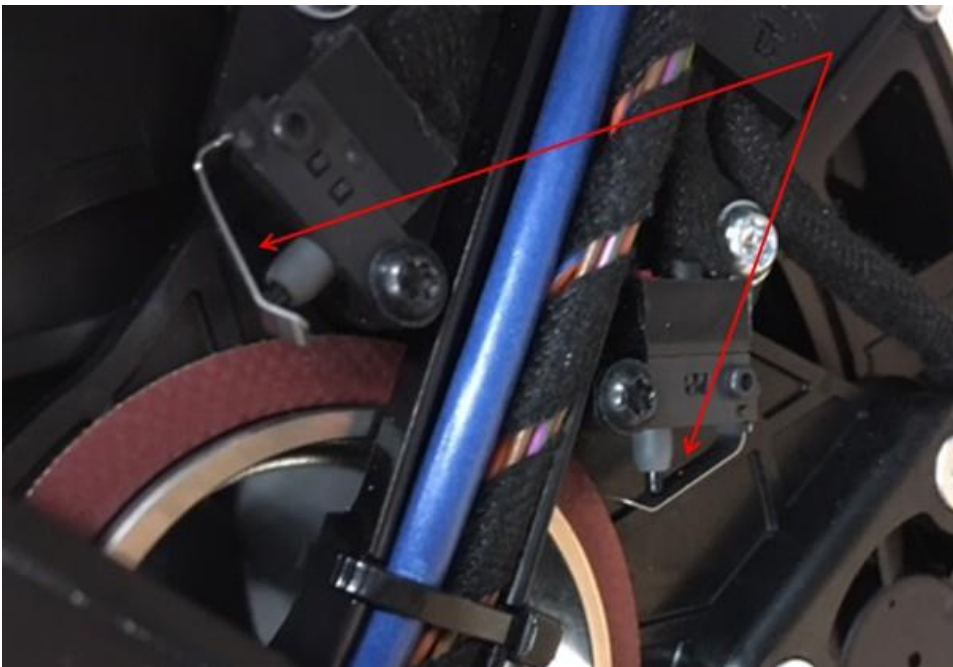
Figure 3

Check the condition of both micro switches for damage or connection misalignment (Figure 3).

If the micro switches are damaged or misaligned, attempt to repair and retest. Refit the rotating display to a state that it can be tested then carry out re-initialisation and retest. Should this not be successful raise a DISS technical query with photos attached, do not follow any more steps at this point.

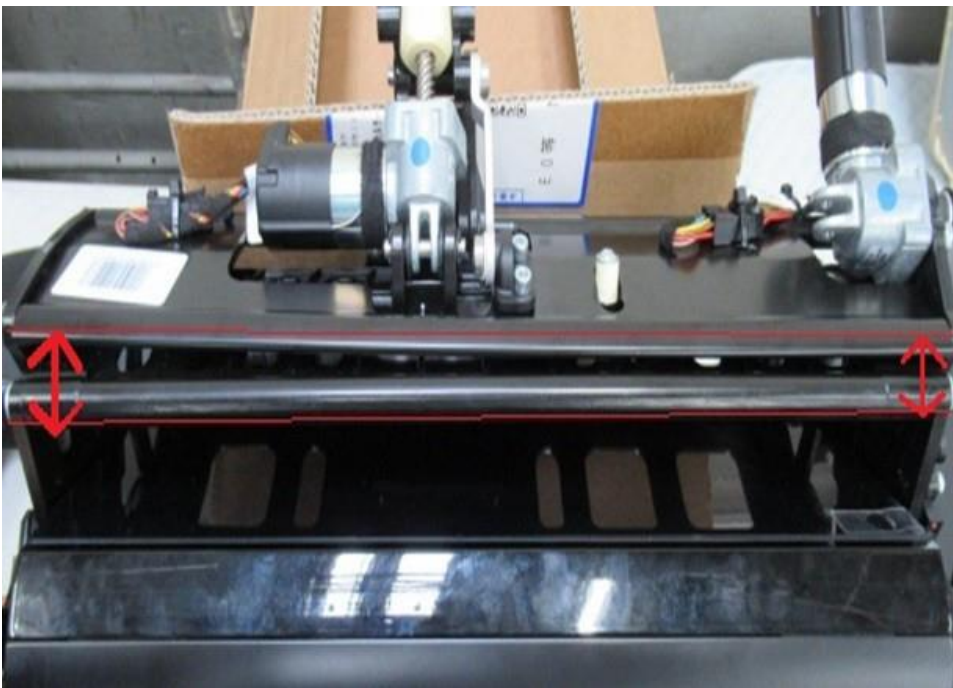
Figure 4

Check the alignment of inner to outer mechanism as shown (Figure 4).

If the mechanism is out of alignment raise a DISS technical query with photos attached, do not follow any more steps at this point.

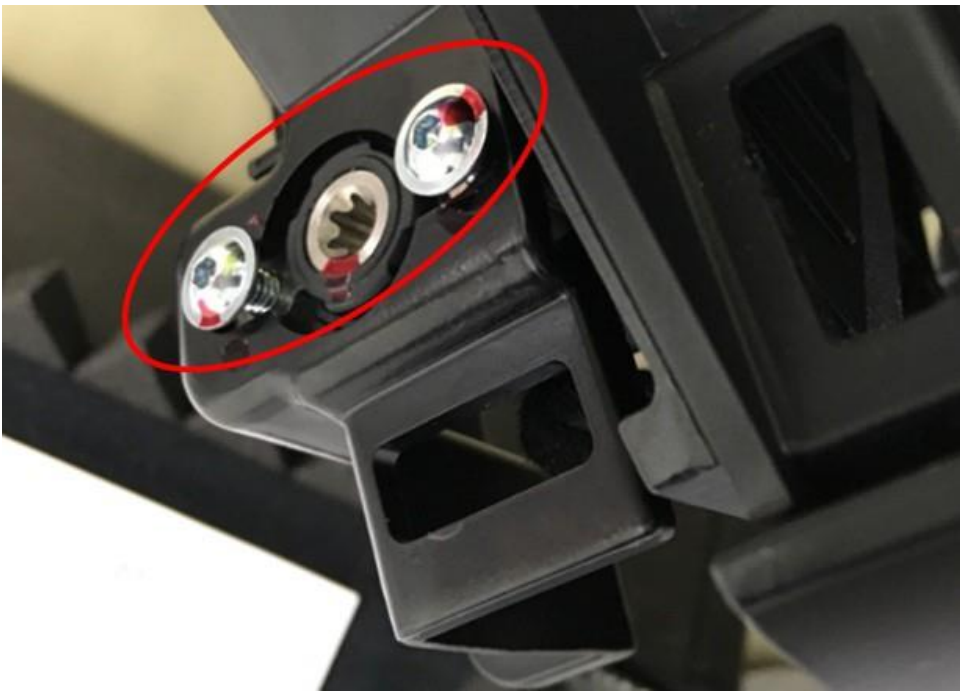
Figure 5

Check the tightness of the fixing screws highlighted (Figure 5), there are 8 fixing screws in total.

Check and retighten where necessary (3Nm).

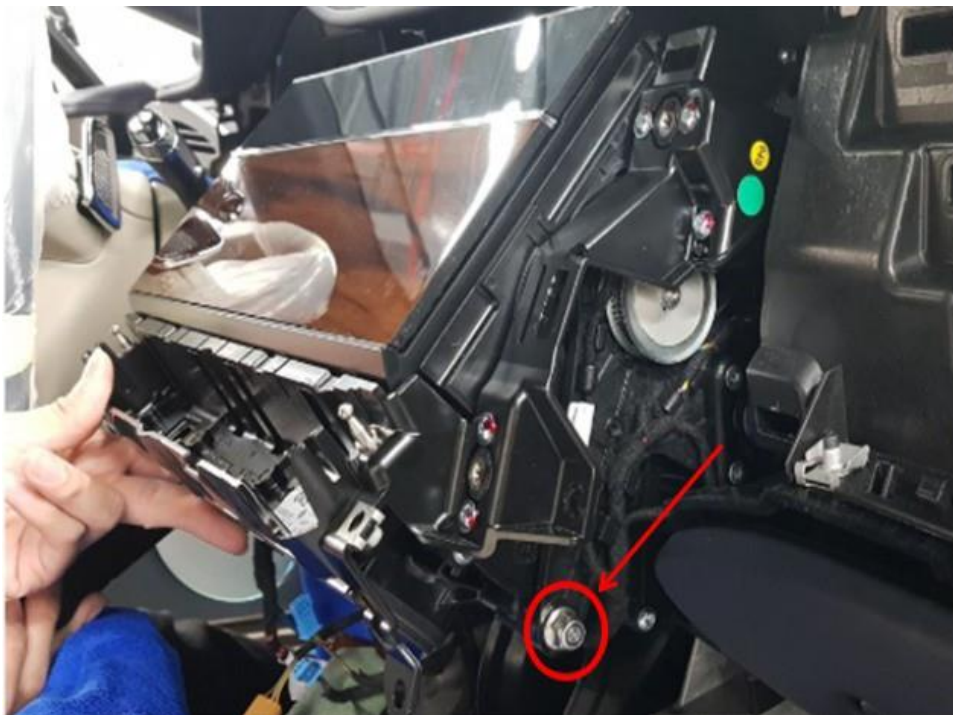
6

Check the tightness of the fixing nut highlighted (Figure 6), there is one nut on each side of the assembly. Check and retighten where necessary (5Nm).

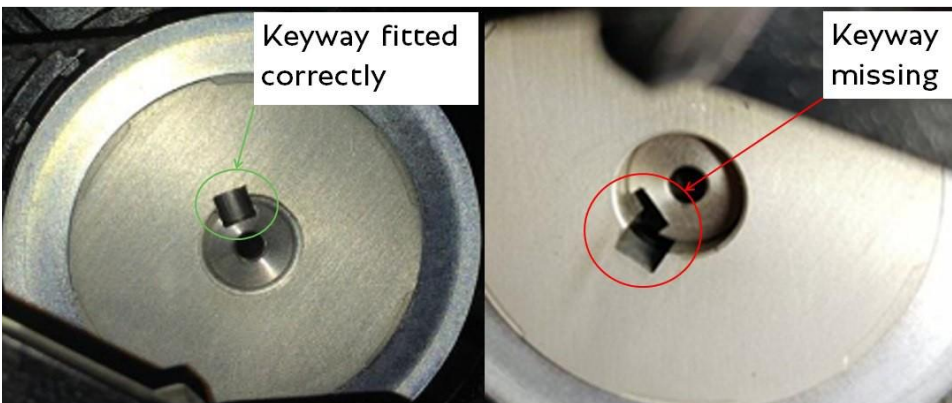
Figure 8

1. Remove rotating display then check pulley wheel for looseness and ensure keyway is present and fitted correctly (Figure 8).

If either defect is present raise a DISS technical query with photos attached.
