Technical product information

Topic	Rotating screen alignment
Market area	Bentley: worldwide (2WBE),Hongkong-Macau (5HK)
Brand	Bentley
Transaction No.	2051526/8
Level	EH
Status	Approval
Release date

New Continental GT - New Continental GTC and New Flying Spur

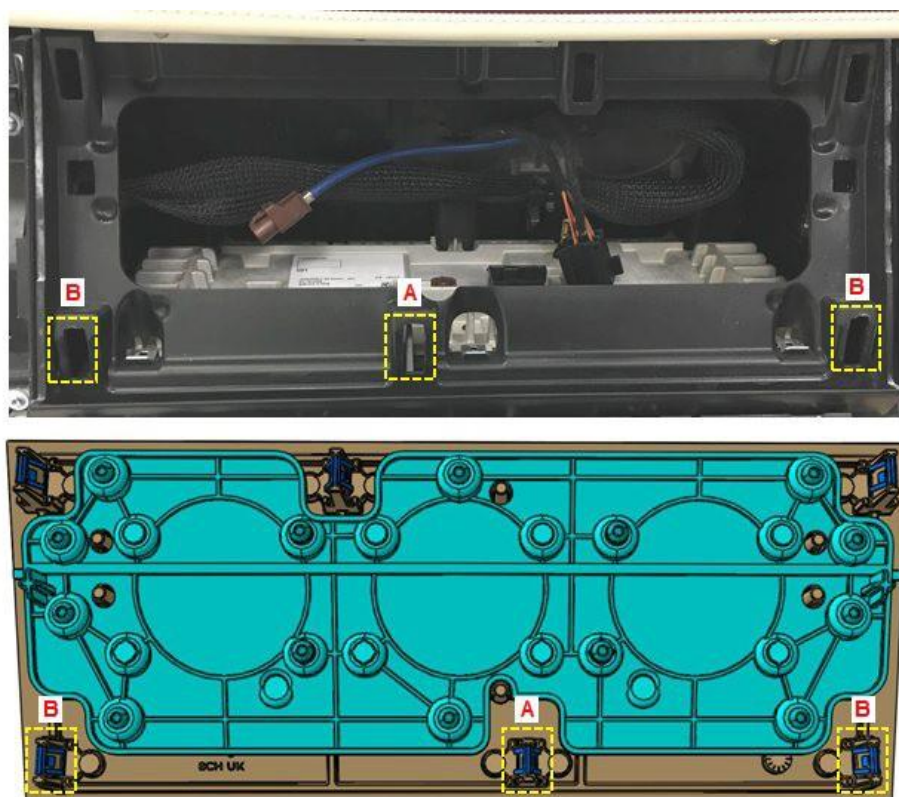
Figure 1

The veneer face fascia panel is fixed to the “BRD” by six locator pins and receiving holes. See Figure 1.

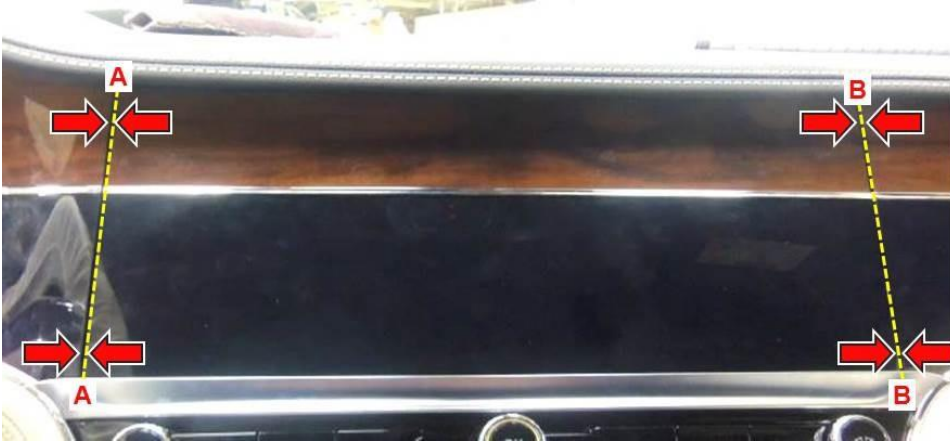
Figure 2

Measure the gaps (A & B) between the veneer face fascia panel and the passenger and drivers side fascia panels. See Figure 2.

The specified gapping is 1.5mm +/- 0.5mm tolerance. The gap between the "BRD" veneer face fascia panel and passenger and drivers side fascia panels MUST be parallel on both sides.

If the gaps are not within the specified values then adjust as follows.

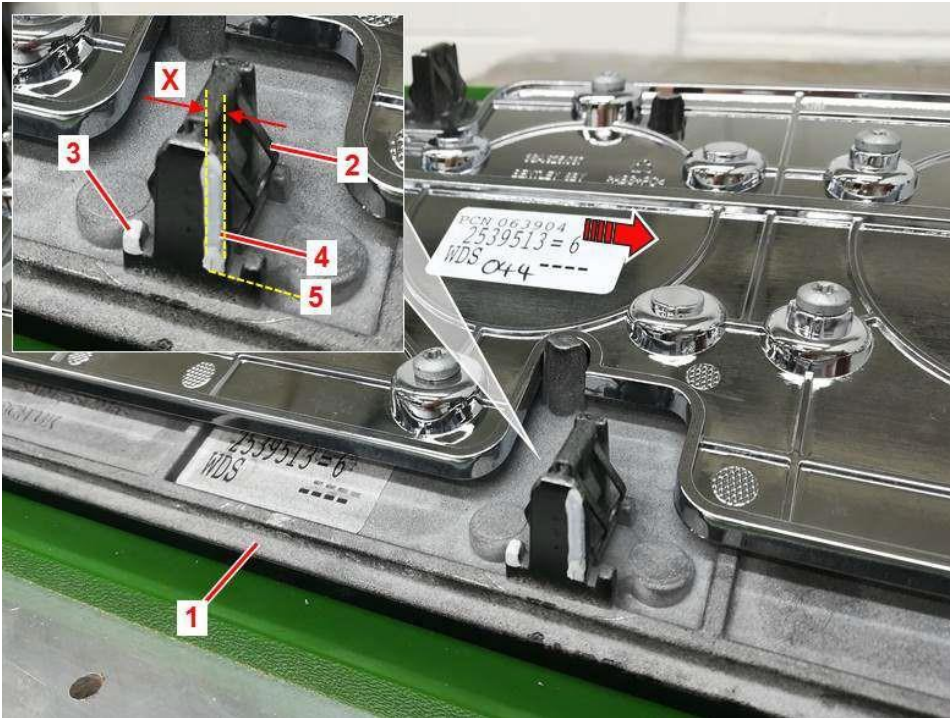
Figure 3

i Only the centre lowermost locator pin shown governs the side to side movement of the fascia panel. Only this locator pin will require modifying.

Place the veneer face fascia panel (1) face down on a soft, clean and protective work surface and mark accordingly the direction in which the panel needs to move (arrow). See Figure 3.

Remove the spring retaining clip (2) from the lowermost locator pin. If the fascia panel requires moving by 0.5mm then remove the same amount of material (X) from the appropriate side of the lower centre locator pin (4) as shown on the aluminium substrate casting. In addition, file the trailing RPS point (3) flat, level with the recess. See Figure 3.

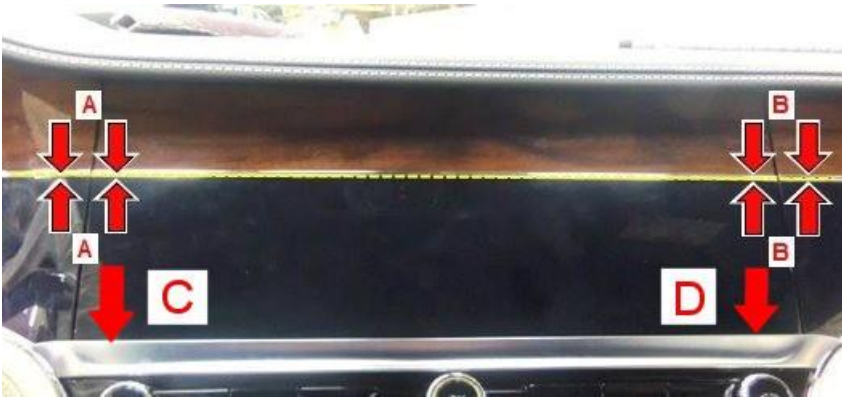
Figure 7

Visually check that the chrome brightware strip on the "veneer face" fascia panel is aligned with the chrome strips at points A & B on the passenger and drivers side fascia panels. See Figure 7.

Check that the minimum functional gap is maintained between the bottom of the BRD and the switch pack at points C & D

The specified tolerance in the vertical plane (A & B) is 0.5mm.

The specified minimum functional gap between the BRD and the switch pack (C & D) is 1mm.

If the chrome brightware strip on the "veneer face" fascia panel is out of line, carry out the following to adjust the panel.

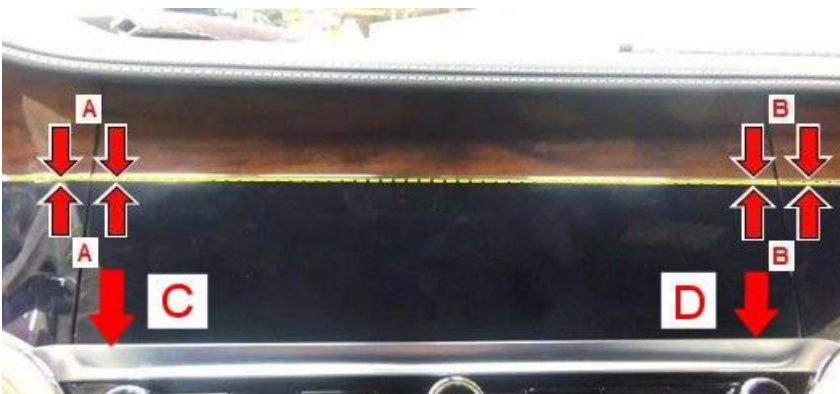
Figure 10

Visually check that the chrome brightware strip on the "veneer face" fascia panel is aligned with the chrome strips at points (A & B) on the passenger and drivers side fascia panels. See Figure 10.

Check that the minimum functional gap is maintained between the bottom of the BRD and the switch pack at points (C & D)

The tolerance in the vertical plane (A & B) is 0.5mm.

The specified minimum functional gap between the BRD and the switch pack (C & D) is 1mm.

If the chrome brightware strip on the "veneer face" fascia panel is still out of line, and is not within the specified tolerance then add/remove anti-creak tape to adjust accordingly.

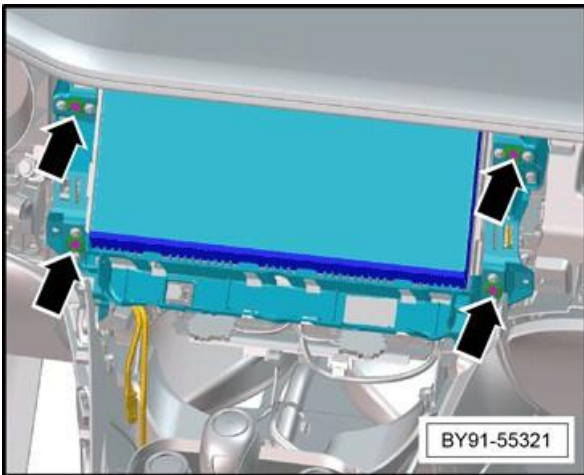
Figure 11

Under no circumstances should any attempt be made to adjust the "BRD" module inboard or outboard by adjusting any of the four setting screws (arrows) shown in Figure 11.

The setting screws (arrows) are factory sealed and any attempt to make adjustments via these four screws may result in failure of the rotating display and/or information display touch screen.

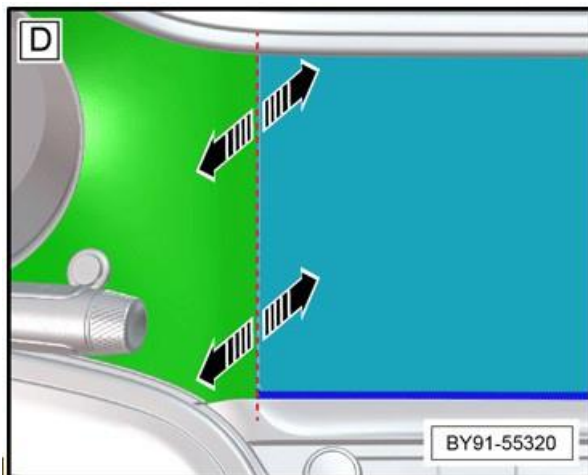
Measure the profile (D) between the "BRD" veneer face fascia panel and the passenger and drivers side fascia panels. See Figure 12

The specified setting dimension for the "BRD" fascia panel is -0.5mm (under flush) +/- 0.5mm tolerance and MUST be equal on both sides.

If either of the passenger and drivers side fascia panels are out of tolerance and require adjustment, make a note of which point requires adjustment and by how much on each panel.

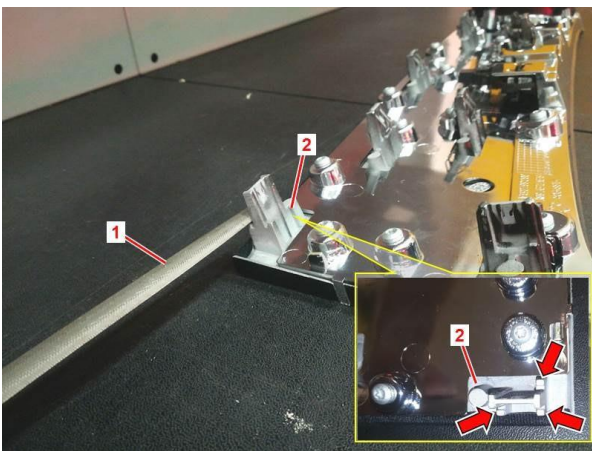
Figure 14

i Note. The upper locator pin (2) has three “RPS” points (arrows) whereas the lower locator pin only has two “RPS” points.

Carefully file the “RPS” points (arrows) by the required amount that the fascia panel needs to move in.

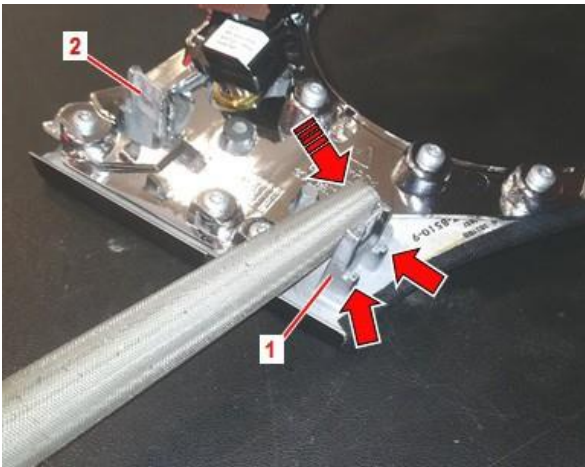
i Note. The upper locator pin (1) has three “RPS” points (arrows) whereas the lower locator pin (2) only has two “RPS” points.

Carefully file the “RPS” points (arrows) by the required amount that the fascia panel needs to move in. See Figure 17
