## Tips & Tricks – All Models

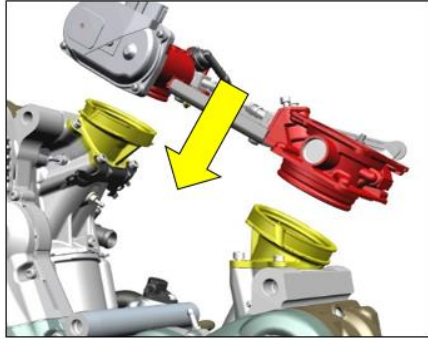
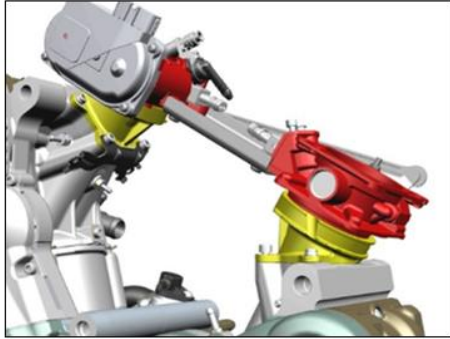
no.	Symptom	Subject	Photo	Notes and Indications - Corrective action
1	<p><u>ONLY</u> <u>Monster 821</u> <u>Monster 1200</u> <u>SuperSport</u></p> <p>Possible engine popping sound during deceleration and/or irregular idling</p>	Airbox

<p>We have received some complaints about a possible engine popping sound during deceleration. The performed analyses have shown that this symptom could be caused by an incorrect installation of the throttle bodies in the relevant intake manifolds (possible deformation of the rubber profile).</p> <p>Therefore, if you find any similar symptoms, we kindly ask you to check the correct installation of the Airbox on the motorcycle and that:</p> <ul style="list-style-type: none"> <li>- throttle bodies are correctly inserted inside rubber intake manifolds, along the whole perimeter;</li> <li>- the rubber profile of the intake manifolds is not deformed.</li> <li>- the 2 fastening ties are correctly positioned in the seat on the intake manifolds.</li> </ul> <p>Please be reminded that, to make throttle body insertion easier on rubber intake manifolds, the use of silicone lubricant or similar product is absolutely necessary.</p> <div style="display: flex; justify-content: space-around;">

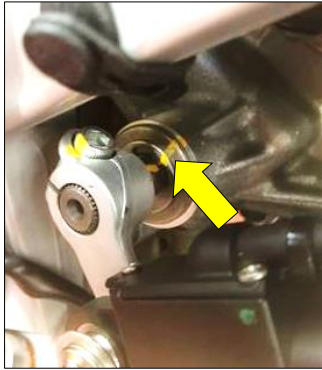
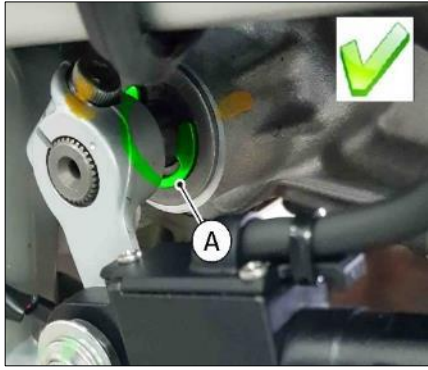
2	<p><u>ONLY</u> <u>Panigale V4</u> <u>(all versions)</u> <u>Streetfighter V4</u> <u>(all versions)</u></p> <p>Introduction gear selector shaft certification</p>	Gear selector

<p>We have received some isolated reports of a possible loss/absence of the <b>snap ring (A)</b> of the gear selector shaft. We would like to inform you that an additional certification on all Desmosedici Stradale engines between snap ring, washer, and crankcase at the outlet of the gear selector shaft has been added along the production line. The first engine serial number with this new certification is ZDM1100WC #001513#.</p> <p>Upon the first workshop service, you are thus invited to check for the presence of the <b>snap ring (A)</b> on all engine serial numbers preceding the one specified above.</p>

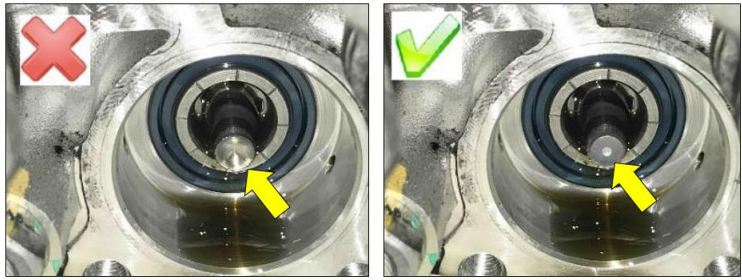
no.	Symptom	Subject	Photo	Notes and Indications - Corrective action
7	<p><u>ONLY</u> <u>models equipped with</u> <u>hydraulically controlled</u> <u>clutch lever</u></p> <p>Possible reduction of the clutch fluid level inside its reservoir</p>	Hydraulic clutch control

<p>We received a few claims concerning a reduction of the clutch fluid level inside its reservoir. We would like to inform you that it is not sufficient to carry out the bleeding procedure or top up the clutch fluid inside the reservoir. We suggest, at a preliminary stage, to check:</p> <ul style="list-style-type: none"><li>• the play between the clutch master cylinder and the lever</li><li>• if the clutch pushrod is worn or damaged in the area of contact with the clutch slave cylinder (ball)</li><li>• the condition of the clutch slave cylinder protective diaphragm, which must not be torn.</li></ul> <p>According to our analyses, this phenomenon is due to a DOT4 leakage from the primary seal of the clutch slave cylinder (missing fluid in the reservoir builds up in-between the clutch slave cylinder diaphragms); in some cases, this phenomenon is also accompanied by wear of the clutch pushrod. We therefore ask you to replace the slave cylinder with a new <b>part no. 19540091D</b> featuring a new gasket in order to prevent the phenomenon described above.</p> <p>If the clutch pushrod is damaged as shown in the figure, replace it as well.</p> <div data-bbox="1256 727 1995 1007">

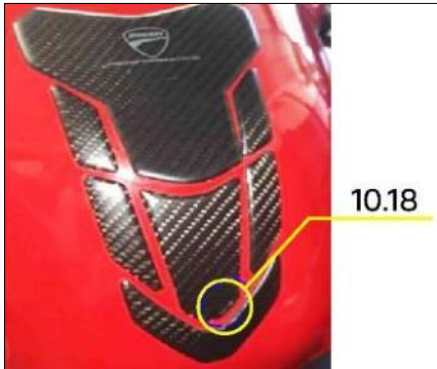
no.	Symptom	Subject	Photo	Notes and Indications - Corrective action
8	<p><u>ONLY</u> <b>Panigale V4</b> <b>StreetFighter V4</b> <b>(all model versions)</b></p> <p>Possible detachment of the carbon adhesive protection <b>part no. 97480161A</b> from the fuel tank</p>	<p>Tank carbon adhesive protection <b>part no. 97480161A</b></p>

<p>We have received some reports about the detachment of the carbon adhesive protection from the fuel tank. We inform you that the supplier of the component has introduced improvements to avoid the detachment of the protection, since year of manufacture 2019. The lot and the year of manufacture <b>XX-19 (week-year of manufacture)</b> can be identified on the component, like in the example shown in the figure.</p>

<p>In case you still have in stock some carbon tank protectors produced in 2018 you can still sell them to Customers and install them. Should any anomaly occur on the latter, you can manage the replacement of the protection through an accessory warranty. The spare parts in stock have been reclaimed. In any case, it is essential to follow the accessory instructions ISTR-892 ed.01 published in DCS for the application of the tank protection. The cleaning of the tank surface and the use of the template supplied with the protection are essential for a successful application.</p>

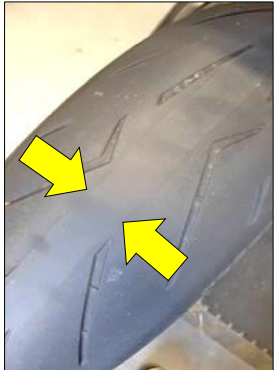
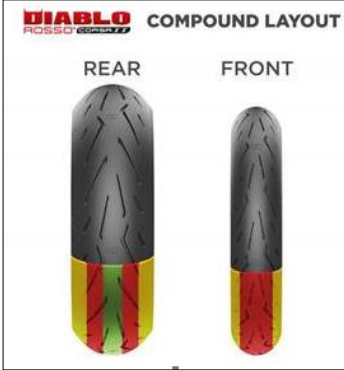
9	<p>Possible formation of a well-marked "band" in correspondence with the central area of the Pirelli Diablo Rosso Corsa II rear tire</p>	<p>Pirelli Diablo Rosso Corsa II rear tire</p>

<p>We have received some isolated reports of the appearance of a "band" in correspondence with the central area of the Pirelli Diablo Rosso Corsa II rear tire.</p> <p>We would like to inform you that, since these are extremely sporty tires with 5 different compound zones at the rear, it can happen that, depending on the type of use of the motorcycle, they wear out in a different way causing the above mentioned phenomenon to occur; sometimes this occurs on the shoulder area, sometimes in the central area but, in general, it is a purely aesthetic phenomenon that does not affect the performance of the tire itself.</p>

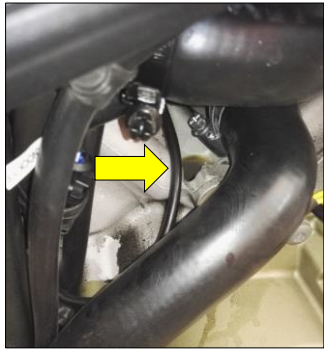
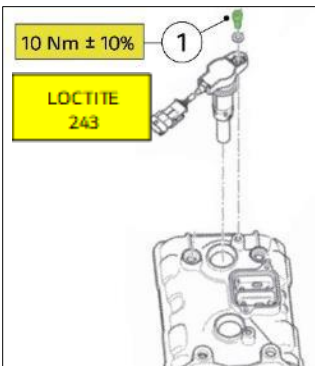
no.	Symptom	Subject	Photo	Notes and Indications - Corrective action
10	<p style="text-align: center;"><u>ONLY</u> <b>Panigale V4</b> <b>StreetFighter V4</b> <b>(all model versions)</b></p> <p>Possible engine oil leakage from the water pump drain hole</p>	Water pump

<p>We have received some isolated reports of possible traces of engine oil leaking out of the drain hole of the water pump; the analysis has shown that this phenomenon is due to a possible incorrect installation of the oil seal by the supplier.</p> <p>We inform you that a new re-designed water pump <b>Part no. 24920510H</b> that avoids the phenomenon described above is now available as a spare part . Should you find traces of engine oil in the drain hole of the water pump on engines with serial number prior to the one indicated above, replace the component.</p>
11	<p style="text-align: center;"><u>ONLY</u> <b>Panigale V4</b> <b>StreetFighter V4</b> <b>(all model versions)</b></p> <p>Possible engine power delivery discontinuity</p>	Engine power delivery	-	<p>We have received some isolated reports about a possible engine power delivery discontinuity.</p> <p>Before making further analyses, we would like to ask you to check coil fastening and, in particular, to <u>apply LOCTITE 243</u> along the threading of fastening screws and tighten them to a torque of <b>10 Nm ± 10%</b>.</p> <div style="border: 1px solid black; padding: 5px; width: fit-content; margin-left: auto; margin-right: auto;">

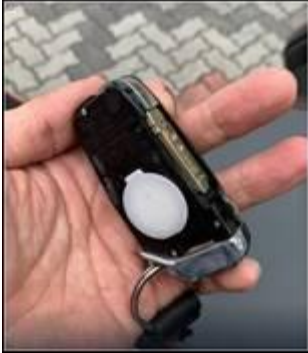
<p>We have received some isolated reports about the possible loss of the rear cover of the active key Part no. 59810361F. Analyses have shown that this phenomenon occurs after repeated opening/closing of the cover itself, resulting in the deterioration of the shell.</p> <p>We would like to inform you that the new rear cover <b>Part no. 4601L831A</b>, avoiding the phenomenon described above, is now available.</p>

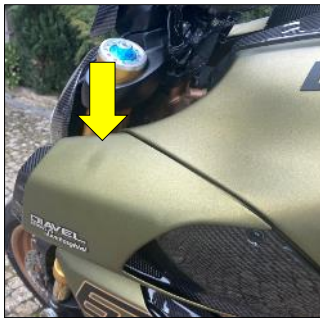
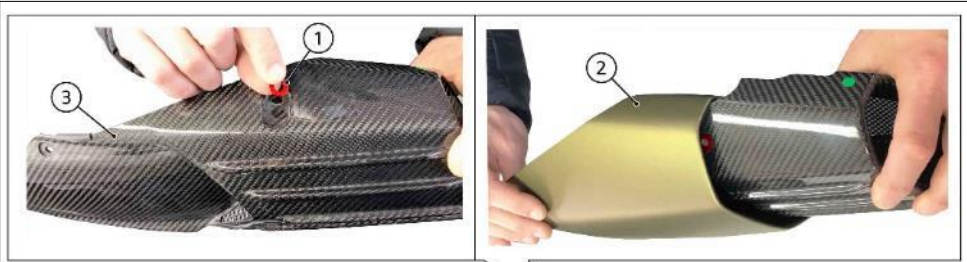
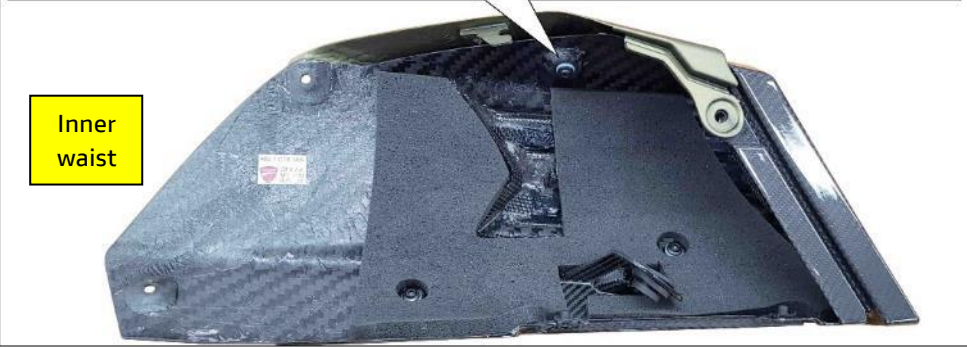
no.	Symptom	Subject	Photo	Notes and Indications - Corrective action
1	<p><u>ONLY</u> <u>Diavel Lamborghini</u></p> <p>Possible indentation of RH and/or LH outer cover of the air conveyor</p>	RH and LH air conveyor covers

<p>We have received some isolated reports about a possible indentation of the RH and/or LH outer cover of the air conveyor.</p> <p>To avoid this phenomenon, it is necessary to position <b>washer (1)</b> 4x14x1 Part no. 85240171A between <b>outer cover (2)</b> and carbon air <b>conveyor (3)</b> in the upper fixing point, as shown in the figure.</p>

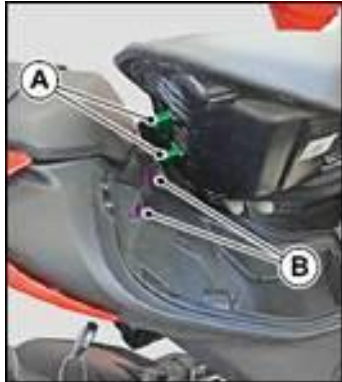
3	<p><b>Monster MY21 (937cc)</b> <u>ONLY</u></p> <p>Possibility of unhooking of the rear rider seat fasteners</p>	<p>Rider seat</p>

<p>We have received some reports about the possibility of unhooking the rear fasteners of the rider seat (the two <b>pins (A)</b> on the rear end of the underseat plate come out of from their <b>seats (B)</b> on the rear subframe).</p> <p>We would like to inform you that to avoid the phenomenon described above, the underseat plate has been updated by lengthening the rear fasteners; the new specific part numbers for each country version are indicated below:</p> <ul style="list-style-type: none"> <li>• Part no. 595P6961BA: lowered rider seat (country versions Japan, South Korea and Taiwan)</li> <li>• Part no. 595P6801CA: rider seat</li> </ul> <p>The new seats were introduced into production at the end of May and the spare parts warehouse has been rectified with the new part numbers.</p>

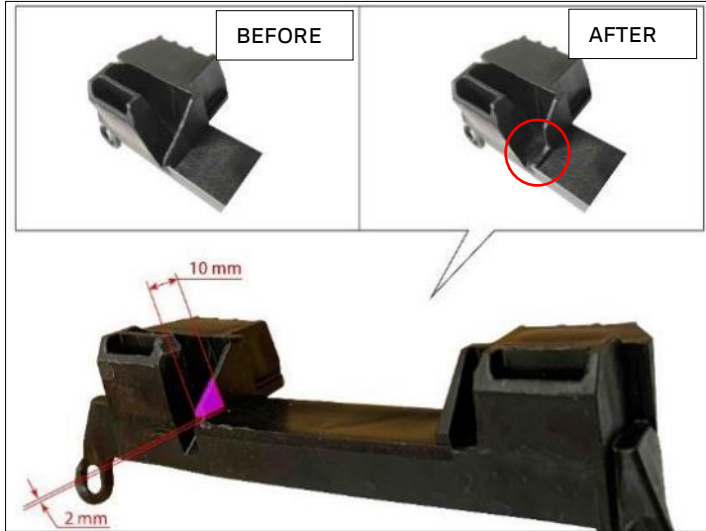
no.	Symptom	Subject	Photo	Notes and Indications - Corrective action
1	<p><u>ONLY</u> <b>Multistrada 1260</b> <b>(all model versions)</b></p> <p>Possible wrong coupling between rider's seat lower riser and RH side body panel in "high seat" configuration</p>	Rider seat

<p>When mounting the rider seat in "high configuration", an excessive gap can be seen between the lower trim and the RH side panel. This is due to interference between the central riser and its support. To avoid such interference and therefore improve the coupling between the rider seat and the side panel, it is necessary to:</p> <ol style="list-style-type: none"> <li>1) Remove the center riser from the seat;</li> <li>2) Working on the RH side support, remove the excess material with a cutter, as shown in the figure.</li> <li>3) Reinstall the center riser to the seat.</li> </ol>

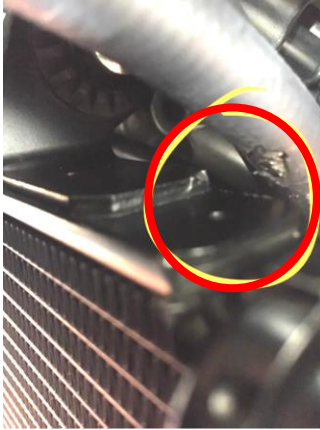
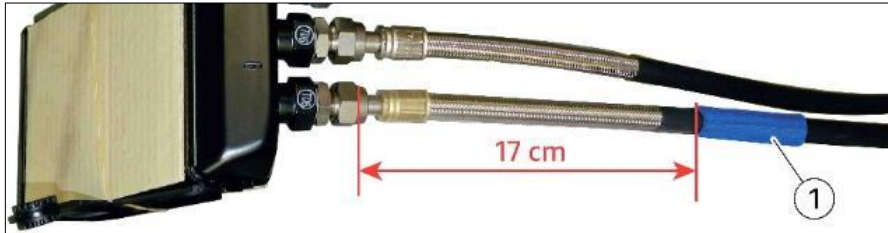
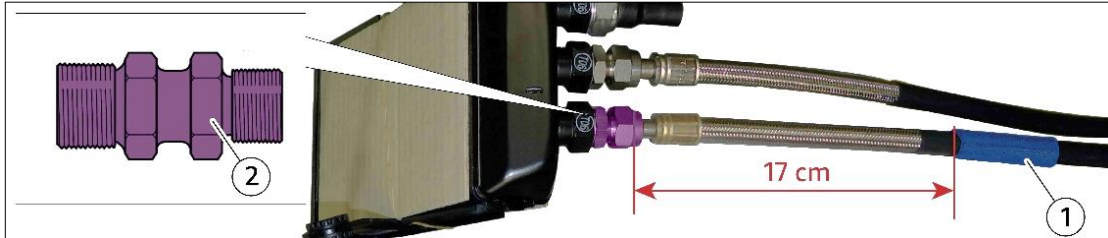
no.	Symptom	Subject	Photo	Notes and Indications - Corrective action
3	<p><u>ONLY</u>  <b>Multistrada 950 MY 17-20</b>  <b>Multistrada 1200 MY 15-17</b>  <b>Multistrada 1260 MY18-20</b>  <u>(all model versions)</u></p> <p>Possible superficial damage to the oil cooler return pipe</p>	Oil cooler pipes

<p>We have received some isolated reports of possible surface damage to the oil cooler return pipe due to rubbing with the top of the coolant radiator, over time. <u>This phenomenon is purely aesthetic and does not affect the correct operation of the system.</u> We inform you that for the models:</p> <p>a) <b>Multistrada 1260:</b>  starting from the frame number ZDMAC03AAAKB011354 (on 27/05/2019) the <b>anti-abrasion sheath (1) part no. 4601H701A</b> has been introduced on the oil cooler return pipe, positioned at a distance of <b>17 cm</b> measured from the upper end of the fitting. <u>(This solution is also applicable to all Multistrada 1200 versions Model Year 2015-2017).</u></p>

<p>b) <b>Multistrada 950:</b></p> <ul style="list-style-type: none"> <li>- starting from the frame number ZDMAD00AAKB002259 (on 10/05/2019) the <b>anti-abrasion sheath (1) part no. 4601H701A</b> has been introduced on the oil cooler return pipe, positioned at a distance of <b>17 cm</b> measured from the upper end of the fitting;</li> <li>- starting from the frame number ZDMAD00AALB005691 (on 12/03/2020) the longer <b>fitting (2) part no. 81510391A</b> has been introduced at the oil return pipe outlet from the cooler.</li> </ul>

<p>We ask you to always check the condition of the oil cooler return pipe, and to replace it <b>ONLY</b> if the rubber sheath is damaged and the metallic braided hose can be seen. Follow the assembly notes indicated above according to the reference model. The spare part catalogue has been updated.</p>

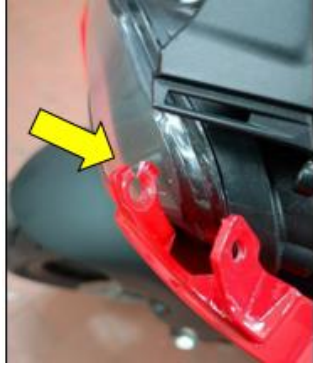
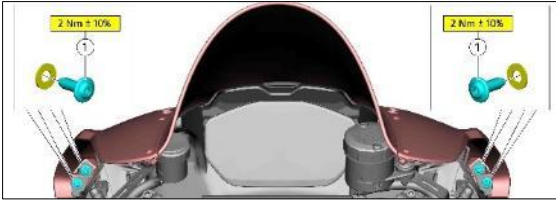
no.	Symptom	Subject	Photo	Notes and Indications - Corrective action
1	<p><u>ONLY</u> <u>Panigale V2</u></p> <p>Precautions during PDI: installation of the side half-fairings</p>	Side half fairings

<p>We received some isolated claims about the possible breakage of the top fastener retaining the LH side half-fairing to the headlight fairing.</p> <p>During PDI and whenever removing the side half-fairings, we remind you to pay utmost attention to the tightening of the <b>2 screws M5x0.8 (1)</b> retaining the upper LH and RH half-fairings to the headlight fairing; always comply with the specified tightening torque of <b>2 Nm ± 10%</b>.</p>

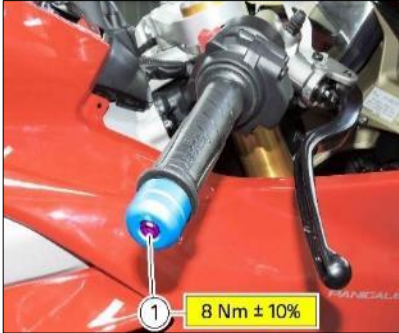
2	<p><u>ONLY</u> <u>Panigale V4</u></p> <p>Precautions during PDI: installation of the balancing weights on the handlebar</p>	Handlebar counterweights

<p>We received some isolated claims about the possible triggering of a longitudinal crack on the handlebar, on balancing weight side. Our laboratory analyses found that said crack is due to an excessive tightening torque applied when installing the balancing weights.</p> <p>When installing balancing weights on the handlebar, please comply with the tightening torque specified for the M6x55 screw of <b>8 Nm ± 10%</b>, as indicated on the bulletin introducing the model and on the Workshop Manual.</p>

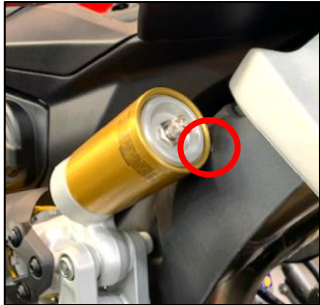
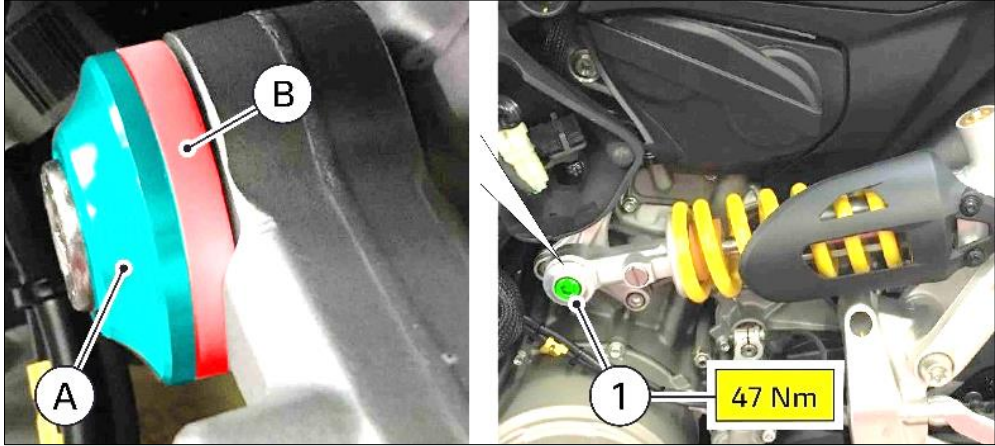
16	<p><u>ONLY Panigale V2</u></p> <p>Possible contact of Sachs rear shock absorber reservoir with vertical head manifold heat guard</p>	Sachs rear shock absorber reservoir

<p>We would like to inform you that starting from the frame number <b>ZDMHAATW2MB003762</b>, a spacer and a Teflon anti-rotation washer have been introduced at the front fixing screw of the shock absorber to prevent possible contact between the rear shock absorber reservoir and the vertical head manifold head guard. The contact results in a cosmetic defect only.</p> <p>In case of complaints from the Customer, it is possible to proceed with the installation of spacer <b>part no. 7111D981AA (A)</b> and washer <b>part no. 7131E352A (B)</b>, as shown in the figure.</p> <p>We remind you to always apply the screw <b>M10x45 (1)</b> with Shell GADUS S2 V220 AD 2 grease and to tighten the screw to the new torque of <b>47 Nm</b> (the previous tightening torque was 45 Nm).</p>

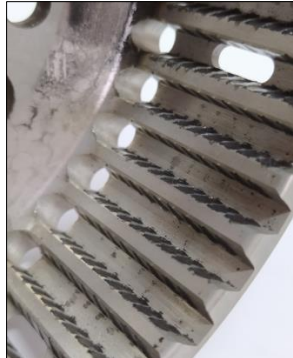
<p>We have received some isolated reports of possible clutch slipping, due to clutch housing indentation, which does not allow the drive and driven plates to come back into contact with each other correctly. This phenomenon depends on the use of the motorcycle and the user, therefore for racing use we suggest replacing the plates approximately every 5000km,.</p> <p>We would like to inform you that the new clutch housing with deep anodizing <b>part no. 19810671C</b>, replacing the natural grey one, is available as a spare part; this treatment improves the reliability of the clutch housing reducing the damaging of the drive plates on its contact surface.</p>

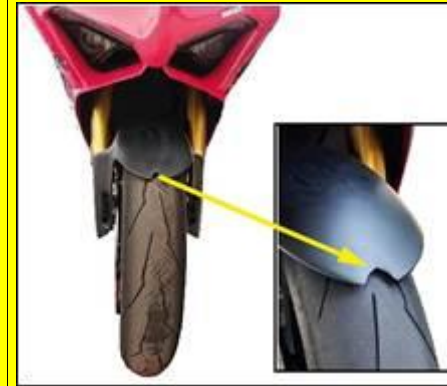
no.	Symptom	Subject	Photo	Notes and Indications - Corrective action
<b>NEW</b> 20	<u>ONLY</u> <u>Panigale V4 and V4 S.</u> Contact between tyre and front mudguard	Front mudguard	-	<p>We have received some isolated reports on the possible contact between the front tire and the relevant mudguard. This contact can cause an aesthetic damage to mudguard front side. Please, fill in a <b>YouTech</b> service request and then replace the component under warranty by ordering a new spare one as follows:</p> <ul style="list-style-type: none"><li>• Panigale V4: Part no. 56416741AA</li><li>• Panigale V4 S: Part no. 56416741AK</li></ul>

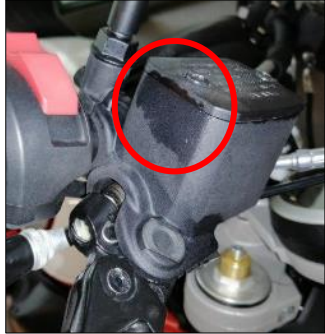
no.	Symptom	Subject	Photo	Notes and Indications - Corrective action
3	<p><u>ONLY</u>  <u>Scrambler Desert Sled</u>  <u>Scrambler ICON</u>  <u>Scrambler Full Throttle</u>  <u>Model Year 2019 - 2020</u></p> <p>Possible brake fluid leaks from reservoir cover</p>	Front brake fluid reservoir

<p>We inform you that in case of complaints from Customers about a possible oozing out of front brake fluid from the relevant reservoir, This condition does not affect the operation of the brake system. it is possible to order the following kit part no. 89340331A as spare part to avoid the symptom in question.</p> <p>The kit part no. 89340331A includes:</p> <ul style="list-style-type: none"> <li>• 2 screws (1)</li> <li>• Cover (2)</li> <li>• Membrane (3)</li> <li>• Baffle (3)</li> </ul>

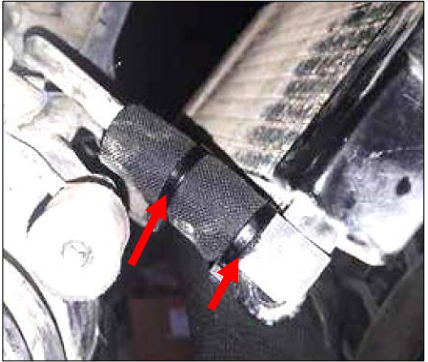
5	<p><u>ONLY</u>  <u>Scrambler 1100 PRO</u>  <u>(all versions)</u></p> <p>Irregular operation at idle speed and engine power loss</p>	Vertical cylinder LH spark plug cable	-	<p>As a result of continuous quality tests on the product, we have found a possible irregular operation at idle speed and engine power loss. This phenomenon is due to a settling of the vertical cylinder LH spark plug cable on the coil caused by the contact with the fitting of the oil return pipe from cooler (visible on motorcycle RH side). The MIL light does not come on.</p> <p>We ask you to always check the conditions of vertical cylinder LH spark plug cable and to apply the protective sheath Part no. 4601C581A (cut in half and secured in place with two small self-locking ties) on the fitting of the oil return pipe from cooler to avoid the above-described phenomenon.</p>

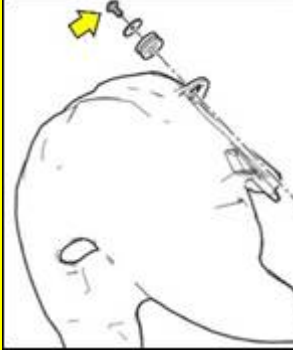
10	<p><b>NEW</b></p> <p>Possible loosening of the screw retaining the heat guard</p>	Screw 77244163B retaining the rear bank exhaust manifold heat guard	-	<p>We have received a few reports about a possible loosening of the screw retaining the rear bank exhaust manifold heat guard.</p> <p>The issue is being investigated, therefore, we kindly ask you to check the correct tightening of the above-mentioned screw (part no. 77244163B) when coming to the workshop (the prescribed tightening torque is <b>5 Nm ± 10%</b>).</p>
