MULTISTRADA: > Right-hand switch button backlighting  
> Possible appearance of stains and white dots on the instrument panel  
> Possible malfunction of the heated passenger seat  
> Upcoming Infotainment and HMI improvements

## ← Tips & Tricks – All models

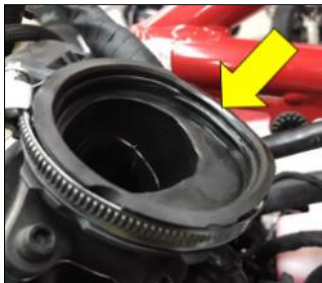
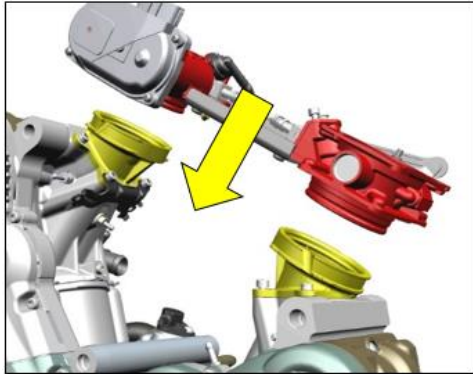
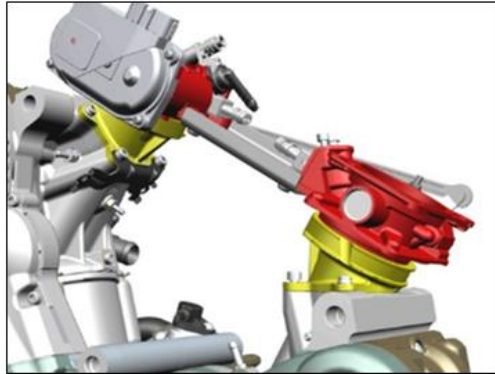
no.	Symptom	Subject	Photo	Notes and Indications - Corrective action
1	<p><u>ONLY</u> <u>Monster 821</u> <u>Monster 1200</u> <u>SuperSport</u></p> <p>Possible engine popping sound during deceleration and/or irregular idling</p>	Airbox

<p>We have received some complaints about a possible engine popping sound during deceleration. The performed analyses have shown that this symptom could be caused by an incorrect installation of the throttle bodies in the relevant intake manifolds (possible deformation of the rubber profile).</p> <p>Therefore, if you find any similar symptoms, we kindly ask you to check the correct installation of the Airbox on the motorcycle and in particular that:</p> <ul style="list-style-type: none"><li>- throttle bodies are correctly inserted inside rubber intake manifolds, along the whole perimeter;</li><li>- the rubber profile of the intake manifolds is not deformed.</li><li>- the 2 fastening ties are correctly positioned in the seat on the intake manifolds</li></ul> <p><b>Please be reminded that, in order to make throttle body insertion easier on rubber intake manifolds, the use of silicone lubricant or similar product is absolutely necessary.</b></p> <div data-bbox="1137 675 1608 1050">

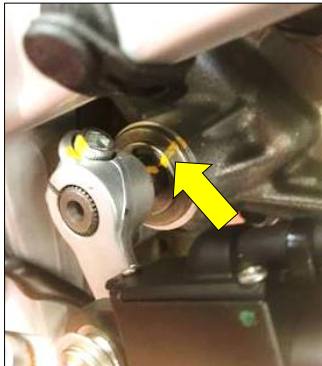
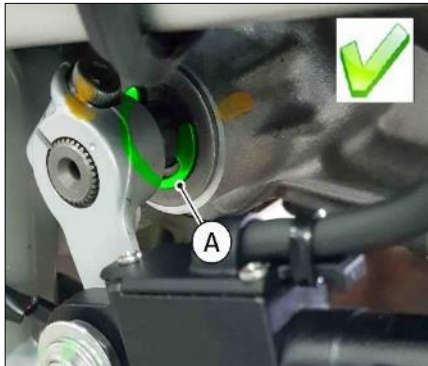
2	<p><u>ONLY</u> <u>Panigale V4</u> <u>(all versions)</u> <u>Streetfighter V4</u> <u>(all versions)</u></p> <p>Introduction of gear selector shaft certification</p>	Gear selector

<p>We have received some isolated reports of a possible loss/absence of the <b>snap ring (A)</b> of the gear selector shaft. We would like to inform you that an additional certification on all Desmosedici Stradale engines between snap ring, washer, and crankcase at the outlet of the gear selector shaft has been added along the production line. The first engine serial number with this new certification is ZDM1100WC #001513#.</p> <p>Upon the first workshop service, you are thus invited to check for the presence of the <b>snap ring (A)</b> on all engine serial numbers preceding the one specified above.</p> <div data-bbox="1771 1066 2197 1433">

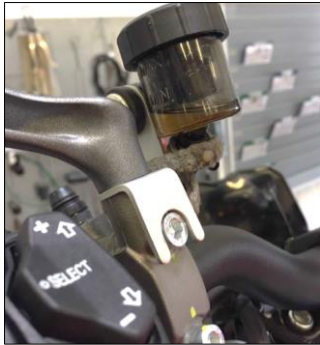
no.	Symptom	Subject	Photo	Notes and Indications - Corrective action
6	<p><u>ONLY</u> <u>models equipped with</u> <u>hydraulically controlled</u> <u>clutch lever</u></p> <p>Possible reduction of the clutch fluid level inside its reservoir</p>	Hydraulic clutch control

<p>We received a few claims concerning a reduction of the clutch fluid level inside its reservoir. We would like to inform you that it is not sufficient to carry out the bleeding procedure or top up the clutch fluid inside the reservoir. We suggest, at a preliminary stage, to check:</p> <ul style="list-style-type: none"><li>• the play between the clutch master cylinder and the lever</li><li>• if the clutch pushrod is worn or damaged in the area of contact with the clutch slave cylinder (ball)</li><li>• the condition of the clutch slave cylinder protective diaphragm, which must not be torn.</li></ul> <p>According to our analyses, this phenomenon is due to a DOT4 leakage from the primary seal of the clutch slave cylinder (missing fluid in the reservoir builds up in-between the clutch slave cylinder diaphragms); in some cases, this phenomenon is also accompanied by wear of the clutch pushrod. We therefore ask you to replace the slave cylinder with a new <b>part no. 19540091D</b> featuring a new gasket in order to prevent the phenomenon described above.</p> <p>If the clutch pushrod is damaged as shown in the figure, replace it as well.</p> <div data-bbox="1227 715 2024 1015">

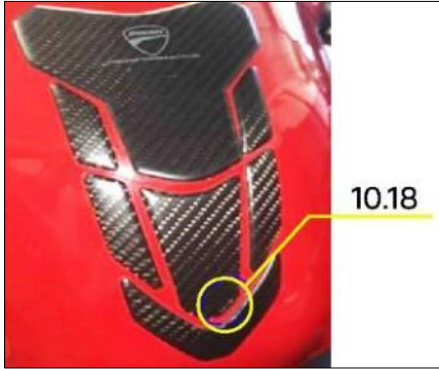
<p>We have received some reports about the detachment of the carbon adhesive protection from the fuel tank. We inform you that the supplier of the component has introduced improvements to avoid the detachment of the protection, since year of manufacture 2019. The lot and the year of manufacture <b>XX-19 (week-year of manufacture)</b> can be identified on the component, like in the example shown in the figure.</p>

<p>In case you still have in stock some carbon tank protectors produced in 2018 you can still sell them to Customers and install them. Should any anomaly occur on the latter, you can manage the replacement of the protection through an accessory warranty. The spare parts in stock have been reclaimed.</p> <p>In any case, it is essential to follow the accessory instructions ISTR-892 ed.01 published in DCS for the application of the tank protection. The cleaning of the tank surface and the use of the template supplied with the protection are essential for a successful application.</p>

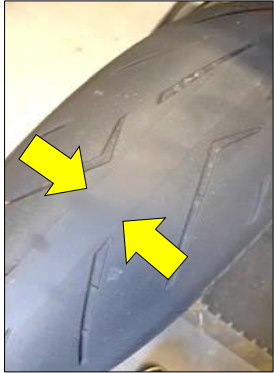
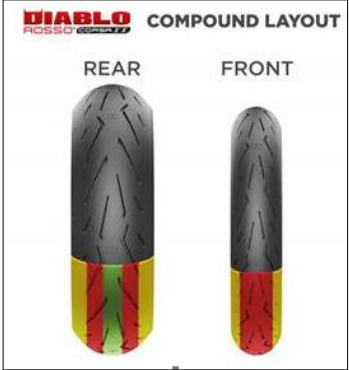
8	<p>Possible formation of a well-marked "band" in correspondence with the central area of the Pirelli Diablo Rosso Corsa II rear tyre</p>	<p>Pirelli Diablo Rosso Corsa II rear tyre</p>

<p>We have received some isolated reports of the appearance of a "band" in correspondence with the central area of the Pirelli Diablo Rosso Corsa II rear tyre.</p> <p>We would like to inform you that, since these are extremely sporty tires with 5 different compound zones at the rear, it can happen that, depending on the type of use of the motorcycle, they wear out in a different way causing the above mentioned phenomenon to occur; sometimes this occurs on the shoulder area, sometimes in the central area but, in general, it is a purely aesthetic phenomenon that does not affect the performance of the tyre itself.</p>

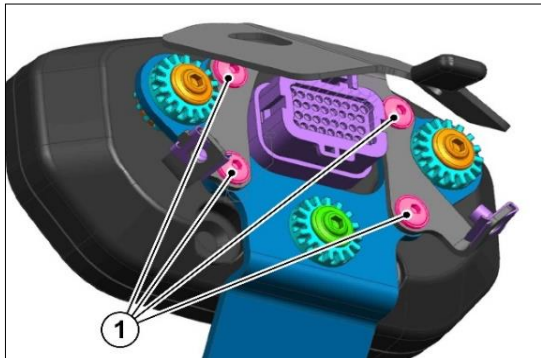
no.	Symptom	Subject	Photo	Notes and Indications - Corrective action
1	<p><u>ONLY</u> <b>Monster Plus MY21 (937cc)</b></p> <p>M5x8 screws are missing from the kit supplied with the bike</p>	<p>Kit supplied with the bike</p>

<p>We have received a few reports stating that <b>4 M5x8 screws (1)</b> part no. 77240243C required to fix the headlight fairing support bracket to the instrument panel support bracket are missing from the kit supplied with the motorcycle.</p> <p>We would like to inform you that the kits available in stock have all been sorted out.</p> <p>For the headlight fairing assembly procedure and all Pre-delivery operations, please refer to the model introduction bulletin SRV-SRB-21-022.</p>

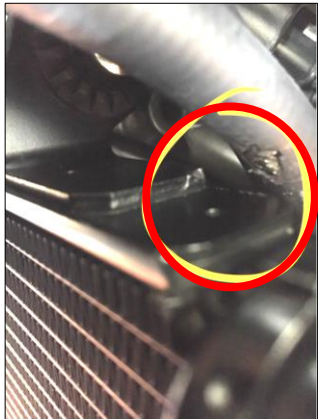
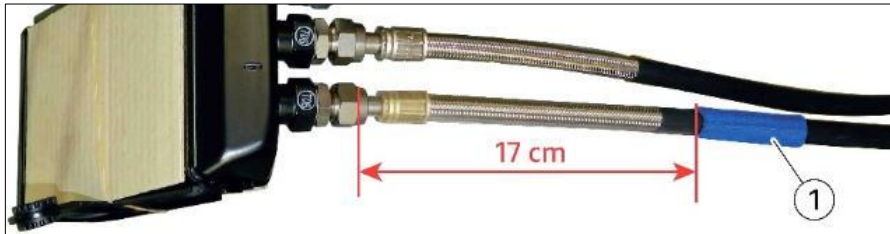
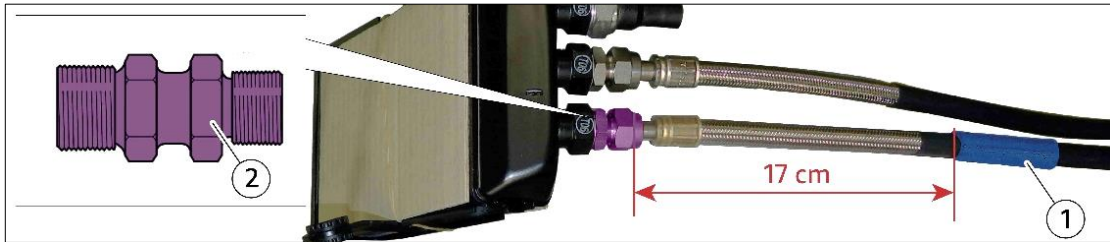
no.	Symptom	Subject	Photo	Notes and Indications - Corrective action
3	<p><u>ONLY</u>  <b>Multistrada 950 MY 17-20</b>  <b>Multistrada 1200 MY 15-17</b>  <b>Multistrada 1260 MY18-20</b>  <b>(all model versions)</b></p> <p>Possible superficial damage to the oil cooler return pipe</p>	Oil cooler pipes

<p>We have received some isolated reports of possible surface damage to the oil cooler return pipe due to rubbing with the top of the coolant radiator, over time. <u>This phenomenon is purely aesthetic and does not affect the correct operation of the system.</u> We inform you that for the models:</p> <p>a) <b>Multistrada 1260:</b>  starting from the frame number ZDMAC03AAAKB011354 (on 27/05/2019) the <b>anti-abrasion sheath (1) part no. 4601H701A</b> has been introduced on the oil cooler return pipe, positioned at a distance of <b>17 cm</b> measured from the upper end of the fitting. (This solution is also applicable to all Multistrada 1200 versions Model Year 2015-2017).</p>

<p>b) <b>Multistrada 950:</b></p> <ul style="list-style-type: none"> <li>- starting from the frame number ZDMAD00AAKB002259 (on 10/05/2019) the <b>anti-abrasion sheath (1) part no. 4601H701A</b> has been introduced on the oil cooler return pipe, positioned at a distance of <b>17 cm</b> measured from the upper end of the fitting;</li> <li>- starting from the frame number ZDMAD00AALB005691 (on 12/03/2020) the longer <b>fitting (2) part no. 81510391A</b> has been introduced at the oil return pipe outlet from the cooler.</li> </ul>

<p>We ask you to always check the condition of the oil cooler return pipe, and to replace it <b>ONLY</b> if the rubber sheath is damaged and the metallic braided hose can be seen. Follow the assembly notes indicated above according to the reference model. The spare part catalogue has been updated.</p>

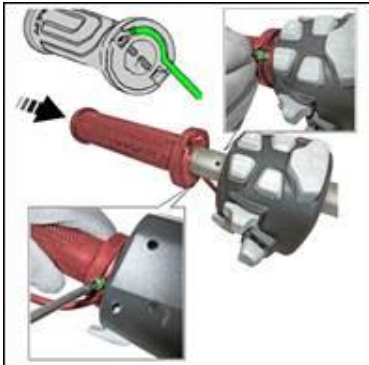
<p>We have received some reports about heated handgrips that have not been installed correctly and so the cable between the handgrip and the switch may be pinched.</p> <p>We kindly ask you to always follow the instructions provided on the DCS under the "accessories catalogue" section or in the model presentation bulletin (SRV-SRB-20-049) and to <u>comply with the correct orientation of the cable and handgrip</u> as shown in the figure.</p>

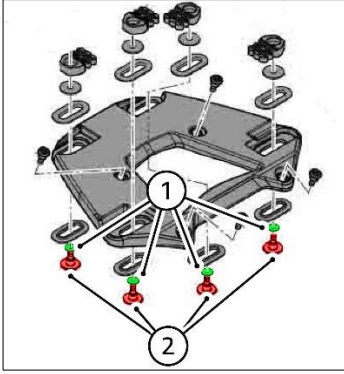
8	<p><b>ONLY</b> <b><u>Multistrada V4</u></b> <b><u>(all model versions)</u></b></p> <p>Possible incorrect operation of the swinging system - Top Case accessory kit part no. 96781531AA</p>	Top Case Part no.96781531AA

<p>We inform you that the first Top Case accessory kits part no. 96781531AA delivered may not operate correctly with the swinging system, which may seem "too braked". To improve this condition, it is possible to insert <b>4 copper washers (1) part no. 85250231A</b> on the <b>4 screws (2)</b> retaining the bottom plate to the top one.</p> <p>For a better understanding of the assembly procedure of the Top Case accessory kit, a video has been made which can be viewed at the following link: <a href="https://youtu.be/DVEHKVvdKQI">https://youtu.be/DVEHKVvdKQI</a>.</p> <p>All Top Case kits in stock will be restored by February 2021.</p>

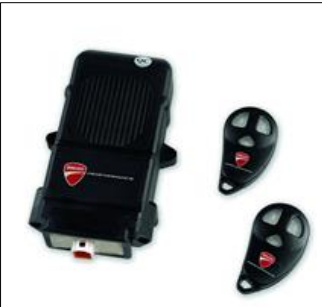
<p>After having installed the anti-theft system Kit Part no. 96681081AA and enabled it on the BBS control unit, some malfunctions may occur during activation due to a possible incorrect pin arrangement in the connector of the wiring branch supplied with the kit.</p>

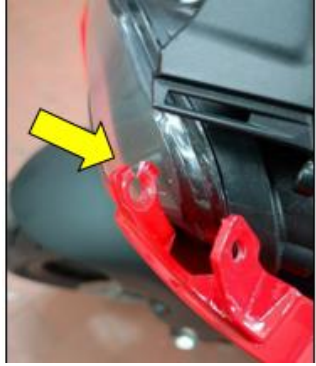
<p>We received some isolated claims about the possible breakage of the top fastener retaining the LH side half-fairing to the headlight fairing.</p> <p>During PDI and whenever removing the side half-fairings, we remind you to pay utmost attention to the tightening of the <b>2 screws M5x0.8 (1)</b> retaining the upper LH and RH half-fairings to the headlight fairing; always comply with the specified tightening torque of <b>2 Nm ± 10%</b>.</p>

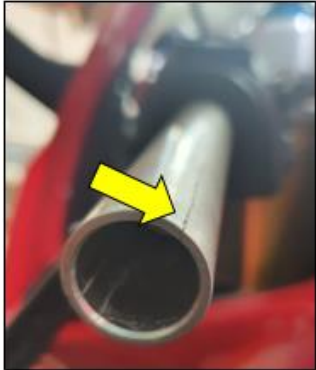
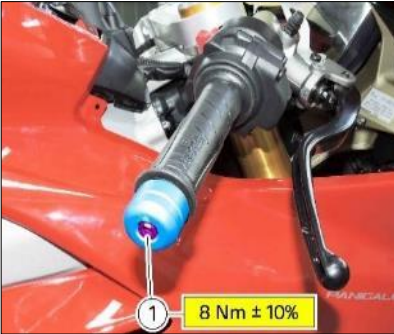
<p>We received some isolated claims about the possible triggering of a longitudinal crack on the handlebar, on balancing weight side. Our laboratory analyses found that said crack is due to an excessive tightening torque applied when installing the balancing weights.</p> <p>When installing balancing weights on the handlebar, please comply with the tightening torque specified for the M6x55 screw of <b>8 Nm ± 10%</b>, as indicated on the bulletin introducing the model and on the Workshop Manual.</p>

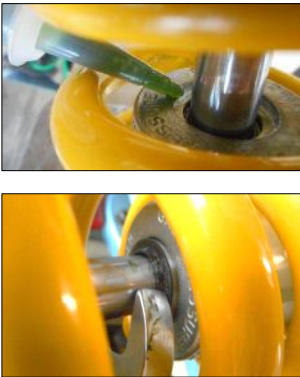
15	<p><u>ONLY Panigale V2</u></p> <p>Possible popping out of the dust seal on the Sachs rear shock absorber buffer support plug</p>	Sachs rear shock absorber

<p>We have received some isolated reports about the possible popping out of the dust seal on the rear shock absorber buffer support plug.</p> <p><u>Do NOT replace the rear shock absorber.</u></p> <p>To avoid the phenomenon described above it is necessary to:</p> <ul style="list-style-type: none"> <li>- apply a few drops of <b>LOCTITE 638</b> on the plug, at the dust seal seat;</li> <li>- place the dust seal on the plug using an open-end wrench and hold it for a few seconds;</li> <li>- carefully clean any residues of LOCTITE 638 that may have fallen accidentally on the rod and on any other surface.</li> </ul> <p>Please note that the supplier, Sachs, has introduced LOCTITE 638 during the assembly stage from <u>week 29-2020</u> (this information can be found on the sticker on the shock absorber body).</p>

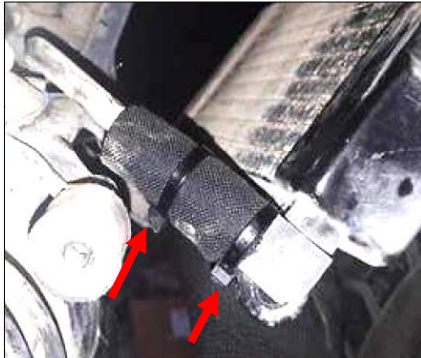
5	<p><u>ONLY</u>  <b>Scrambler 1100 PRO</b>  <b>(all versions)</b></p> <p>Irregular operation at idle speed and engine power loss</p>	Vertical cylinder LH spark plug cable	-	<p>As a result of continuous quality tests on the product, we have found a possible irregular operation at idle speed and engine power loss. This phenomenon is due to a settling of the vertical cylinder LH spark plug cable on the coil caused by the contact with the fitting of the oil return pipe from cooler (visible on motorcycle RH side). The MIL light does not come on.</p> <p>We ask you to always check the conditions of vertical cylinder LH spark plug cable and to apply the protective sheath Part no. 4601C581A (cut in half and secured in place with two small self-locking ties) on the fitting of the oil return pipe from cooler to avoid the above-described phenomenon.</p>
