Valve Cover Oil Leak at T Joint  
VN, VHD, VAH

## **FSB 211-003, Valve Cover Oil Leak at T Joint**

(October 2021)

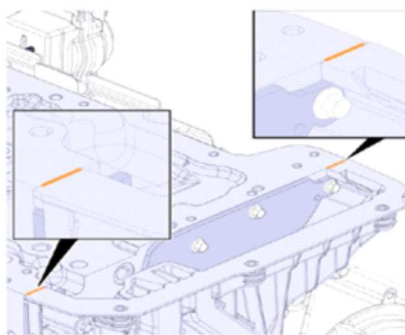
T2176113

**New Seal Pattern**

**13L Wet Seal Timing Gear Plate**

- The lower valve cover frame gasket is NOT to be reused. Always replace the gasket anytime the lower valve cover frame is disturbed (i.e. removed).
- Before applying sealant **BE SURE** the surface is **completely** free of grease, oil, and old sealant. Any oily or greasy residue will prevent the sealant from properly adhering. The use of a cleaning agent/solvent will be required (i.e. Brake-Clean or equivalent).
- When applying the sealant follow the procedure in IMPACT. Use 2 beads of sealant per side at a thickness **no larger than 2mm (.078 in)**. See image below. In this joint, too much sealant causes issues.
- Install the lower frame with new gasket, upper valve cover, and torque to specification within 20 minutes of sealant application.

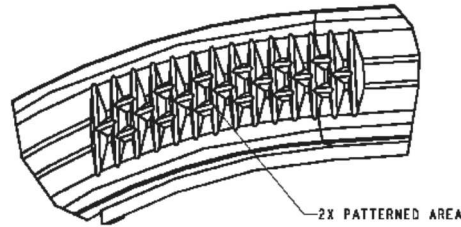
T2176114

**Old Seal Pattern**

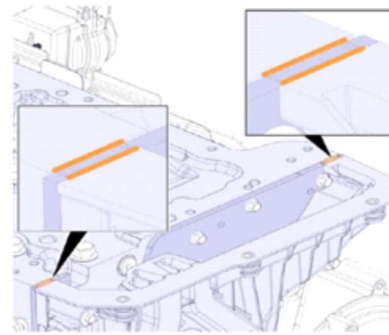
T2176116

**13L Integrated Seal Timing Gear Plate**
