Technical Service Bulletin: TSB210058	Released Date: 02-Sep-2021
Engine Wiring Harness Malfunctions Causing J1939 Datalink Faults

Engine Wiring Harness Malfunctions Causing J1939 Datalink Faults

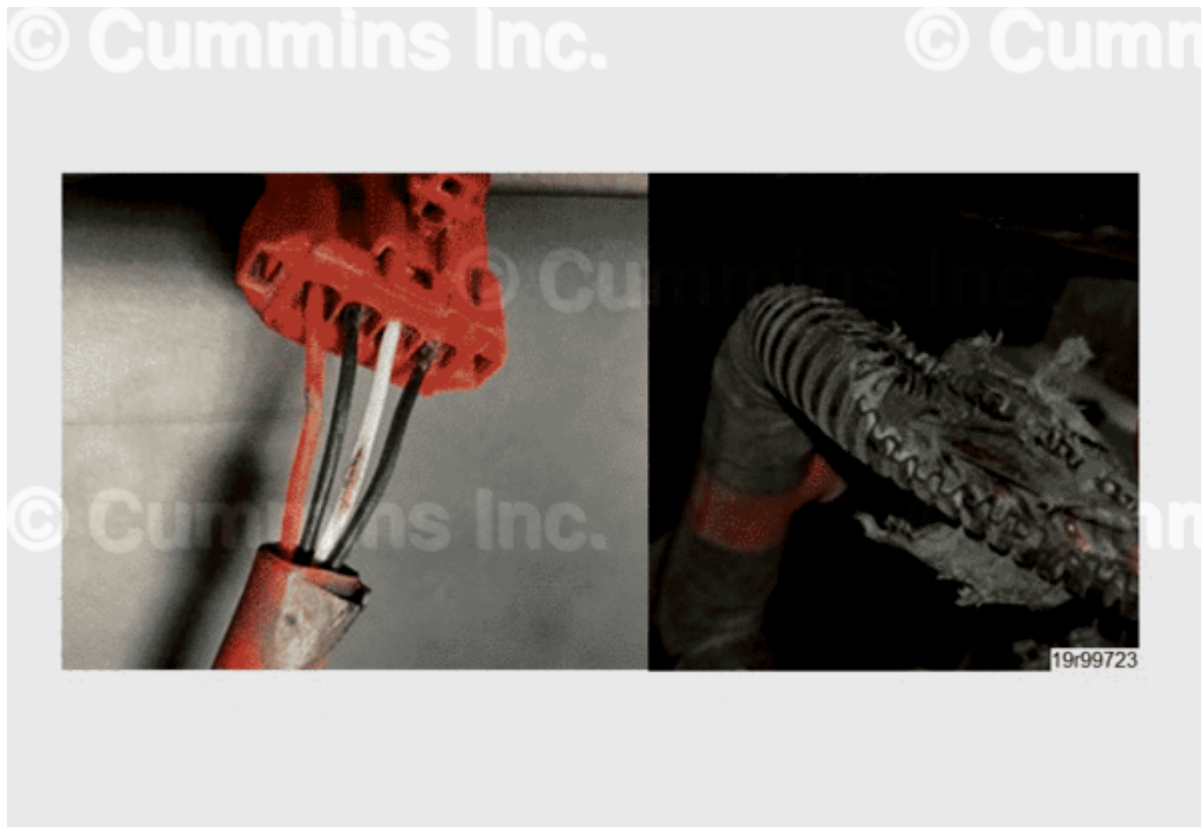
1. Visually inspect the variable geometry turbocharger and aftertreatment interface wiring harness for evidence of wear or damage caused by chafing. See Figure 1 below.

Figure 1, Wire Chafing.

- If evidence of engine wiring harness chafing is observed, remove and replace that section of the engine wiring harness before replacing any other component.
- If there is evidence of dielectric grease usage in a connector, remove the dielectric grease and clean the connector.
- If there is evidence of water intrusion through into a connector, follow the corresponding service procedure to repair or replace the connector.

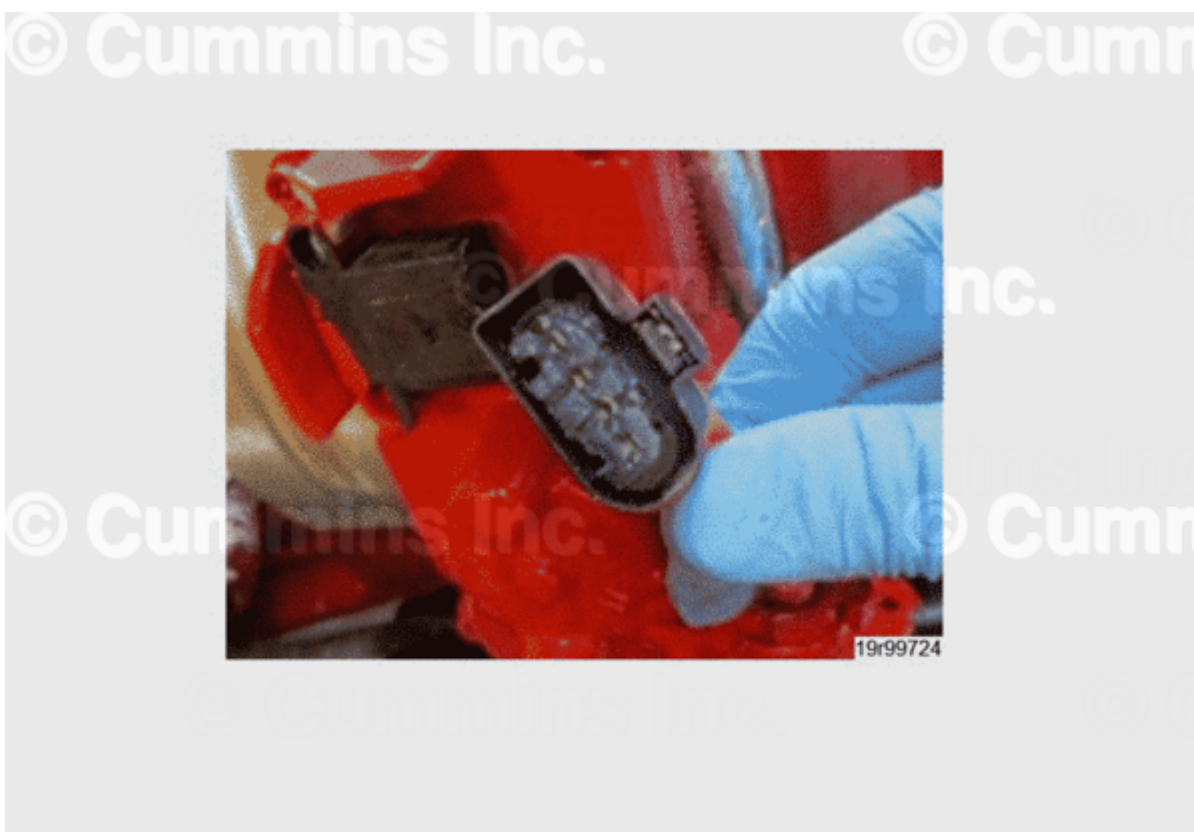
2. If checking a connector while following the published troubleshooting tree, visually inspect the connector for evidence of dielectric grease usage. See Figure 2 below.

Figure 2, Dielectric Grease in Connector.

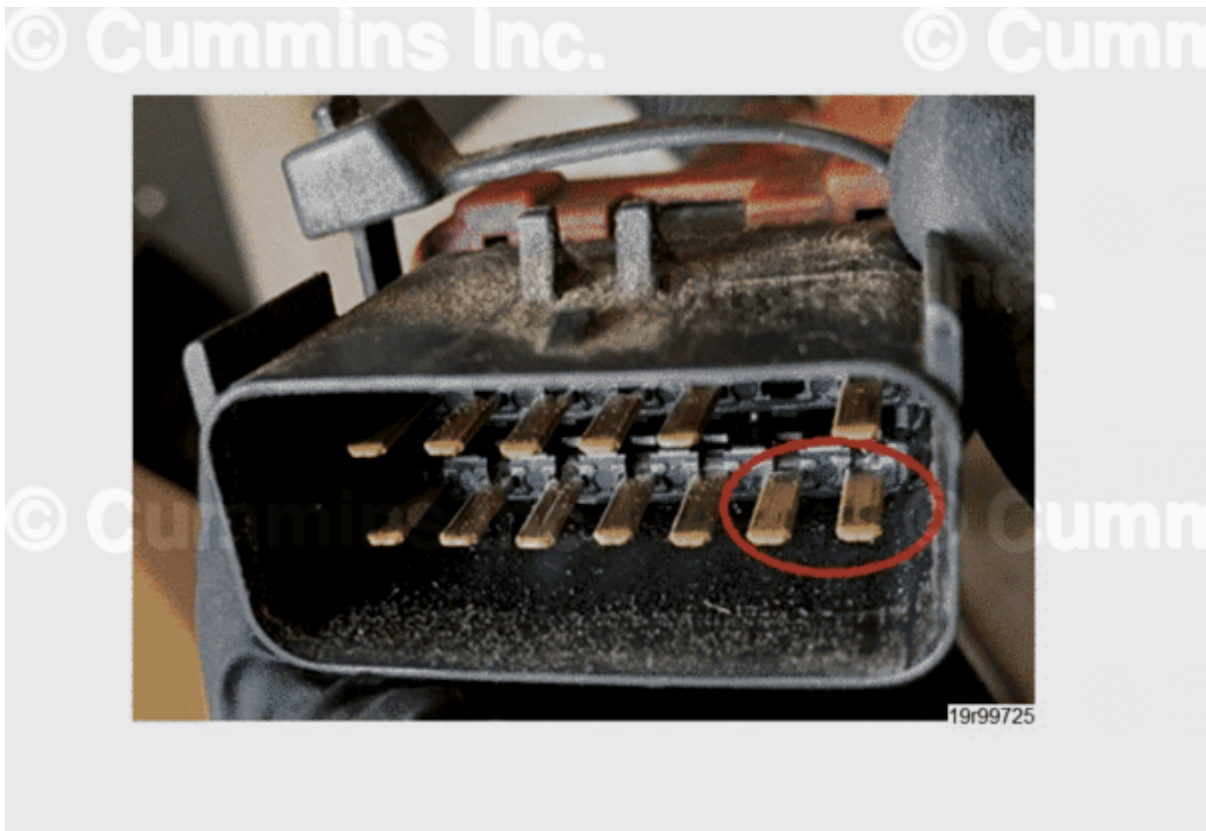
3. If checking a 14 pin connector while following the published troubleshooting tree, inspect connector for evidence of water intrusion or corrosion. See Figure 3 below.

Figure 3, Evidence of Water Intrusion or Corrosion.

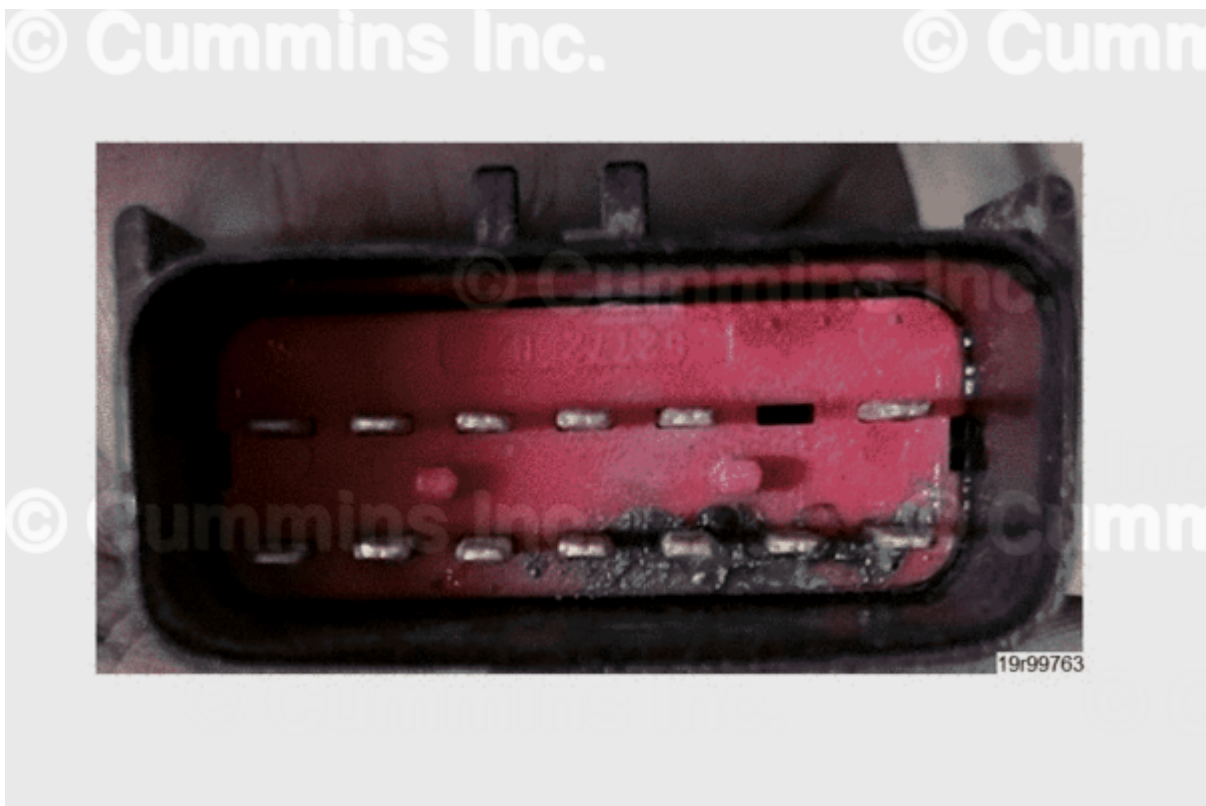
Figure 4, Evidence of Water Intrusion or Corrosion.
