## Technical product information

<b>Topic</b>	Knock/clunk noise from the rear of the vehicle (Rear axle)
<b>Market area</b>	Russische Föderation (5RU),Australia E04 Bentley rest Asia and Australia (6E04),China 796 VW Import Comp. Ltd (Vico), Beijing (6796),Germany E02 Bentley rest Europe (6E02),Japan E03 Bentley Japan (6E03),Korea, (South) E08 Bentley South Korea (6E08),United Arab Emirates E06 Bentley Middle East and Africa (6E06),United Kingdom E01 Bentley UK (6E01),United States E05 Bentley USA and rest America (6E05)
<b>Brand</b>	Bentley
<b>Transaction No.</b>	2064477/2
<b>Level</b>	EH
<b>Status</b>	Approval
<b>Release date</b>

## Knock/clunk noise from the rear of the vehicle (Rear axle)

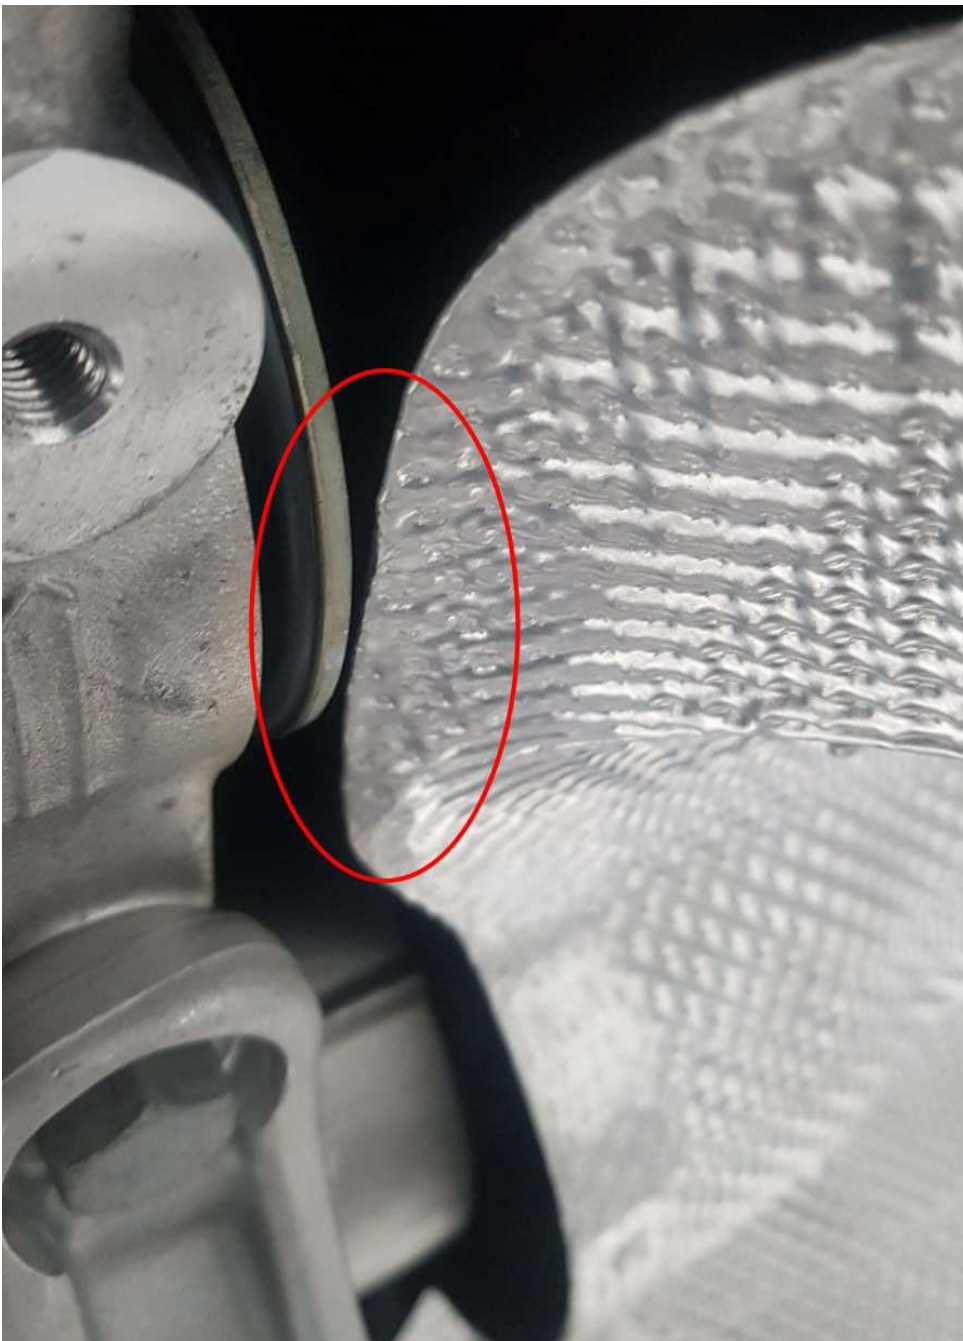
Figure 1

- Check to confirm the heat shields are not in contact or have witness marks showing evidence of contact with the rear differential and/or surrounding components

▪  
NOTE: In the event the issue shown regarding the heatshield is evident, the operative should rectify (relocate the heatshield) and retest

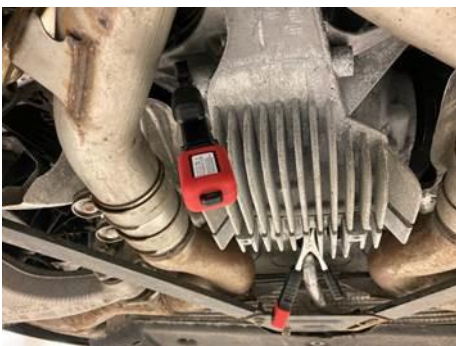
Figure 1

- Use WT 10437 (Chassis Ear Tool) to identify the source of problem by attaching the clamp and module assemblies to the areas of concern. For example, front and rear of the differential casing, as well as the upper control arms on the suspension (see Figures 1 to 3 for examples)
